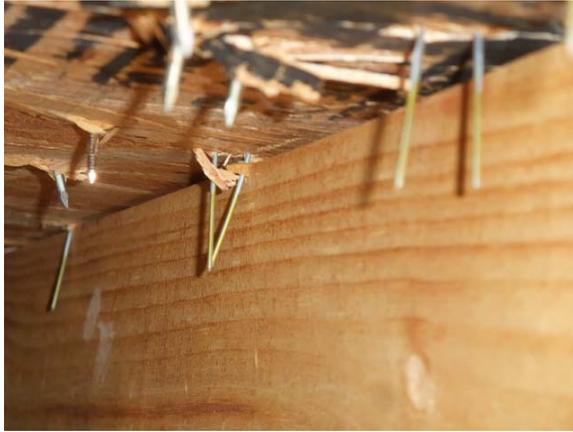
Missed staples evince a stapled roof deck. Staples are but thin wires. They're the worst fastener you can use to secure the roof deck on a house that's in a hurricane-prone coastal area. After the first roof panel is lost, the attic becomes either pressurized or depressurized, depending on the wind direction, and additional panel failures follow like dominoes. (Photo above)

3) Re-secure all roof panels to the framing during the next roof finish replacement interval in compliance with the Institute for Business and Home Safety recommendation at [http://64.16.194.32/content/data/file/FFSL\\_standards.pdf](http://64.16.194.32/content/data/file/FFSL_standards.pdf) (for 110 mph wind zones).

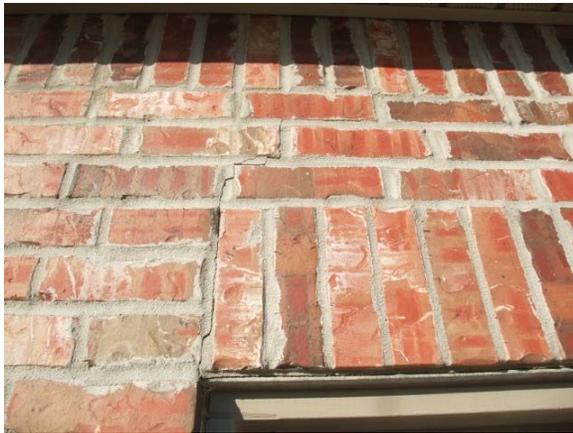
ii) I observed cracks in the brickwork over the garage door and at one location on the left wall of the house. I don't judge either to be significant at

this time though you should monitor them on an annual basis for any changes. At some point, especially if the cracks become too wide, they may indicate a structural instability in the foundation. (Photo at lower left)

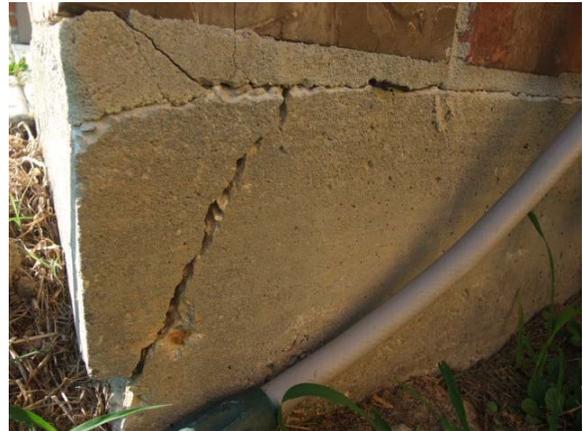
iii) I observed foundation cracks on one corner of the house. I call them v-cracks and they are a result of a difference in temperature between the foundation which is cooled by the Earth and the brick which is heated by the sun. Many houses with monolithic concrete foundations do this and I've never seen it to be much of a problem. My own house has a few. (Photo above)

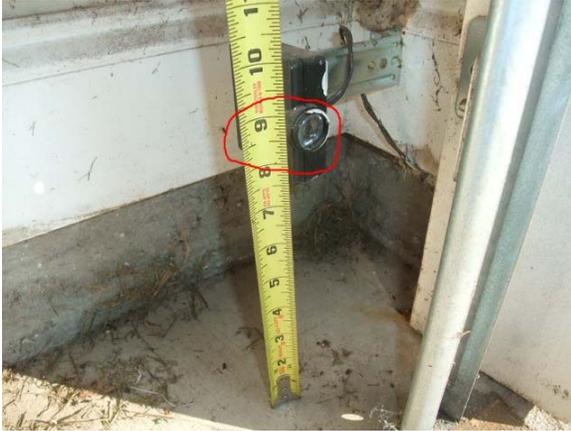
iii) The electronic beam and sensor on the garage door are installed too high. They should be installed between 4 and 6" from the floor. If they are installed too high, small children who lie in the path of a closing door might fit between the beam and the floor, leaving them in danger. (Photo at left)

5) Lower the garage door electronic beam and sensor to between 4 and 6 inches above the garage floor.

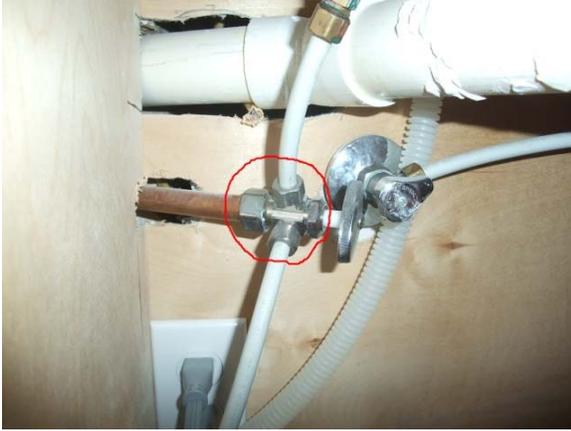
iii) The local shut off valve under the kitchen serves two appliances at once. Each appliance should have its own shut off valve. (Photo above)

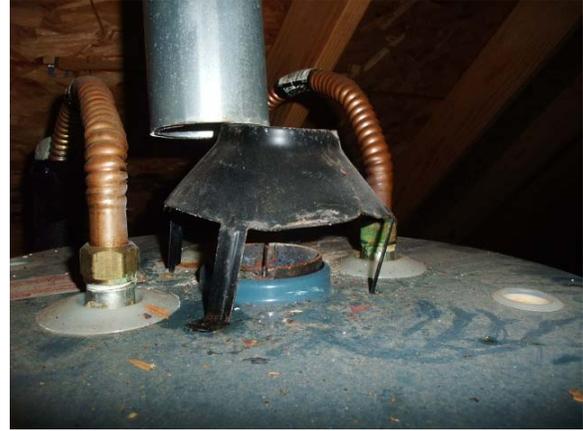
iv) The flue pipe on an attic water heater is not properly situated upon the draft hood. Hot exhaust gases spill into the attic space if the flue pipe is not properly installed. (Photo above)

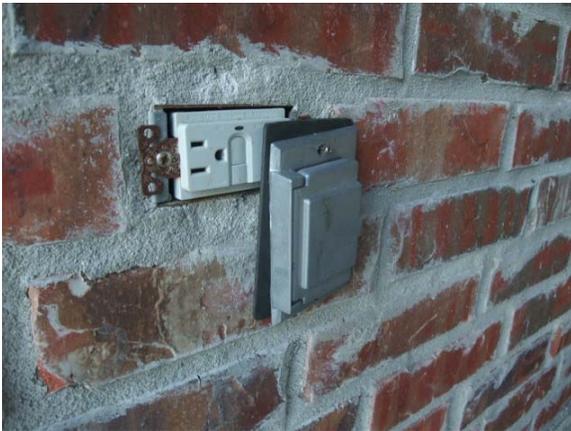
ii) A cover is loose on an outdoor receptacle. Rainwater and electricity do not play well together. (Photo above)

7) Replace or repair the cover on the outdoor receptacle.

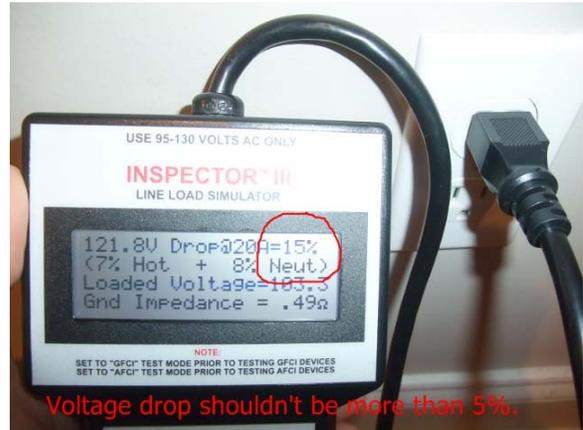
iii) Many indoor general purpose receptacles tested at high values of voltage drop. Voltage drop is the loss of voltage that occurs when a load is placed upon a circuit. For a house, it shouldn't be more than about 5% but values as high as 15% were found. (Photo above)

8) An electrician should examine and rectify the issue with excessive voltage drop. Bring all voltage drop values to within 5%.
