HOUSE INSPECTION REPORT

INSPECTION ADDRESS: 948 W. XXXXXXX Bolingbrook, Illinois

DATE OF INSPECTION: June 15th, 2008

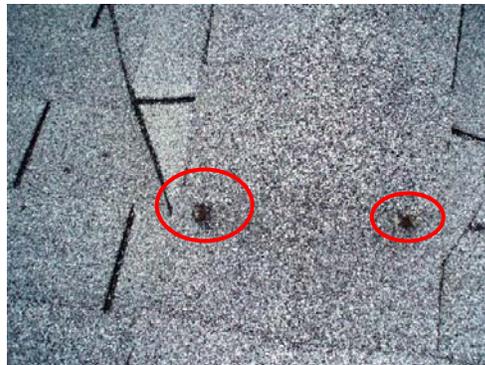
Minor Repair Exposed nail heads found at the end-ridge shingles can corrode and may allow leakage. These exposed nail heads should be dabbed with sealant to prevent or arrest corrosion.

Like these already-corroded nail heads...

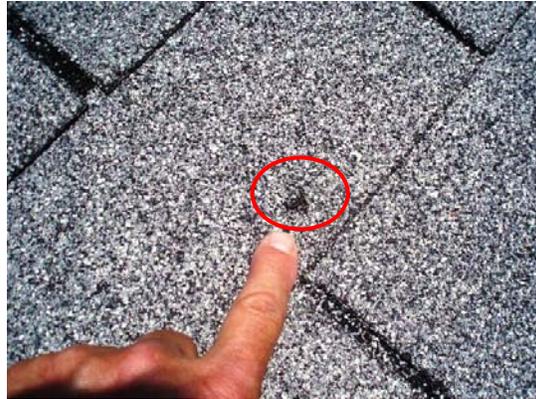
Minor Repair Many of the shingle nails have popped up and punctured through the shingles above, and the resulting exposed nail heads/shingle damage can allow leakage. Have a roofer repair all such popped nails and damaged shingles.

Like this one...

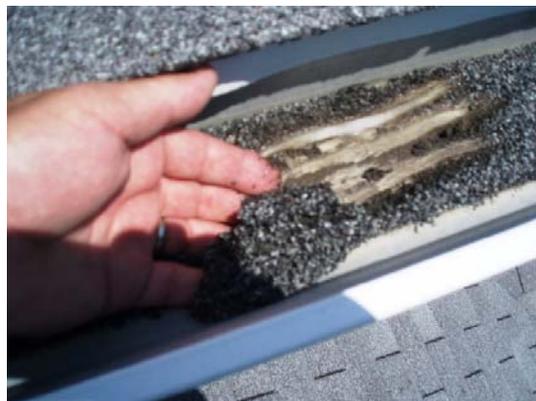
FYI The roof shingles have lost a pretty good amount of protective granule. This can shorten the expected lifespan of the shingles; lack of an adequate amount of protective granule can allow the sun's destructive ultra-violet rays to attack and deteriorate the shingle matting. Seeing how the roof nails are popping, and seeing that the shingles have lost a pretty good amount of protective granule, you better start budgeting for a new roof covering. Barring a severe hailstorm that could destroy the roof shingles overnight, expect no more than another five years of useful shingle life (you might get more, you might get less — no real way to know — only time will tell; but again, start putting money away to cover the cost of a new roof covering).

This is just some of the lost granule lying in the front gutter...

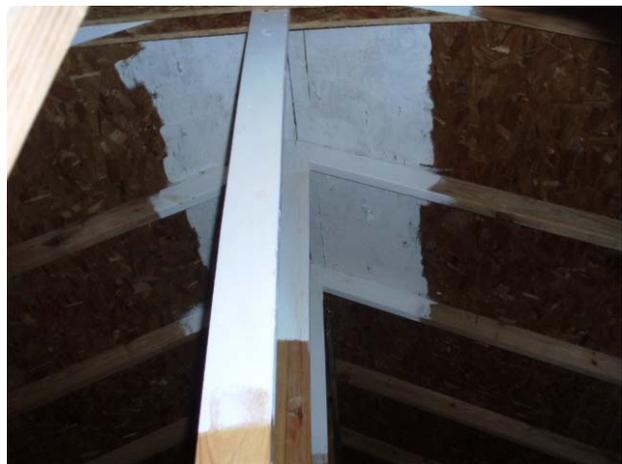
Investigate Further Up in the attic, I don't know why part of the roof framing and roof decking was sprayed with white paint (?). It might be a fungicide addressing mold growth. Ask the seller about this. If indeed there was a history of mold growth, find out what was done to eliminate the moisture source that promoted the mold growth in the first place. (If nothing was done to address the moisture source — assuming there was a mold problem — expect to have mold issues again.)

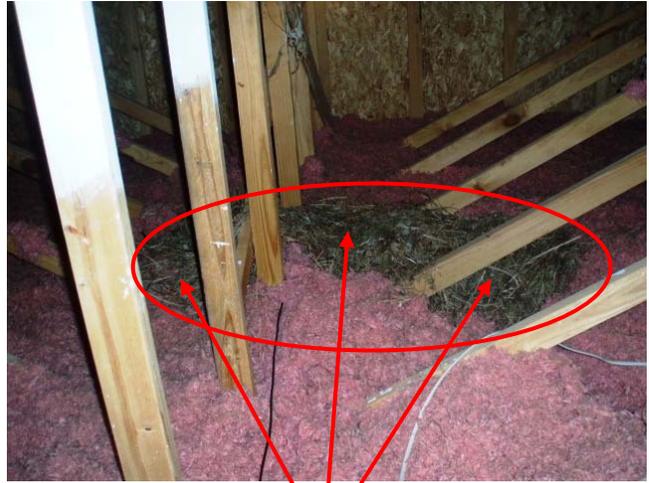
Safety Concern Bird nesting was observed in the attic. Bird droppings can be a source of disease and may represent a serious, even fatal health threat to occupants. Testing to determine if disease is present should be done. If disease is found, cleanup must be done using methods for toxic waste. Costs for cleanup can be significant. Follow up testing should be done after any cleanup. (If no disease is found, cleanup is relatively inexpensive.) For further information, contact a pest control firm or a cleaning company experienced in this type of work.

This nesting...

Minor Repair Have the damaged roof vent fixed (the one where the birds got in the attic).

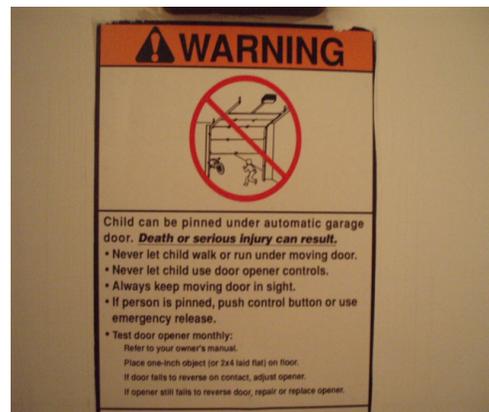
Safety Concern There is supposed to be a Child Safety Warning Label for the garage overhead door’s automatic opener posted right next to the opener’s control button. The missing warning label should be obtained and posted.

This is what the label looks like...

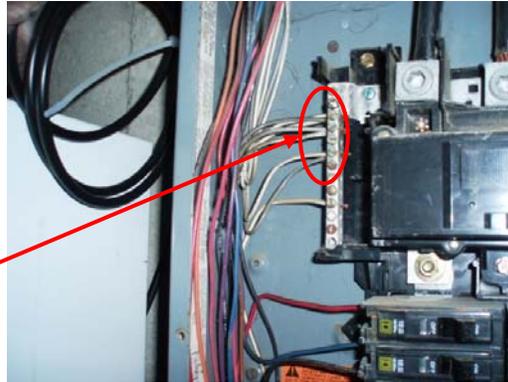
Safety Concern Inside the main electrical panelboard, neutral wires are improperly double-tapped off the left-side neutral bus bar. Such multiple-tapped wires can loosen and over-heat, posing a fire hazard. Have an electrician eliminate the double-tapping.

Here...

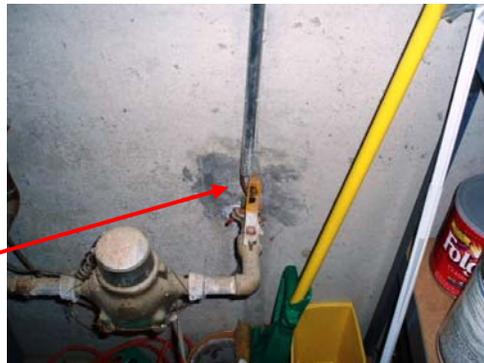
Safety Concern The bond strap is missing on the electrical pipe that contains the electrical system ground wire. Lack of the bond strap poses a potential shock hazard. Have the missing bond strap installed A.S.A.P.

This is where the pipe-strap is missing...

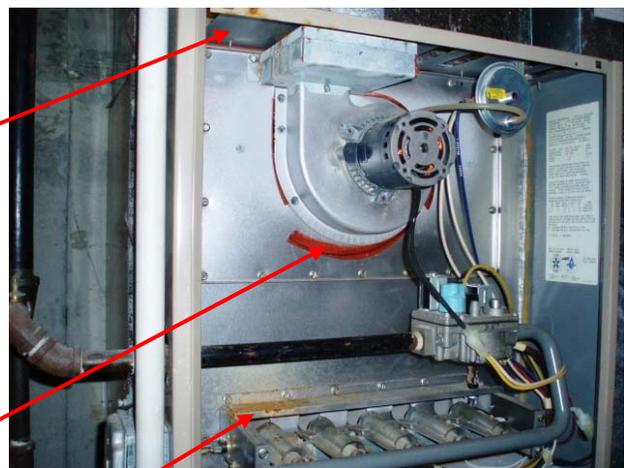
Investigate Further The gasket behind the furnace draft inducer housing has fallen out of proper position. A heating contractor should check this and repair or replace the furnace as needed.

This orange gasket...

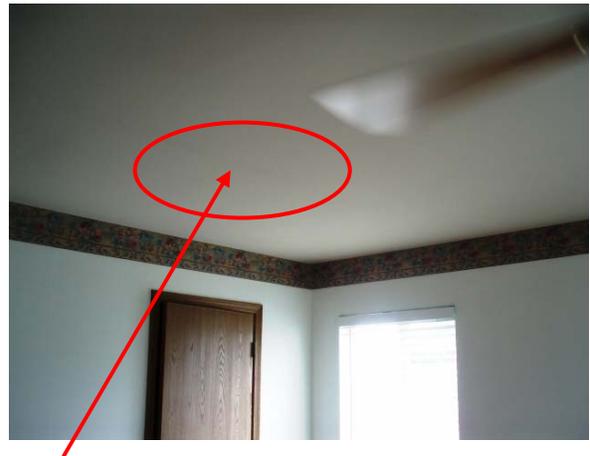
FYI There are moisture stains on the master bedroom ceiling. The stains tested *dry* with an electronic moisture meter (and we've had a lot of rain lately). I don't think the stains are from roof leakage; I think the stains might be related to the bird nesting in the attic which is directly above the stains. Keep this in mind when addressing the cleanup of the attic bird nesting, and know that the drywall will have to be painted, patched, or replaced.

The staining is up here...

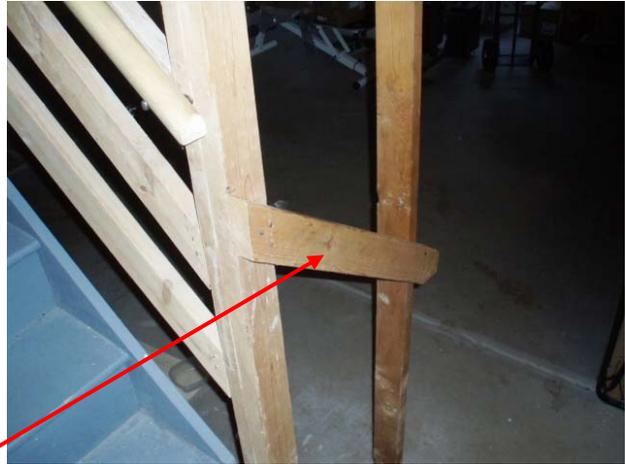
Safety Concern The handrail at the bottom section of the basement stairway does not meet "graspability" requirements (it's a 2x4). One should be able to wrap their hand around a handrail for safety reasons. I recommend the installation of a suitable handrail. Again, falling on steps and stairs is one of the primary causes of injury in the house.

This "handrail"...

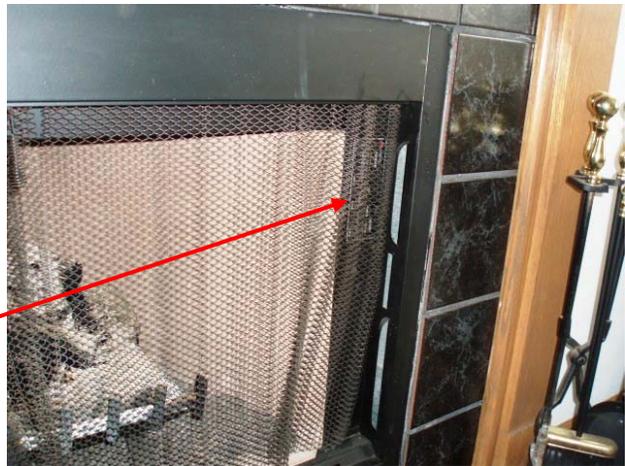
Safety Concern The fireplace manufacturer put a tag on the fireplace that says the fireplace is intended for use with solid wood fuel only. Don't use this wood-burning fireplace until the installed gas log-set is removed.

This tag...

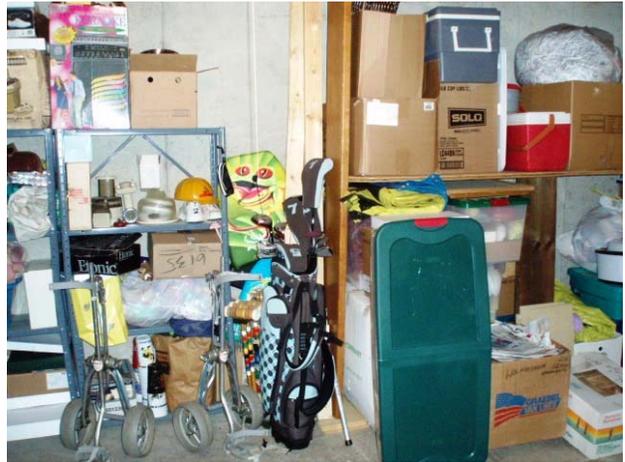
Investigate Further The following areas had a very high amount of storage and clutter present, greatly limiting what I could see during the inspection: the perimeter basement walls. These areas should be inspected when the house is vacant. At a minimum, the Client should perform a diligent final walk-through, with special attention paid to these areas.

For example...
