# ILLINOIS BUILDING INSPECTION, Inc.

## HOUSE INSPECTION REPORT

INSPECTION ADDRESS: \*\*\*\*\* Libertyville, Illinois

DATE OF INSPECTION: September 2nd, 2010

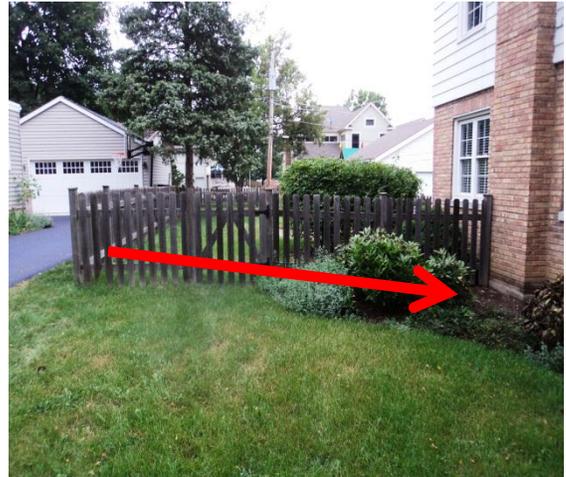
**FYI** The soil along the west side of the house slopes towards the house, quite a bit. This can promote poor drainage and resulting basement seepage. It's hard to tell if the grading will pose a problem, though; there's quite a bit of vegetation growing on the west side of the house, and same is preventing an accurate assessment of the grading. Best I can tell you is that if basement seepage occurs along the west basement wall, the west side of the house will need to be re-graded (and such would make for a Major Repair Item).

The soil slopes this way, quite severely...

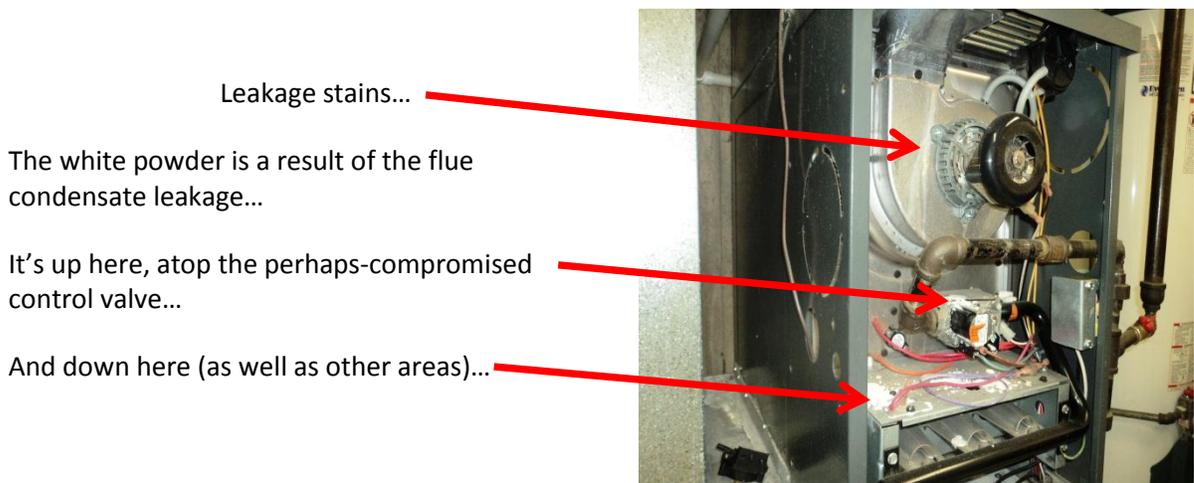
**Investigate Further** Furnace combustion fumes have been cooling and condensing inside the furnace flue pipe before the fumes fully and properly vent up and out of the furnace flue pipe. This condensate moisture is leaking out of the furnace flue joints and out of the furnace draft inducer area, and this leakage can damage the furnace components. Have a heating technician check this, and have the technician do whatever needs doing to stop the leakage and attain a proper draft. Also have the heating technician check for and replace as/if needed any already moisture-damaged furnace components. It's obvious the leakage may have already caused furnace component damage; note the high amount of water staining atop the furnace gas control valve.

**Investigate Further** The above item is likely directly related to the dangerously back-drafting water heater flue pipe mentioned earlier. Both appliances vent into the same flue pipe which in turn vents into the same masonry chimney. This masonry chimney is in suspect condition at best, and the condition of the chimney should be further investigated by having a Level II chimney inspection done, one that entails running a camera down the chimney flue to check for hidden problems. The reasons I flag this chimney as \*suspect\* are as follows: again, the chimney serves improperly venting gas-fired appliances, and as mentioned, such in turn can promote health and mechanical problems; the chimney, from the roofline-up, was once re-built, and apparently not too long ago—but the chimney is already deteriorating—not a lot, but mortar is crumbling at the top of the chimney, bricks are spalling (losing their faces during freeze-thaw cycles), and the white powder (efflorescence) on the chimney suggests chimney leakage; finally, I question why the chimney needed to be re-built in the first place. Regardless, have a Level II chimney inspection done, and have the chimney repaired, patched, replaced, or re-built as/if deemed necessary by the Level II Inspection. One place to find a qualified Level II chimney inspector is at <http://f-i-r-e-service.com/mainframe.html>
