# Photolog/Pictorial Summary

**Kurt Mitenbuler & Assoc., Inc.**  
1021 Wesley Ave. Evanston, IL 60202  
IL Lic, #450.000220

Customer: Joe Blow  
Property Location: 1234 Wesley Ave. Evanston, IL  
Inspection Date Sat, Feb 28, 2015

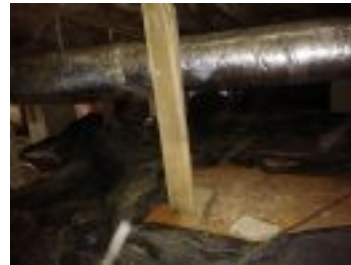
**1**

The crawlspace floor lacks a vapor retarder. The crawl space is wet; wet crawl space conditions cause mold growth or damage. Moisture evaporates up into the house and will condense in areas of the house where you may not see it, causing more mold growth or damage. When I was in the crawl space, it smelled musty/moldy. There's mold.

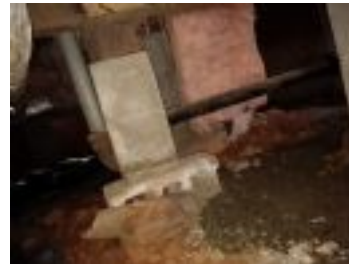
**3**

The concrete block supports are set on their sides or ends; block is not load bearing in these configurations and the block could shatter. The block s settling into the mud like the other supports.

The crawl space is a mess with multiple major problems described in the previous comments. Get a contractor in to tell you what it's going to cost to repair; the cost could be substantial.
