Rescuing a Manufactured-Stone Wall

A properly flashed water-resistant drainage plane is essential when installing stone veneer over a wood-framed wall

by Mark Parlee

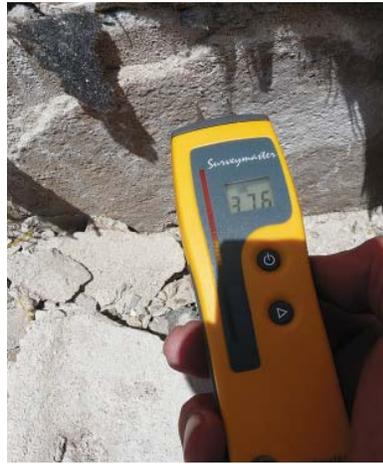
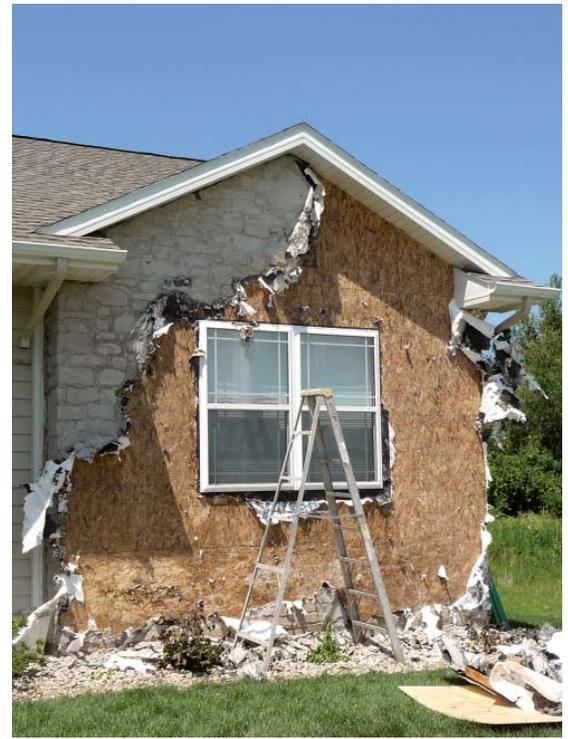
After most of the stone veneer and mortar base coat had been removed and the OSB sheathing exposed, moisture readings confirmed my suspicions: Water was getting behind the cladding and migrating into the wall system — not just around the double window, but everywhere (see Figure 1).

Although the problem was clearly worst around the window, there were elevated moisture levels at the corners of the facade and above the window, as well as in the stone veneer remaining on the wall. Below the window and at the base of the wall, moisture content readings in the wall sheathing exceeded 90 percent.

Figure 1. Though it looked sound from the outside, the manufactured-stone veneer on this nine-month-old house was absorbing water and soaking the mortar base coat (left) and the sheathing and framing underneath. The only way to fix the problem was to pull off the stone (right) and install a proper substrate.

In fact, the builder of this house followed the veneer manufacturer's installation instructions, installing a layer of Tyvek housewrap beneath a layer of 15-pound felt paper, a WRB clearly inadequate for the climate in our part of Iowa. Without any way for water to drain out, the wall was bound to leak sooner or later.

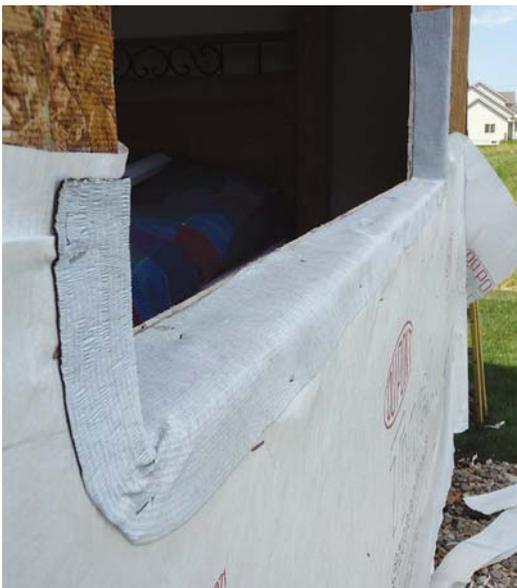
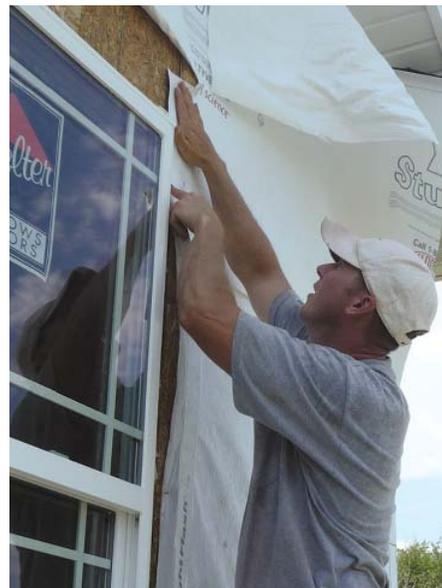
Figure 2. A sill pan fashioned from FlexWrap (far left), installed on top of the StuccoWrap, protects the rough window opening. The window is reinstalled with the nailing flanges set in sealant, then taped to the StuccoWrap (left).

Since most of the leakage occurred around the window opening, we were careful to detail the WRB and flashing properly when we reinstalled the window in the wall (Figure 2, page 2). We used DuPont FlexWrap, a flexible flashing tape, to create a sill pan at the bottom of

the opening. Then we reset the window in a bed of sealant at the nailing flange, finished wrapping the wall with StuccoWrap, and sealed the window nailing flanges to the wrap with StraightFlash self-adhering flashing tape.

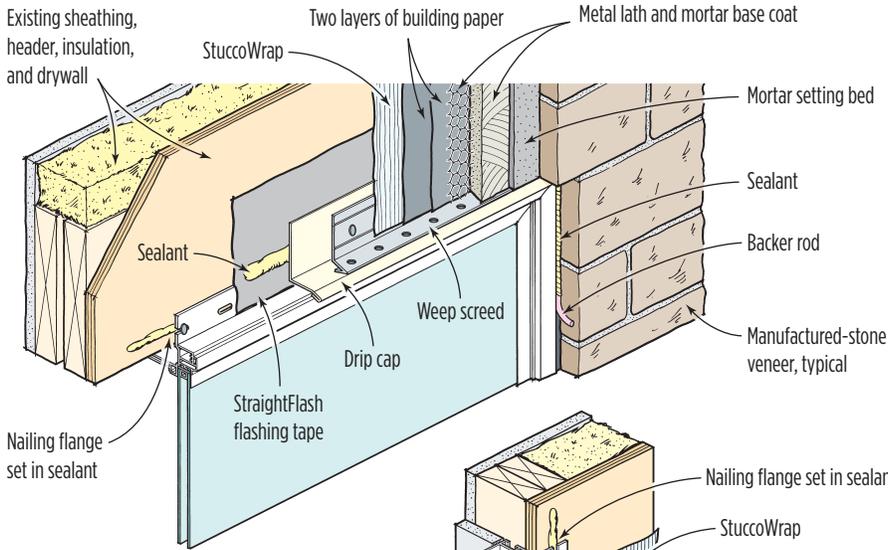
Window Head

A double layer of building paper installed over StuccoWrap creates a drainage plane beneath the mortar base coat. Galvanized metal weep screeds at the top of the window and at the base of the wall allow water to drain out of the assembly.

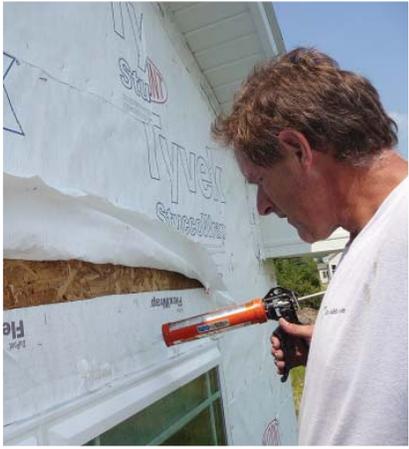
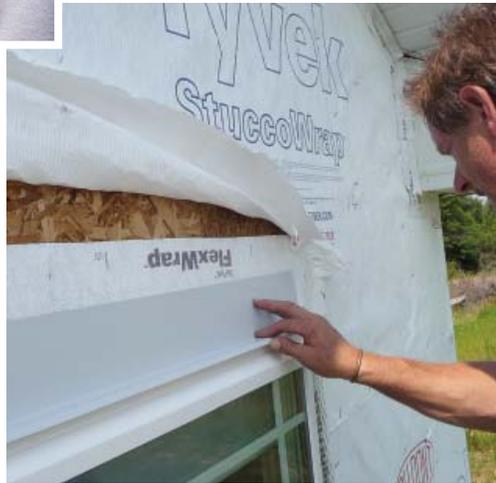
Figure 3. To limit water and air infiltration, the author applies a bed of sealant to the flashing tape above the window (above), then installs the metal cap flashing (right).

It's important that the flashings used with manufactured-stone veneer are wide enough to divert water out and over the stone. The head flashing over this window was custom-fabricated from 24-gauge G90 galvanized sheet metal with a painted finish (800/231-8127, berridge.com). We pulled back the StuccoWrap, applied a bedding sealant, and fastened the drip cap in place (Figure 3, page 4).

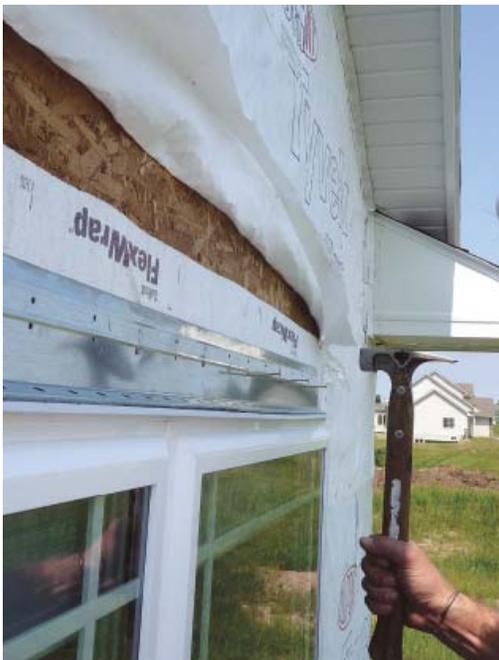
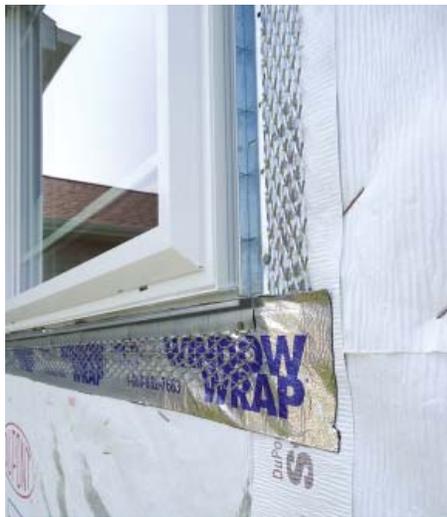
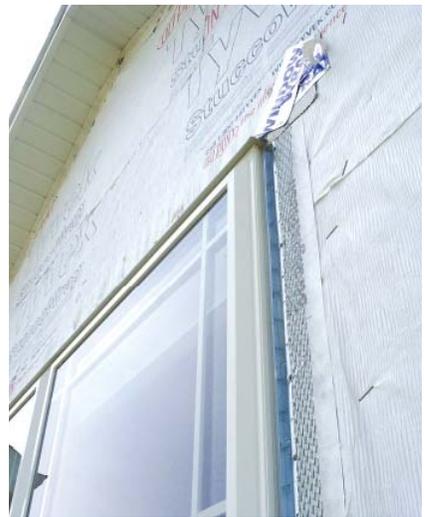
Figure 4. A metal weep screed above the window allows water to drain out from behind the cladding and mortar base coat (left). Metal J-mold is applied underneath the window (above left) and at the jambs (above right); flexible sealant is used to fill the joints between the J-mold and the window.

Before pulling the StuccoWrap back down, we attached a #36 weep screed over the drip cap (Figure 4, page 4). This screed is made from 26-gauge galvanized steel to meet FHA and code requirements for stucco installation (2006 IBC 2512.1.2).

It has a 3¹/₂-inch-wide flange and 1/2-inch-diameter holes in the kickout at the base, which help disperse water flowing down the drainage plane.

At the jambs and bottom of the window, we fastened stucco J-mold.

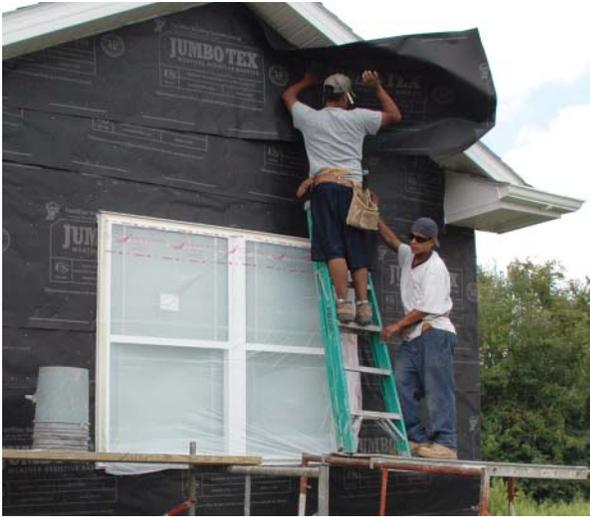
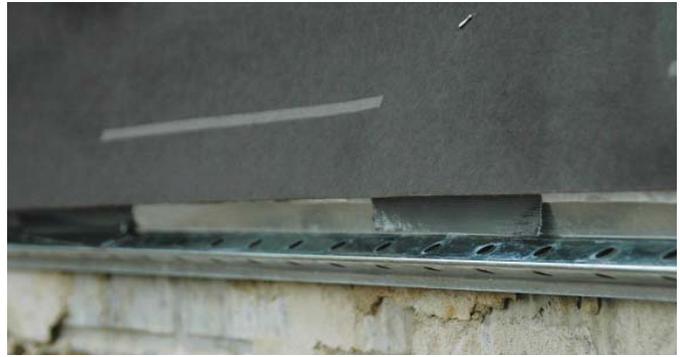
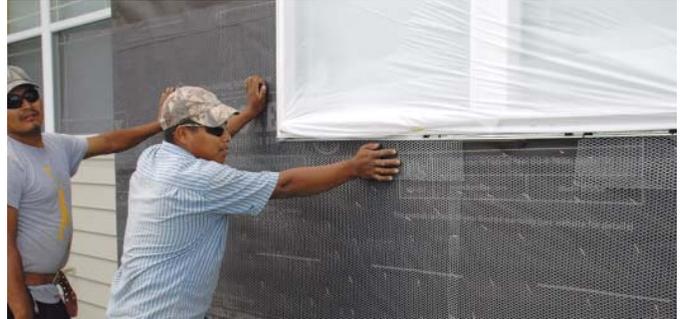
Figure 5. Crew members install a double layer of 60-minute grade D building paper on top of the StuccoWrap (above). The paper laps over a metal weep to allow for drainage at the base of the wall (above right). Galvanized metal lath (right) is then installed over the building paper.

Next we stapled up two layers of 60-minute building paper (Figure 5, page 5). At the base of the wall, we lapped the paper over #7 weep screed, which is similar to #36 screed except with a full V-profile at the ground. Then we installed the galvanized metal lath.

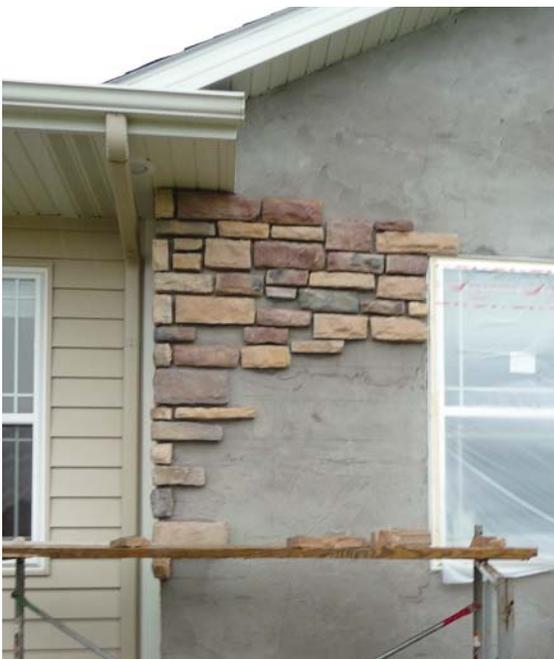
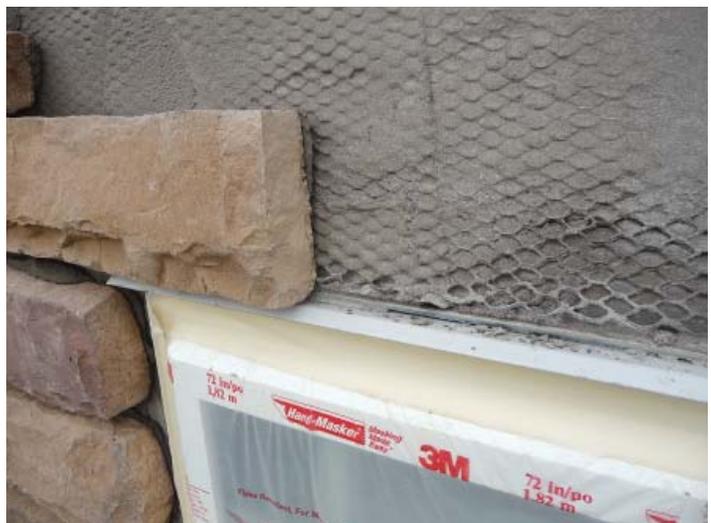
Figure 6. Like stucco, manufactured-stone veneer is applied over a base coat of mortar (left). The cap flashing (above) is sized to match the thickness of the stone veneer, to ensure that water is diverted to the surface.

After the masons applied the mortar base coat and finished reinstalling the stone veneer, we came back and detailed the joints between the window frame and the metal J-mold (Figure 6, page 5). To prevent three-point adhesion, we first filled the joint with backer rod, then applied

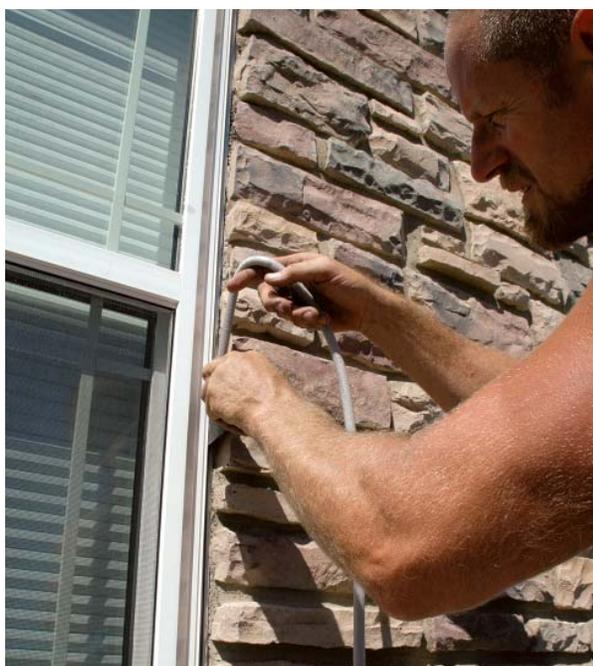
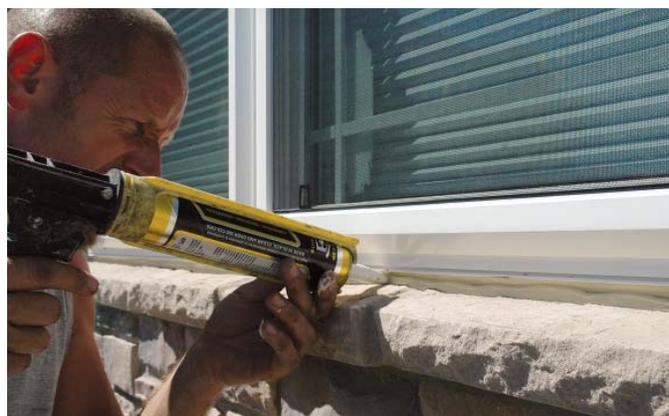
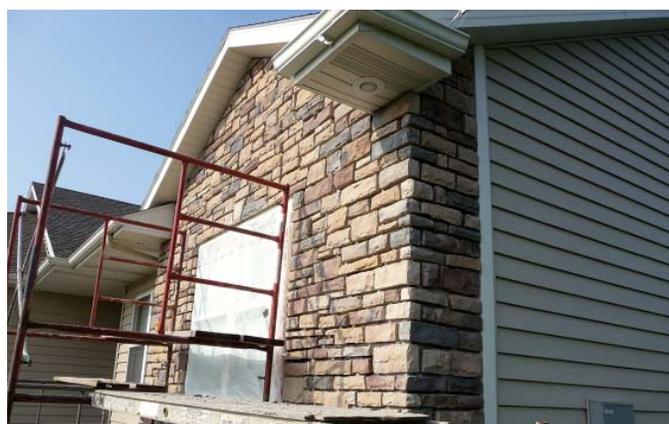
Figure 7. Backer rod inserted between the metal J-mold and the window frame (above) prevents the sealant used to fill the gap (above right) from adhering to the back of the joint, allowing it to remain flexible without pulling away from the sides. At right, the finished wall.

#900 Solar Seal adhesive sealant (800/654-1042, npcsealants.com), a solvent-based product that cures even when the mortar is still damp (Figure 7).
