### HOME INSPECTION REPORT

213 Main Street, Anytown, USA 17 September 2013

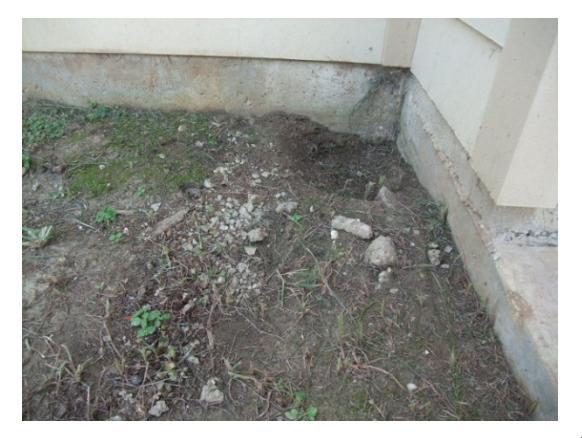
Run-off from the roof has already eroded the grounds next to the house to the point where flooding is necessary before the water is high enough to drain. Water that pools adjacent to the house weakens the soil which supports the foundation, increasing the stress upon it. Too much stress flexes it, cracks the brickwork and may eventually result in foundation failure.

2) Install a gutter/downspout system to carry rainwater away from the perimeter of the house

#### and avoid erosion.

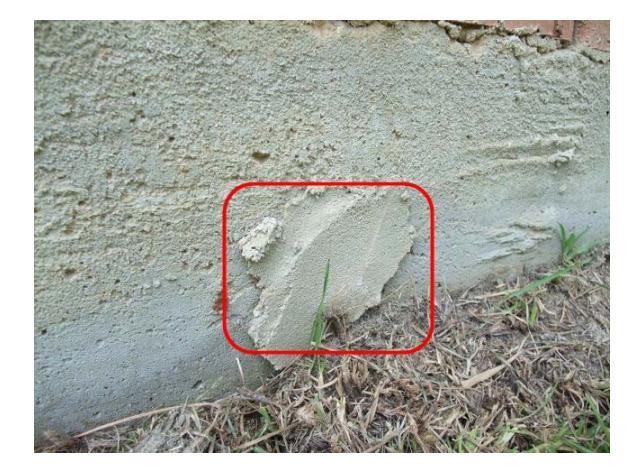
Patches of parging on the foundation suggest a post-tensioned system is installed. This is one of several desirable construction features rarely seen on houses in this part of the state.

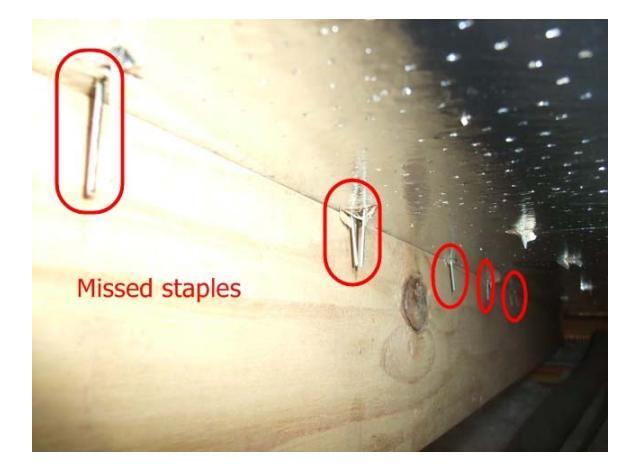
ii) Missed staples evince a stapled roof deck. Staples are but thin wires. They're the worse fastener you can use to secure the roof deck on a house that's in a hurricane-prone coastal area. After the first roof panel is lost, the attic becomes either pressurized or depressurize, depending on the wind direction, and additional panel failures follow like dominoes.

3) Re-secure all roof panels to the framing during the next roof finish replacement interval in compliance with the Institute for Business and Home Safety recommendation at http://64.16.194.32/content/data/file/FFSL\_sta ndards.pdf (for 110 mph wind zones).

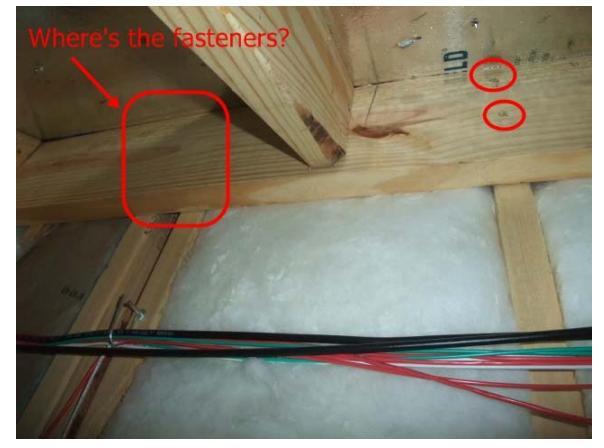
iii) A structural band behind the downstairs furnace that receives the top end of a series of rafters is sparsely fastened to the wall supporting it. I found very few nails in place. For a while, I wondered what held it there.

4) Nail the above referenced band to the wall behind it.

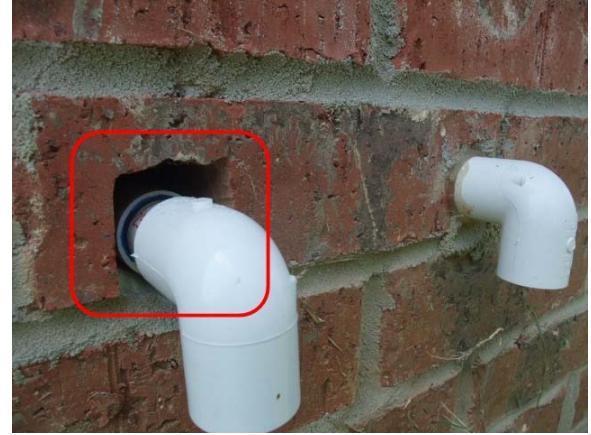
One of two penetrations in the brick veneer is unsealed. Leaving an opening unsealed invites a water intrusion issue.

6) Seal all penetrations in the exterior wall finish.

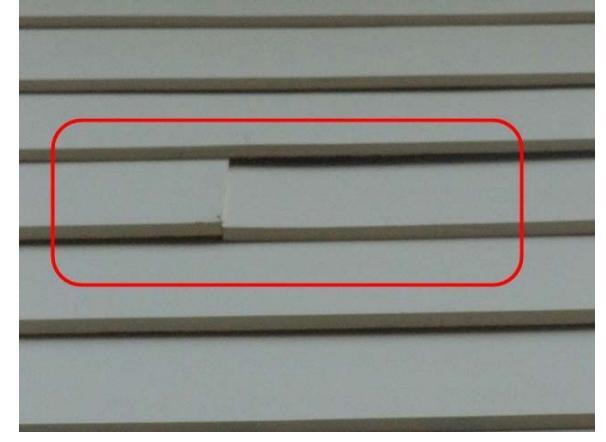
ii) The fiber-cement lap siding is very irregular in many places. Wide gaps between successive courses are present which suggest it isn't fastened properly. The problem is that this is a 110 mph wind zone. The gaps allow wind to catch it more easily and rip it off. The first defense against damage from water intrusion during a hurricane is exterior finishes that remain intact.

7) Remove all fiber-cement lap siding and repeat the installation with new siding in compliance with the manufacturer's installation instructions as well as ICC Evaluation report #ESR-2290 (for 110 mph basic wind speed), a copy of which is attached to this report. ESR-2290 details the fastener requirements for hi-wind nailing as a function of wind speed and choice of fastener.

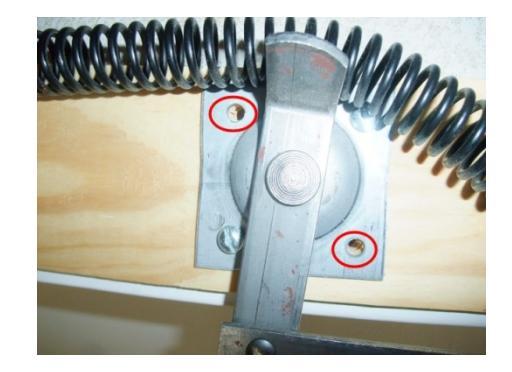
The garage fold-down attic access ladder is not properly secured to the framing. The manufacturer provides nail openings on each hinge to facilitate installation.

8) Drive a fastener into each hinge nail opening on the garage fold-down attic access ladder. Do this only after properly shimming the hinge to framing.

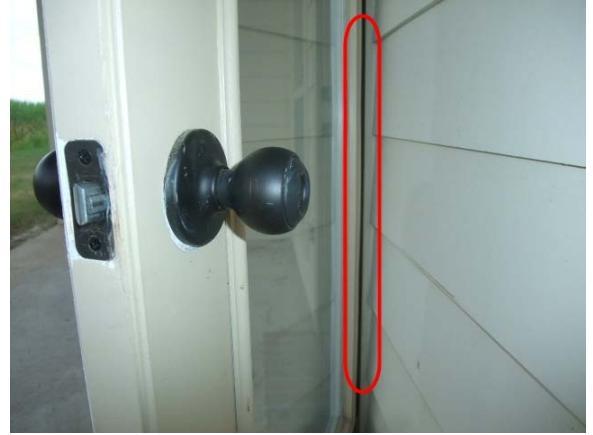
The rear entrance door doesn't have any mechanisms to prevent opening momentum from damaging something. As currently installed, the hinges might be ripped out of the door and door frame if the door was forced to full open position.

9) Ask a carpenter to install a door stop mechanism of some sort on the rear entrance door to limit door movement and avoid damage to it. An alternate solution is to install a chain/spring accessory, commonly used on storm doors, to limit door movement. 10) Ask a carpenter to install two safety hinges on the rear exterior entrance door, one at top and one at bottom.

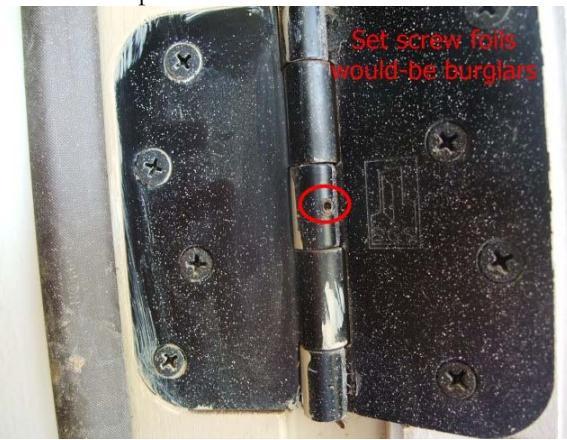
ii) The rear entrance door is an outswing door which means the hinges are outside the house, not inside like most exterior doors. It's not a problem except that a would-be burglar could easily open such a door, even when locked, by removing the hinge pins. A safety hinge is installed but there's only one. There should be at least two, one at the top and one at the bottom. A safety hinge is an ordinary hinge with a set screw that locks the hinge pin in place and can be accessed only when the door is opened.

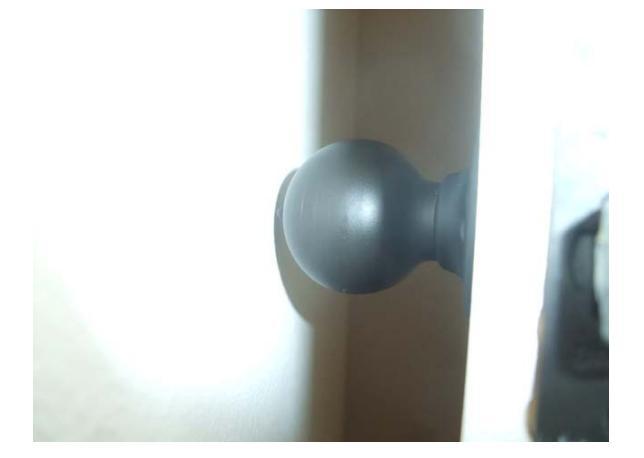
iii) The door knob on one particular door, I believe the garage entrance door, makes contact with the wall despite the presence of a door stop.

This doorstop is not effective in preventing the doorknob from damaging the wall behind it should someone swing it to full open position.

11) Install an effective doorstop on the garage entrance door to prevent the doorknob from damaging the wall behind the door.

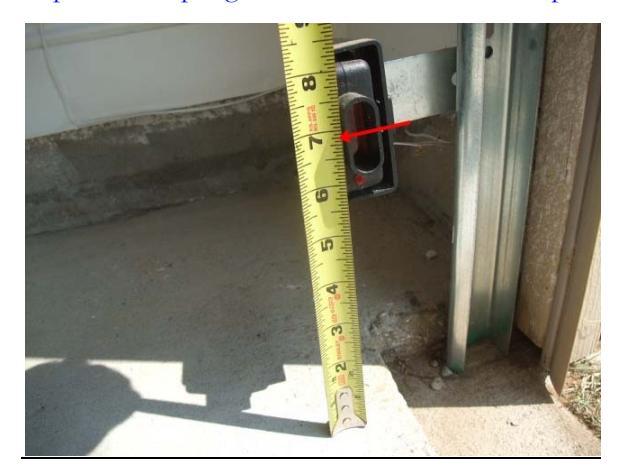
iv) The electronic beam and sensor for the garage door is installed too high. They should be installed between 4 and 6" from the floor. If they are installed too high, small children who lie in the path of a closing door for amusement might fit between the light beam and the floor, leaving them in danger of suffocation when the door comes down upon them. For more information, view document # 523 at the Consumer Products Safety Commission at

12) Lower the garage door electronic beam and sensor to between 4 and 6 inches above the garage floor.

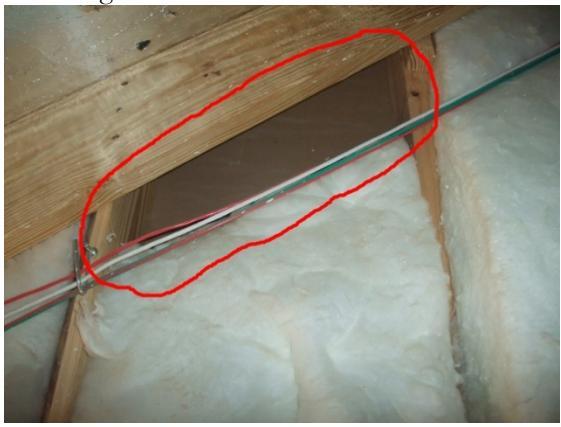
Some attic wall insulation is loose and has already begun slipping out of position. A small breach in the insulation envelope ruins the investment in a much larger insulated area.

15) Secure all attic wall insulation and eliminate all breaches in the insulation envelope.

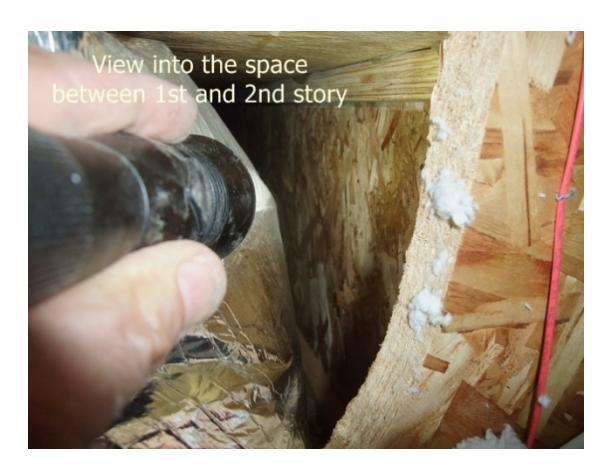
ii) The space between the downstairs ceiling and the upstairs floor doesn't need to be insulated since both downstairs and upstairs interior spaces are conditioned but this space should indeed be insulated from the attic. In every observable location, it was not. The insulation in the upstairs walls stops at the bottom of the wall and the insulation on the attic floor doesn't rise to it. The gap between them constitutes a breach in the insulation envelope of the house. (photo next page)

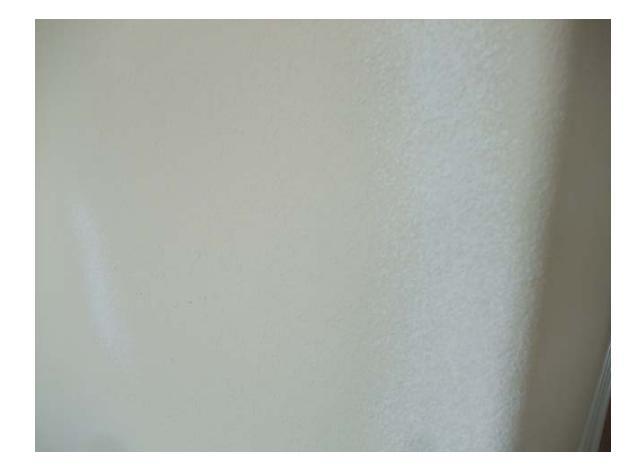
The interior wall paint is very thin in many places. This is entirely a cosmetic issue.

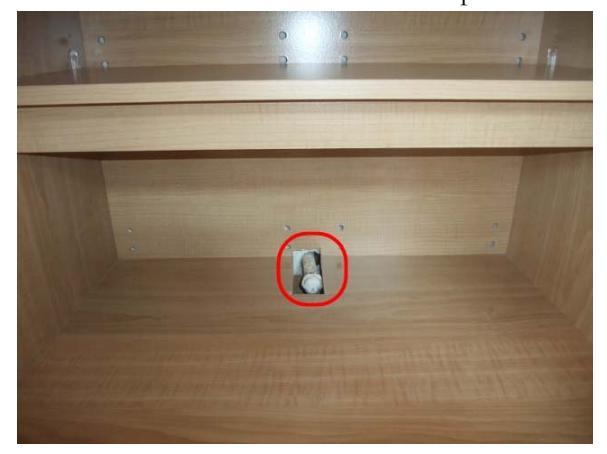
ii) A kitchen base cabinet has an opening in it for an unused gas line. There's no escutcheon installed. Escutcheons are not just cosmetic. They separate the combustible materials within the wall from the conditioned interior spaces.

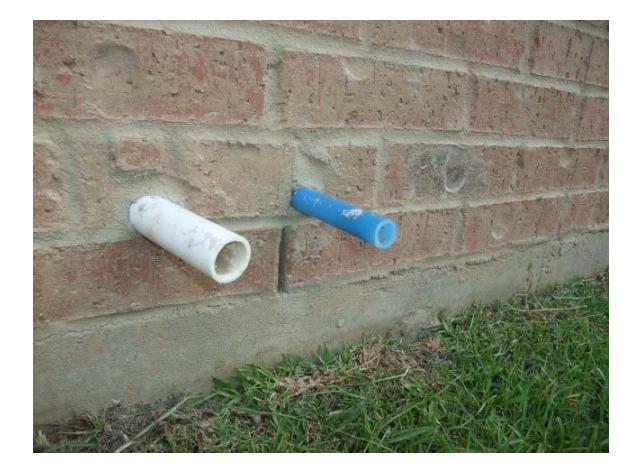
The water heater T&P safety relief valve drain and water pan drain lines terminate just outside the brick exterior wall finish. They should terminate only once they point downward to the earth. This is to reduce the chance that someone or something will plug them. (photo next page)

16) A plumber should complete the two water heater drain lines so that they point downward.

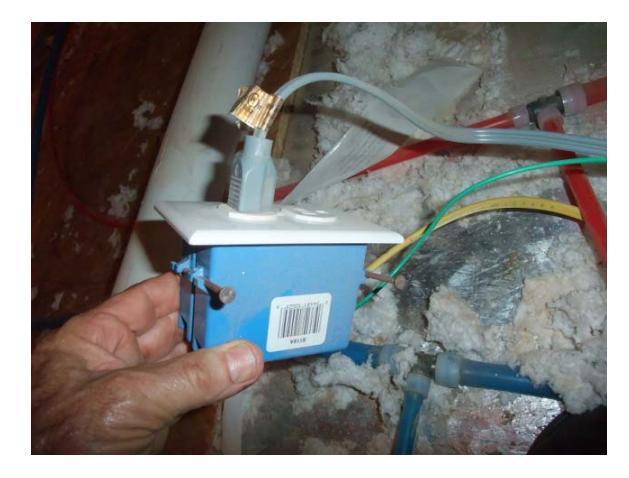
A device box in front of downstairs gas furnace lies loose on the attic floor. Electrical boxes should always be secured. This is a common finding on older homes but not new construction.

18) Secure the loose electrical box in front of the downstairs furnace.

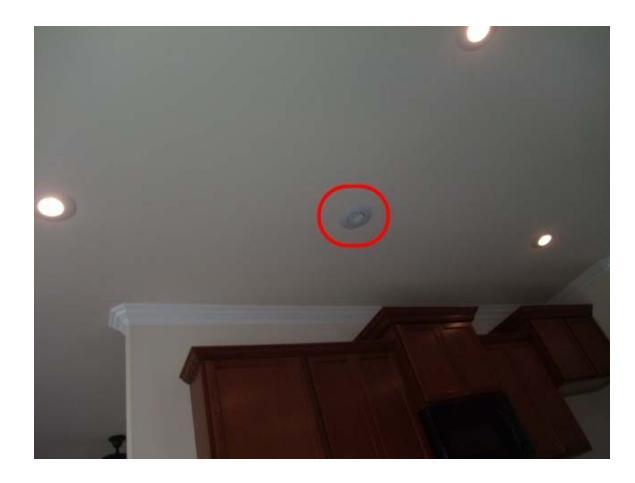
ii) A recessed light fixture above the range hood did not illuminate. (photo at right)

19) Ask an electrician to examine the recessed light fixture above the range hood.

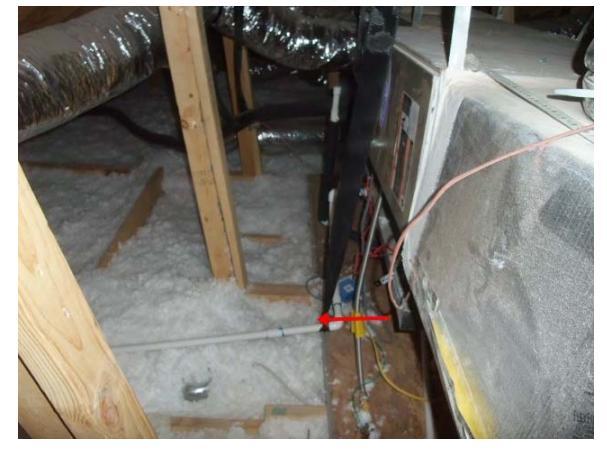
There's no solid working surface in front of the service side of each attic furnace/cooling coil. Each attic appliance should have one that measures at least 30 inches square. This space should be clear and unobstructed.

M1305.1.3 Appliances in attics. Attics containing appliances requiring access shall be provided with an opening and a clear and unobstructed passageway large enough to allow removal of the largest appliance, but not less than 30 inches (762 mm) high and 22 inches (559 mm) wide and not more than 20 feet (6096 mm) long when measured along the centerline of the passageway from the opening to the appliance. The passageway shall have continuous solid flooring in accordance with Chapter 5 not less than 24 inches (610 mm) wide. A level service space at least 30 inches (762 mm) deep and 30 inches (762 mm) wide shall be present along all sides of the appliance where access is required. The clear access opening dimensions shall be a minimum of 20 inches by 30 inches (508 mm) by 762 mm), where such dimensions are large enough to allow removal of the largest appliance.

20) Install a minimum 30 inch square solidly deck work surface on the service side of each attic installed appliance. Leave these work surfaces unobstructed by framing, plumbing pipes and tubing, electric cables, condensate lines, refrigerant line sets and air conditioning ducts.

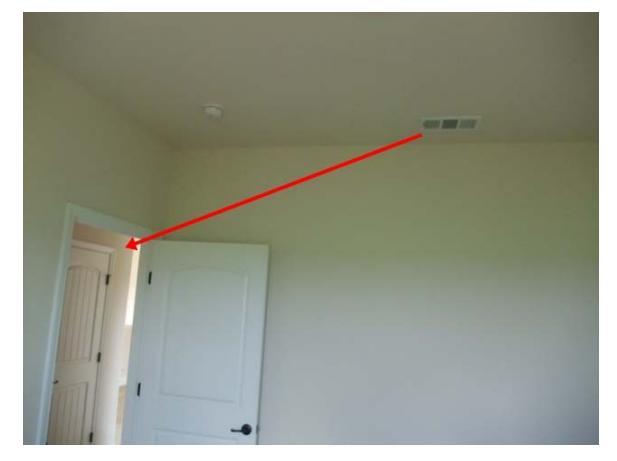
ii) The ceiling registers in two bedrooms are installed too close to the entrance door. This might result in uneven temperatures within the room since the air supply crosses only a small portion of the room before it exits out the door. It might also result in frequent short cycles of the HVAC system because the thermostat is too close to the registers. The registers should be further away from the entrance door and closer to the windows so as to cause the conditioned air to cross as much of the room as reasonably possible.

21) Relocate the bedroom ceiling registers further away from the entrance door and closer to a window.

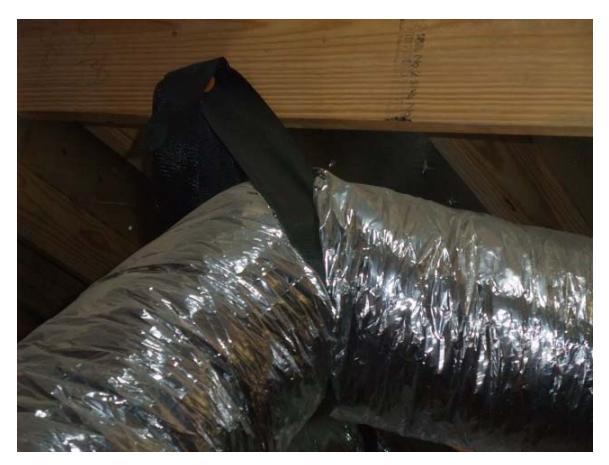
iii) There are many instances where flexible duct is crimped over a structural member, pipe or some other. This reduces the air flow through it and ruins the results of a 'D' calculation performed on the ductwork. The radius of a bend in flex duct should not be less than the diameter of the duct itself. For more information, visit

22) Re-route all attic ductwork to avoid sharp bends in flex duct. Provide a bending radius at least equal to the duct diameter.

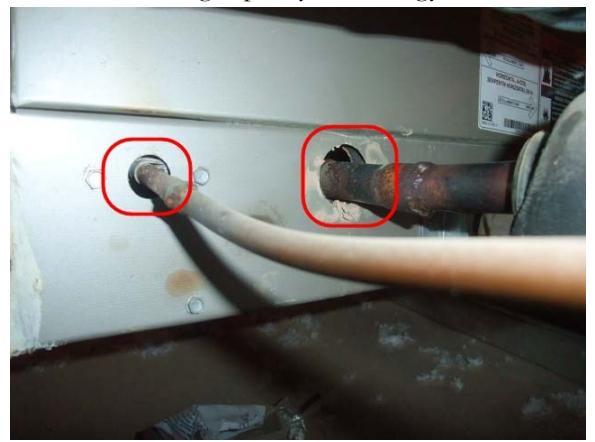
v) Several penetrations in each cooling coil cabinet are unsealed and allow conditioned air – and money – to escape into the attic. They provided this inspector with a welcomed respite from the attic heat but you should now seal them to conserved cooling capacity and energy loss.

24) Seal all penetrations and air leaks in the cooling coil cabinets.
