Hawkeye Home Inspections

Inspection date: 10/16/07
Address:

Building Inspection Report

Year Built	1955
Square Footage	1334
Bedrooms	3
Bathrooms	2
Garage	None

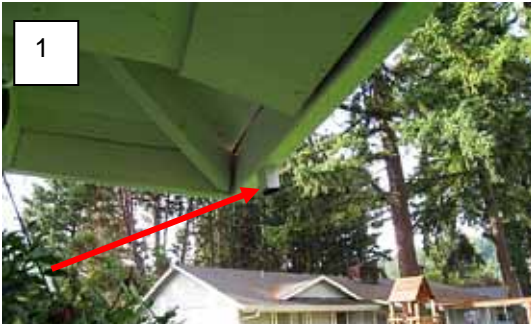
Item 2 - Missing downspout on the front entry.

- 2) **Roof drainage system:** I found a number of issues with the roof drainage system; for example, it looks like the gutters were hung too low and flashing was installed to try and cover the large gap between the roof and the gutters. This flashing was just stuffed loosely into place and not fastened at all. Winds will dislocate this flashing. The gutters were filling up with leafs and the downspout was missing right of the front entry and downspouts also drain next to the house. Have a gutter contractor come out and reinstall the gutters properly. If flashings are needed then get them fastened in properly to the roof. Clean out the gutters and install leaf guards. Ensure that all downspouts are installed and have leaders draining away from the house. See photos 1 & 2 on page 4. See photo 2 on page 5. See photo 7 on page 5. See photo 1 on page 7.

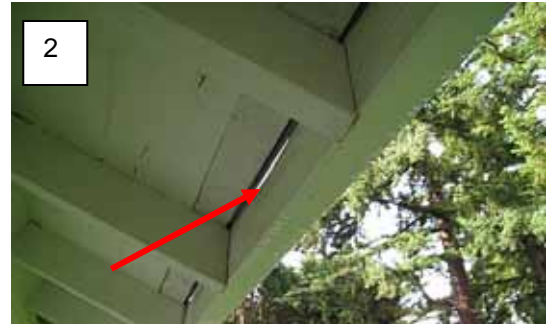
Item 2 - Gap between the roof and gutter on the front of the house.

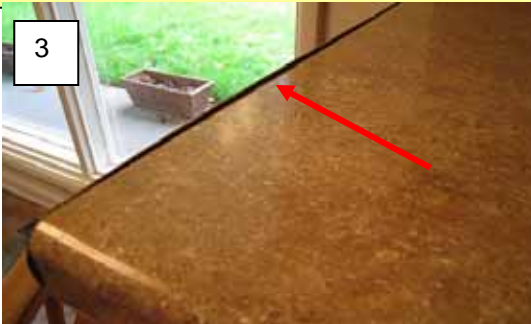
Item 28 - Protruding end cap on kitchen counter is vulnerable to damage.

- 28) **Counters:** In the kitchen, the laminate counter top end cap is protruding and will likely become damaged. Have it trimmed flush with the counter. See photo 3 on page 4.

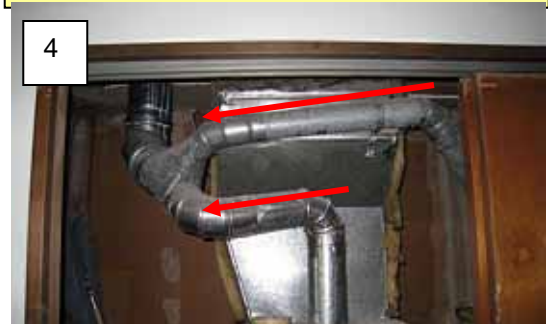
Item 21 - Item 20 - Furnace and water heater vents slope downwards.

- 20) **Hot water heater:** The water heater was not lit, had water in the pan, the vent installation is wrong and hazardous and the water heater is way beyond its expected service life. Don't even try and see if it can be fixed. Have the water heater replaced. See photo 4 on page 4. See photo 5 on page 4.

- 21) **Heating:** The furnace needs repairs for example the vent installation is wrong and hazardous, the fan has a broken blade on the exhaust inducer and makes a lot of noise, the furnace and filter are dirty. Have a HVAC contractor evaluate further and repair the furnace right away. See photo 4 on page 4. See photo 6 on page 4. See photo 8 on page 7.

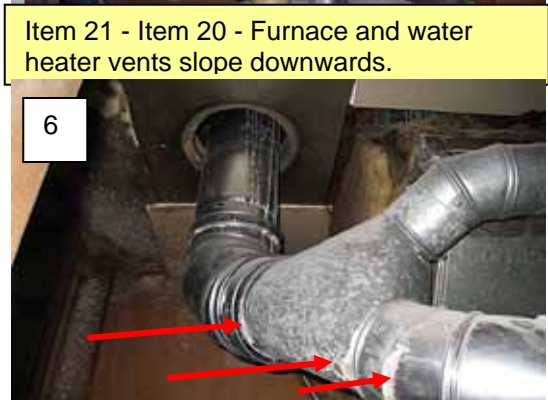
Item 21 - Corrosion at joints of furnace/water heater vent.

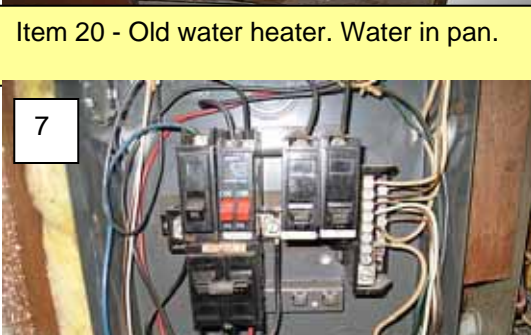
Item 12 - No proper 4 conductor feeder to sub panel. No isolation of grounds and neutrals.

- 12) **Electrical:** The main electrical panel is a Zinsco brand panel and the ITE subpanel installation is completely messed up and hazardous. Zinsco panels are problematic. Don't even bother trying to straighten this mess out. Have an electrician upgrade the service and replace both panels with a single panel right away. See photos 7 & 8 on page 4.

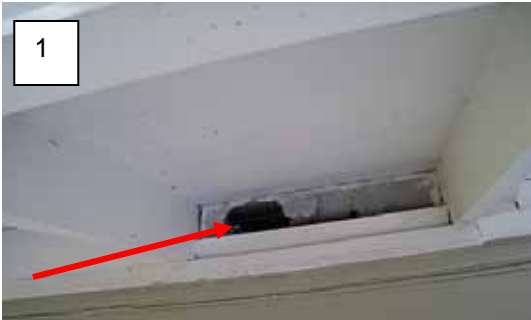
Item 4 - Torn open eave vent screen on the back of the house next to patio.

- 4) **Exterior:** On the back of the house the eave vent screen is torn open west of the rear porch. Repair the screen. Looks like some type of animal has been entering thru it. See photo 1 on page 5.

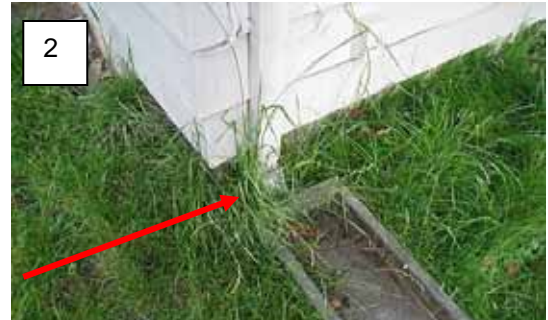
Item 2 - Downspouts drain next to the house.

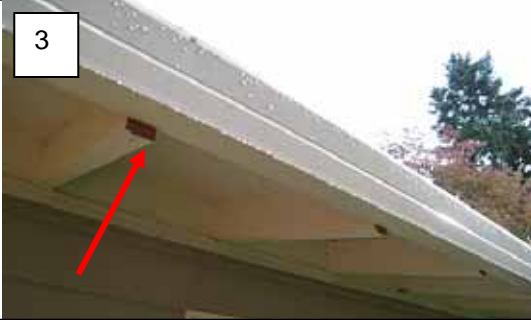
Item 6 - Rafter tails are not painted at their ends.

- 6) **Exterior:** The ends of the rafter tails are not primed and painted. They should have been before the gutters were installed. Try coordinating with the gutter contractor to have these rafter tails primed and painted when they rehang the gutters. If you don't you, should count on some deterioration to various rafter tails and higher repair costs later. See photo 3 on page 5.

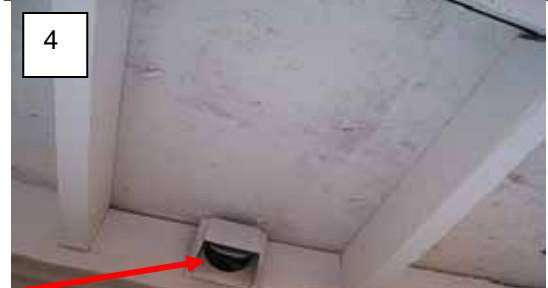
Item 27 - Bathroom vent housing not mounted right. Damper door is always open.

- 27) **Ventilation:** On the east side of the house the 2nd bathroom exhaust vent is installed wrong and damper door hangs open. Have it installed properly. See photo 4 on page 5.

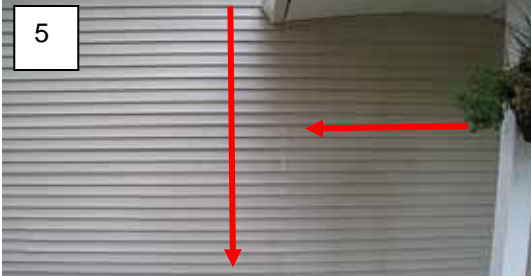
Item 7 - Water streaming down from gutter interface siding on the left side of the front entry.

- 7) **Exterior:** At the time of the inspection, there were rain showers, and water was streaming down the siding on the front of the house where the gutter on the east side of the front entry me the house. Have flashing installed to prevent this. See photo 5 on page 5.

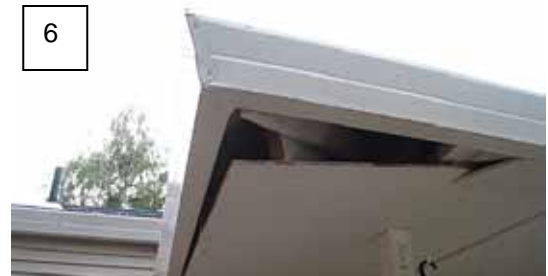
Item 3 - Soffits should be fully open or fully closed to prevent birds from nesting in them.

- 3) **Exterior:** It looks like someone was trying to cover the open eaves of the front entry but left the corners open. Close up the openings to ensure that birds and vermin don't nest in the front entry roof cover. See photo 6 on page 5.

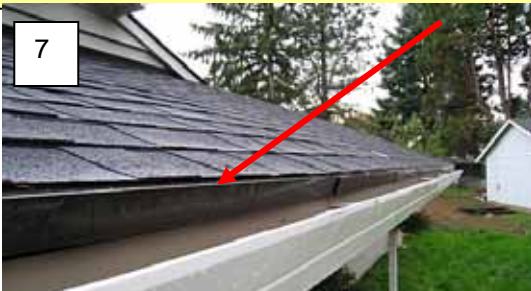
Item 2 - Drip edge flashing unfastened.

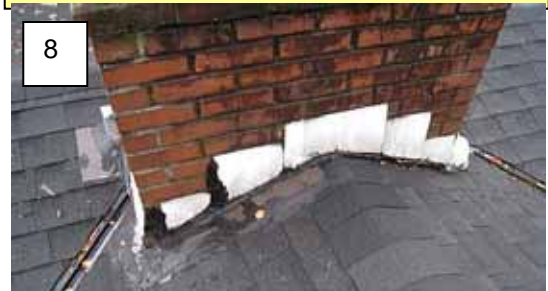
Item 1 - Chimney is improperly flashed in.

- 1) **Roof:** The roofing installation is not satisfactory and a mess. For example lots of shingles were aligned to the nailing chalk line and were not sealing down, chimney flashing is installed wrong and gooped with copious amounts of black roofing sealant, valleys are installed poorly (front valleys were sloppily cut, the left valley metal sections are not aligned and the interface between the two sections is gooped with copious amounts of black roofing sealant, the rear valleys are woven wrong), none of the sidewall interfaces at the gables are installed right (For example at the west gable the roofing is incomplete, bare roof decking is exposed, underlayment is not installed properly, there's no flashing and its absolutely roofed wrong at the end of the northern end rafter. This gable end obviously leaks.) At other gable ends the flashing is either not installed or installed wrong. And there is no flashing at the electrical service mast; another point that will leak. These are just examples and not a complete list of issues. In order to obtain any warranty from the roofing mfg, the roofing must be installed per their instructions and recommendations which in this case it is not. The shingles look like a 25 – 35 year product, it follows then the installation of the roofing system should be capable of lasting that long and it's not. Find out who the shingle mfg. is. Have the rep come out and inspect the installation and see if they will even warranty the installation assuming the installation can be repaired to the mfg's satisfaction. Have a licensed roofer perform the repairs properly and not the last person who made this roof a mess. See photo 8 on page 5. See photos 1, 2, 3, 4, 5, 6, 7 & 8 on page 6. See photo 2 on page 9.

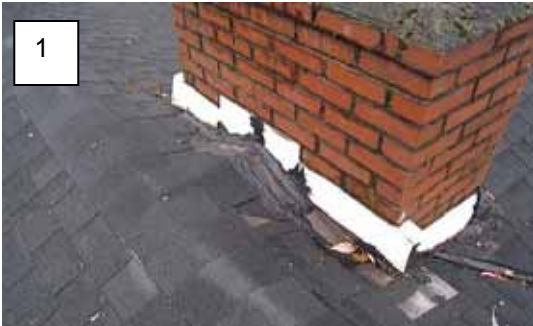
Item 1 - Another view of improperly flashed in chimney.

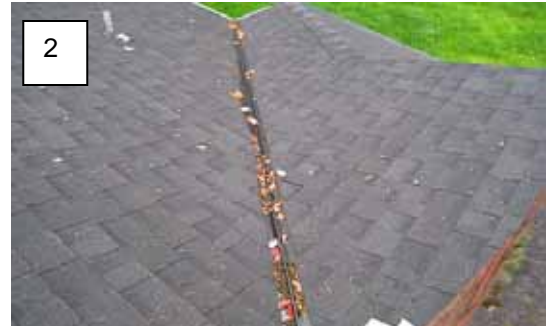
2

Item 1 - Shingles along the valley are sloppily cut.

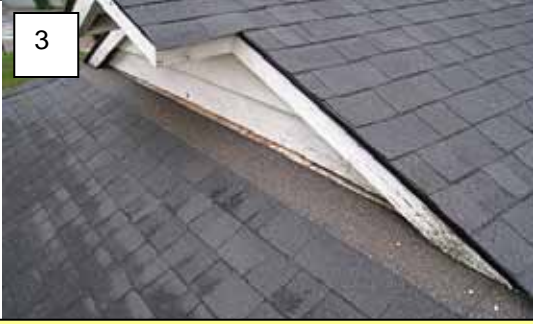
3

Item 1 - Roofing installation is incomplete at the west gable. Bare decking is

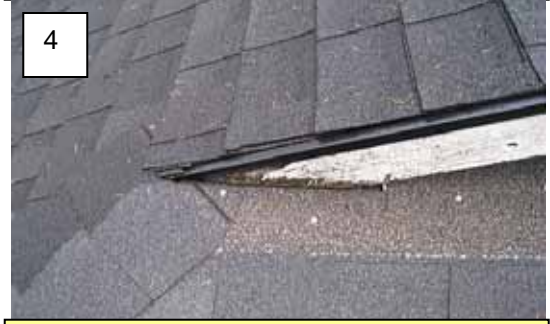
4

Item 1 - The roofing is installed wrong at the north end of the end rafter on the west

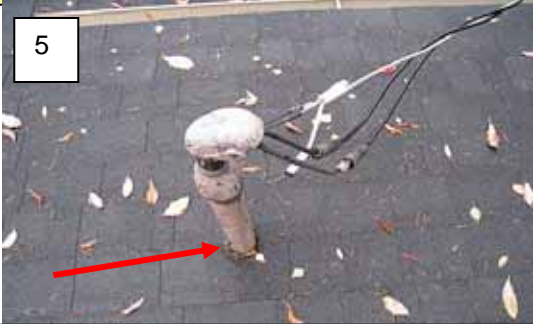
5

Item 1 - No flashing what so ever around the electrical service mast.

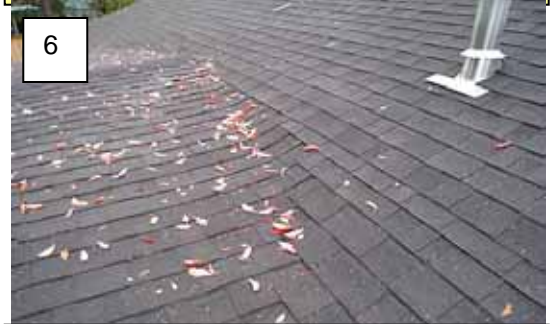
6

Item 1 - Valleys woven wrong where patio roof meets the house.

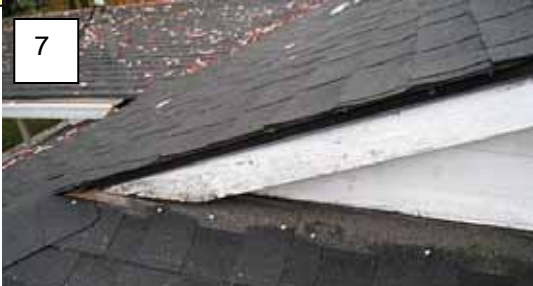
7

Item 1 - East gable has no flashing.

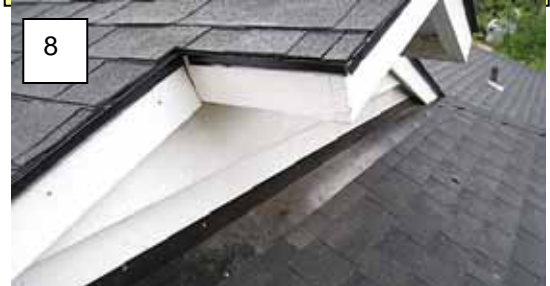
8

Item 1 - North gable has the sidewall flashing not counter flashed.

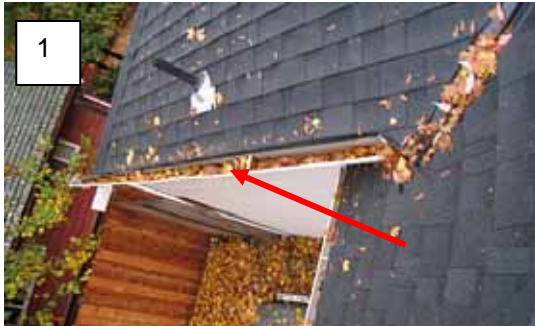
Item 2 - Gutters need cleaning.

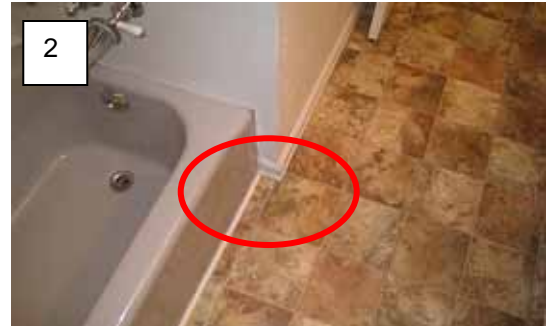
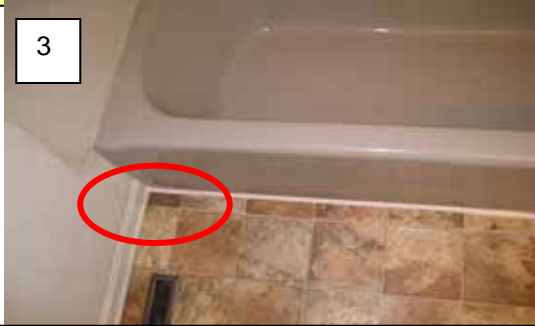
Item 29 - Floor is soft adjacent to ends of the bathtub.

- 29) **Floors:** The hall bathroom floor is damaged at both ends of the tub. In the crawlspace under the tub the subflooring is stained by moisture and decay fungi growth and I could see rot damage between the floor boards. Whenever I have seen this degree of deterioration in the crawlspace under shower walls it has meant that there is most probably deterioration and damage in the walls. Have a qualified contractor replace all rot/moisture damaged materials in the floors and walls at the bathtub. The source of the moisture I think is from condensation off of the bank of single pane windows. Have the windows replaced. Don't let water from condensation drip on to the floor or even wet the sills and jambs of the windows. See photos 2 & 3 on page 7. See photo 1 on page 9.

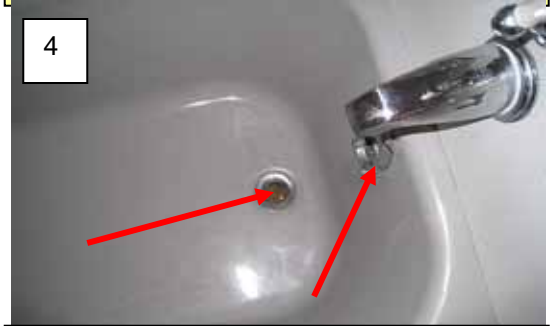
Item 19 - Strainer is busted out and stopper assembly is not working.

- 19) **Plumbing:** In the hall bathroom the tub drain strainer is busted out and the stopper assembly does not function. Have a plumber replace the drain/waste/stopper assembly on the bathtub. See photos 4 & 5 on page 7.

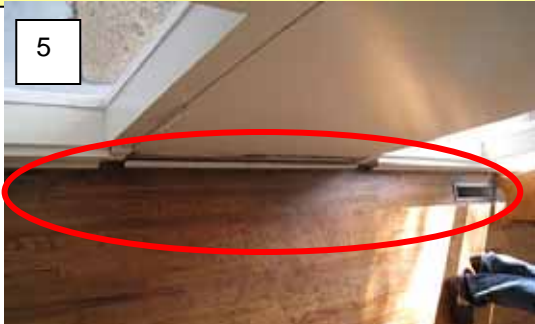
Item 19 - Moisture deterioration to wood flooring along the south wall in the living

- 31) **Floors:** The wood flooring along the south(rear) wall of the living room is moisture damaged. Contact a couple of flooring contractors and discuss options and cost to repair the flooring.

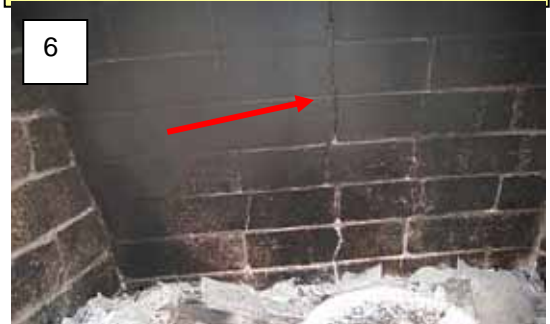
Item 23 - Open thermal cracks in the back of the firebox.

- 23) **Fireplace:** There is significant cracking in the back of the firebox, the damper is not functioning properly and the throat of the chimney is deteriorated. Have a good fireplace/chimney contractor replace the firebox and damage and repair the throat if it's possible (if not possible the chimney may need to be replaced) and evaluate the fireplace and chimney further and repair as needed. See photos 6 & 7 on page 7.

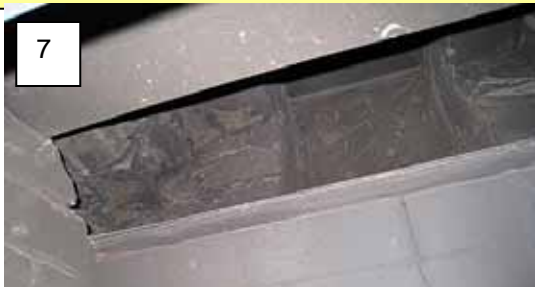
Item 23 - Damaged damper and throat of the fireplace/chimney.

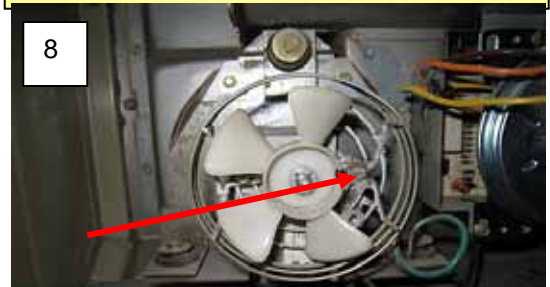
Item 21 - Fan blade broken off on exhaust inducer in the furnace.

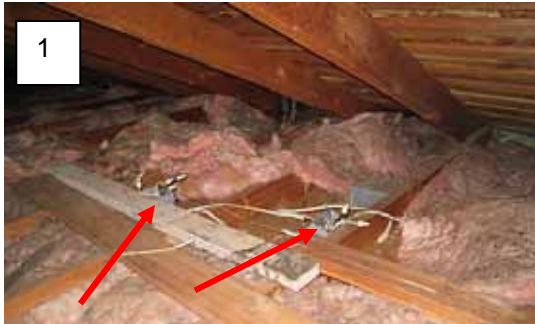
Item 17 - Open junction boxes with splices hanging out over the bathroom.

- 17) **Electrical:** In the attic over the hall bathroom are two open junction boxes with the splices hanging out. Have an electrician examine the wiring, repair as needed and cover the junction boxes. See photo 1 on page 8.

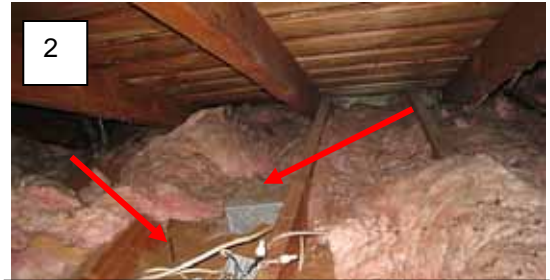
Item 26 - Bathroom ceiling exhaust fan vents into the attic and there is an absence of insulation.

- 25) **Ventilation:** Note there is no kitchen exhaust system other than the one integral with the range/oven and even that one didn't work.
- 26) **Ventilation:** The hall bathroom ceiling exhaust fan vents into the attic. Duct it out to the exterior. This can be done by venting it up into a roof vent. See photo 2 on page 8.

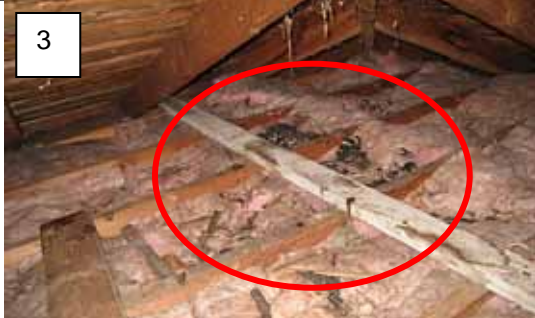
Item 24 - Poop in NW corner of attic.

- 24) **Insulation:** The insulation in the attic is minimal. At the NW corner of the attic there is a lot poop from some type of animal. Note the eave vent screen is torn open west of the rear porch. Have the poop and contaminated insulation removed. Contact a couple insulation contractors and have them take a look at the condition of the insulation in the attic and discuss options and costs to make repairs and add more insulation. See photo 3 on page 8.

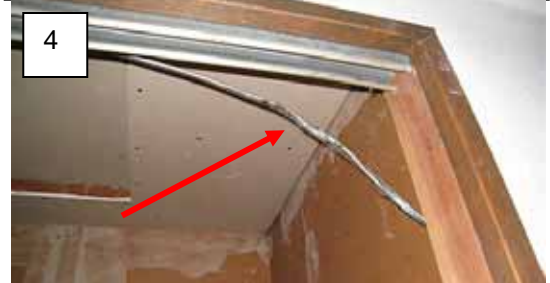
Item 18 - Unprotected and improperly installed NM cable runs in the furnace water heater closet.

- 18) **Electrical:** In the furnace/water heater closet there is unprotected and improperly install NM cable runs. Have an electrician repair the wiring in the furnace/water heater closet. See photo 4 on page 8.

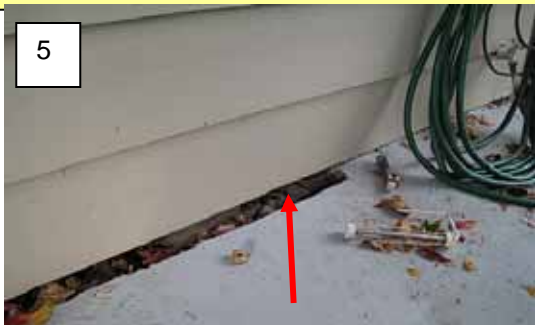
Item 5 - Unscreened opening to under the family room area.

- 5) **Exterior:** Screen the opening under the sleeper floor of the family room that is at the back porch. Leaving it open makes it a nice home for vermin. See photo 5 on page 8.

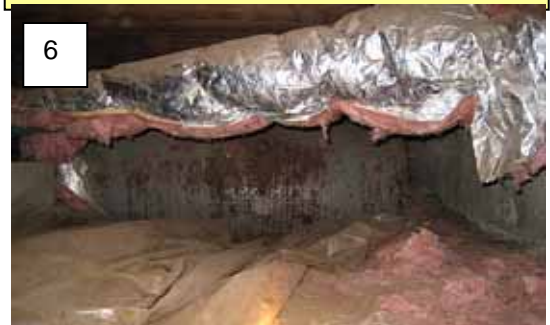
Item 22 - Oil tank in the east end of the crawlspace and strong odor of fuel oil.

- 22) **Oil tank:** There is non-decommissioned oil tank in the crawlspace under the living room. There is a strong odor of fuel oil, which absolutely there should not be, and the tank is intact and in contact with the ground. Tanks in crawlspaces per decommissioning standards should be removed. Note standards for certifying decommissioned oil tanks changed after 2000 and because of fraudulent activity by several decommissioning contractors, lenders have started requiring proof of certification to the new standards. Hire a reputable company to investigate the tank further. Call Brett MacDonald, R.G. @ Active Environmental Solutions (503)-381-8483. See photo 6 on page 8.

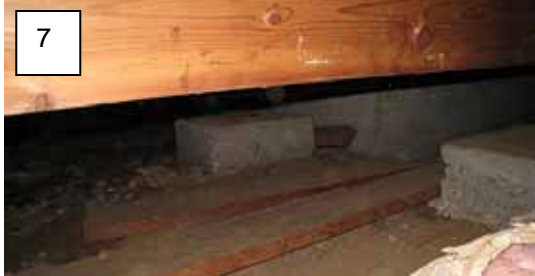
Item 32 - Lots of wood debris on the ground in the crawlspace.

- 32) **Crawlspace:** There lots of debris on the ground in the crawlspace and no real vapor barrier. Have all of the debris cleaned out and cover the ground with a vapor barrier. The vapor barrier should be black in color, 6 mil thick and lapped at least 12". See photos 7 & 8 on page 8.

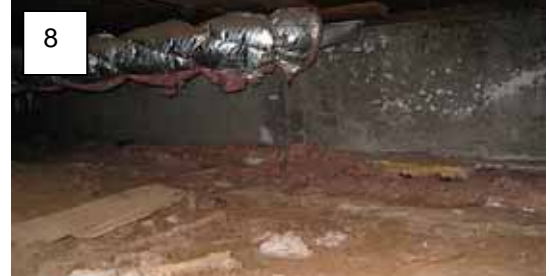
8

Item 32 - Lots of debris and missing vapor barrier.

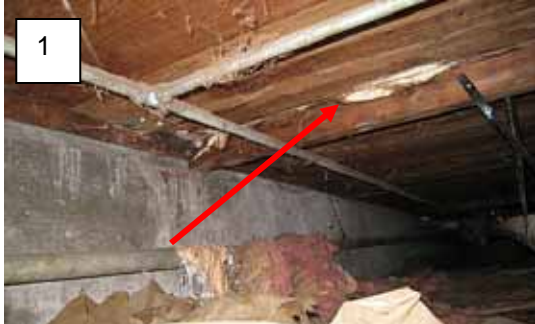
Item 29 - Heavy moisture stains, decay fungi, and rot damage to floor under bathtub.

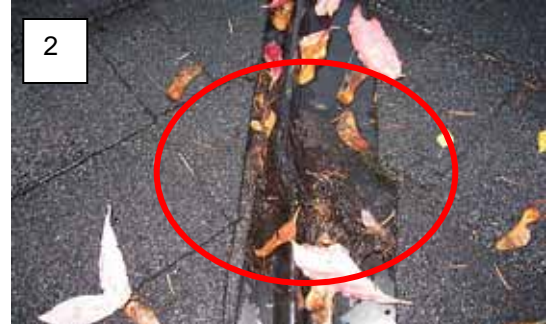
Item 1 - Sloppy valley installation, misaligned valley metal all gooped up with copious amounts of black sealant.
