**REFLECTIVE RADIANT BARRIERS
Good for Energy Savings –
Bad for Fire Safety
(MCDOWELL OWENS ENGINEERING, INC.)**

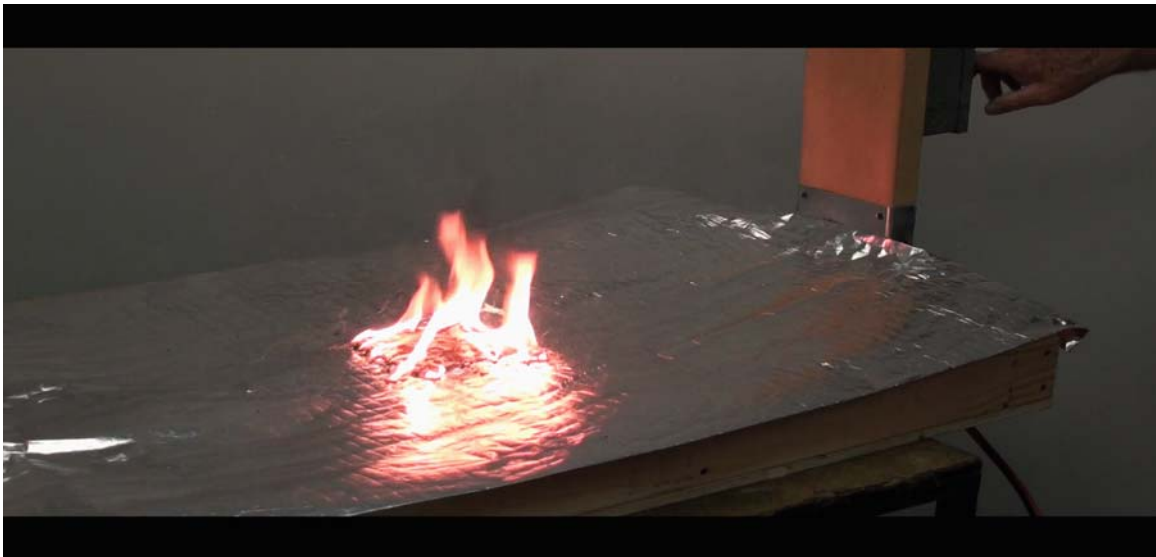
**PHOTO #1 (from a previous study)
Radiant Barrier Material in Flames
After Being Energized by a 20 Amp Circuit**

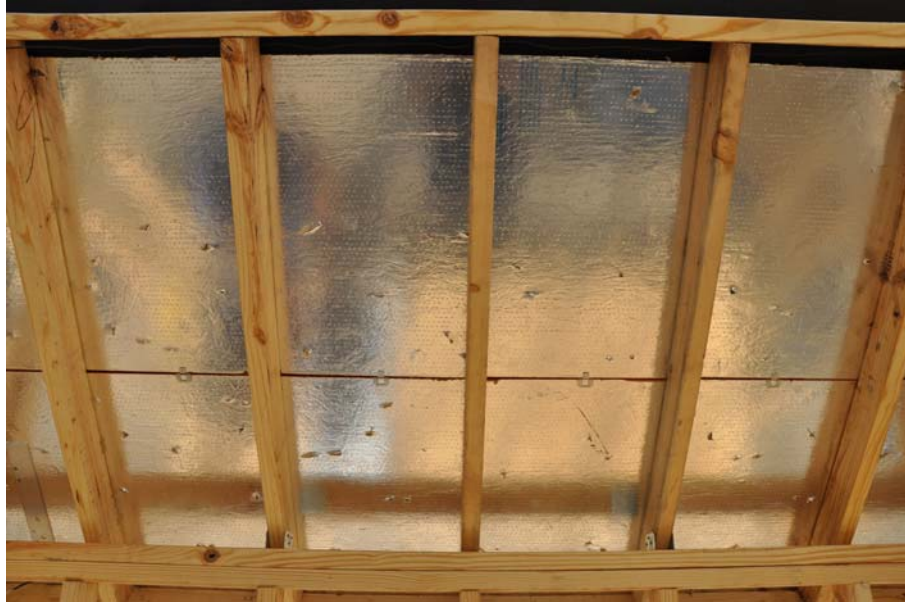
PHOTO #2

**A Typical Attic During Construction Using Roof Decking with Radiant Barrier Material Laminated on the Underside of the Sheathing
(this photo shows the metal plywood clips at sheathing seams)**

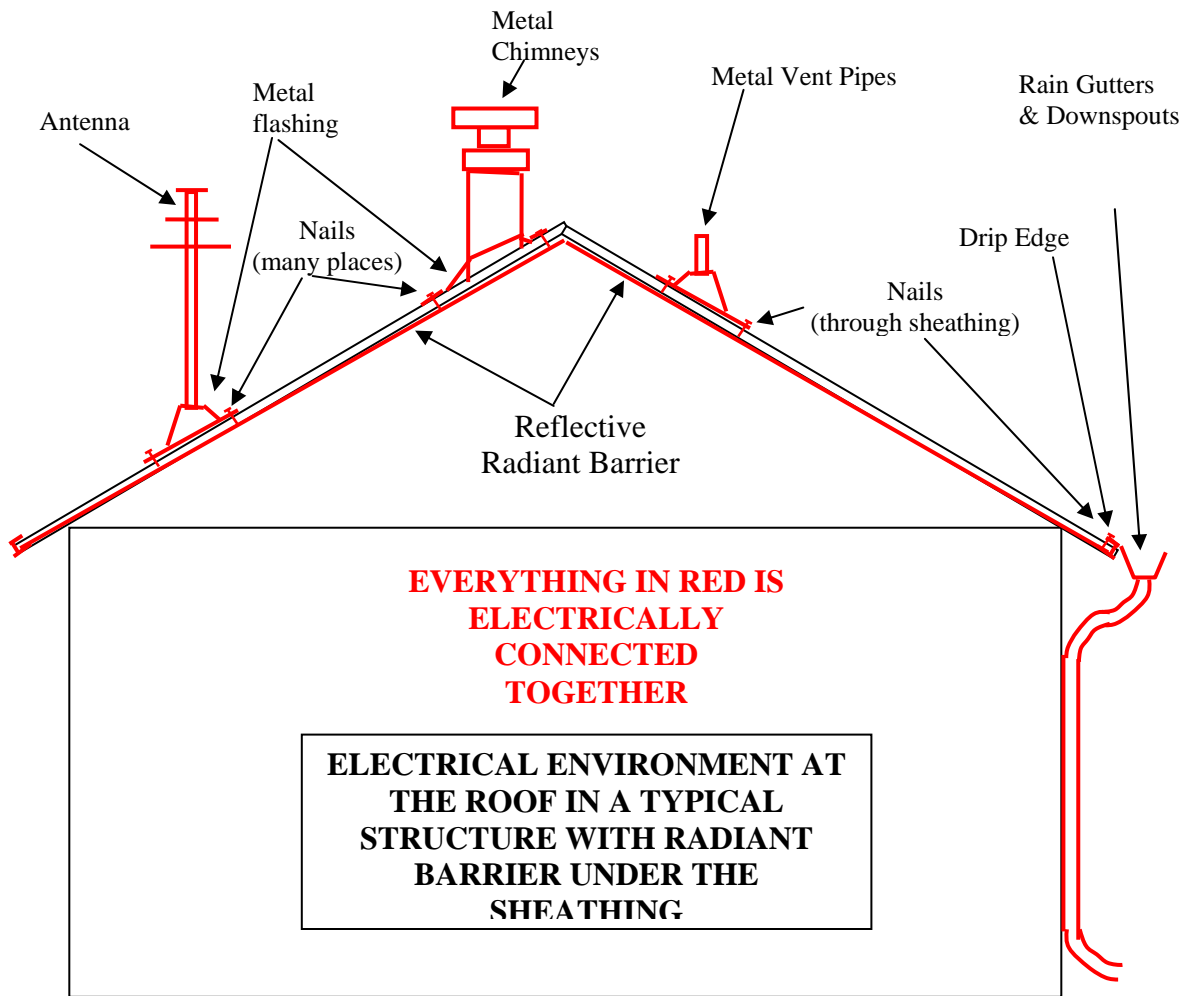
DIAGRAM 1

Diagram 1 illustrates the roof electrical environment we typically find in a structure which has installed the roof sheathing with radiant barrier glued to the underside. **Virtually everything metal on and around the roof of the structure becomes electrically connected through the radiant barrier**, and there is almost always a path to ground. The “electrical interconnection” of everything on and around the roof occurs because of several factors incidental to the installation. The first factor is that when roof decking is installed, proper construction methods require that all sheets of roof sheathing are “supported” in spaces between the roof trusses using “plywood sheathing clips” which slip over the edges of adjacent roofing sheets (see photo #2). These clips are metal, and the result is that the radiant barrier foil on every sheet of roofing is electrically connected to every other sheet.

The second factor results from the fact that roof nails are metal. When installed, the nails penetrate the roof sheathing and contact the aluminum foil on the bottom. On a typical roof installation there are literally thousands of nails. All of these nails and everything they touch is now connected to the radiant barrier metal. Items on the roof which the nails touch (and penetrate) include essentially everything on the roof such as rain gutters, drip rails, chimneys, vent flashing, antenna mounts, satellite dish mounts, and so forth.

Now we have a situation where every sheet of the radiant barrier and everything metal on or around the roof is electrically connected together. What this means is that if lightning strikes virtually anywhere on the roof, it is highly likely that the current will find its way to and through the radiant barrier material at some point.

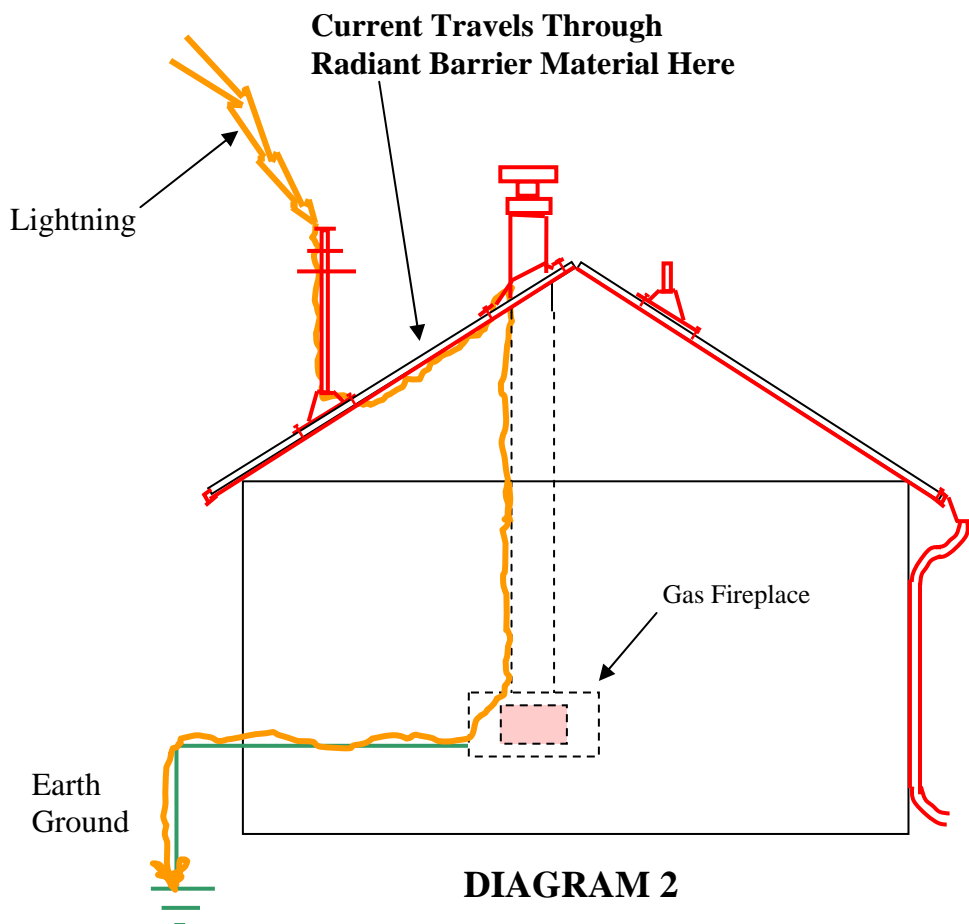
Putting all the factors together we get a situation where the significant ramifications are as follows: **if lightning strikes virtually anywhere on or very near the roof, it is highly likely the current will pass through at least a portion of the radiant barrier on the way to earth ground.**

DIAGRAM 2
A Typical Path for Lightning Current

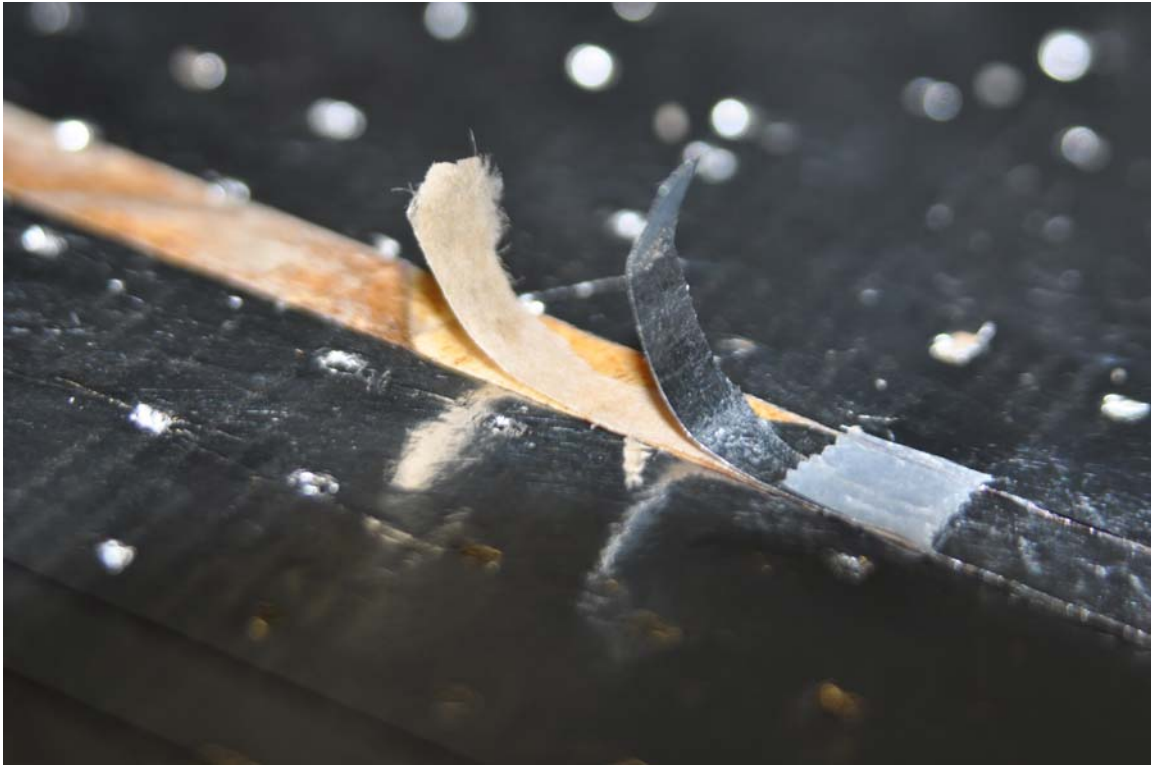
PHOTO #3

The essential physical characteristics of the radiant barrier material which is glued to the underside of the roof sheathing were examined. We found that the material is comprised of two layers. The first layer (which is the one we see on the underside of the roof) is a sheet of aluminum which is approximately 0.01 mm thick. The second layer (between the aluminum and the wood sheathing) is a sheet of paper approximately 0.02 mm thick. These can be seen in photo number 3.

**Louisiana Pacific “Techshield” Roof Sheathing
A section has been cut and “peeled.”**

This shows the layer of thin aluminum over a layer of paper.

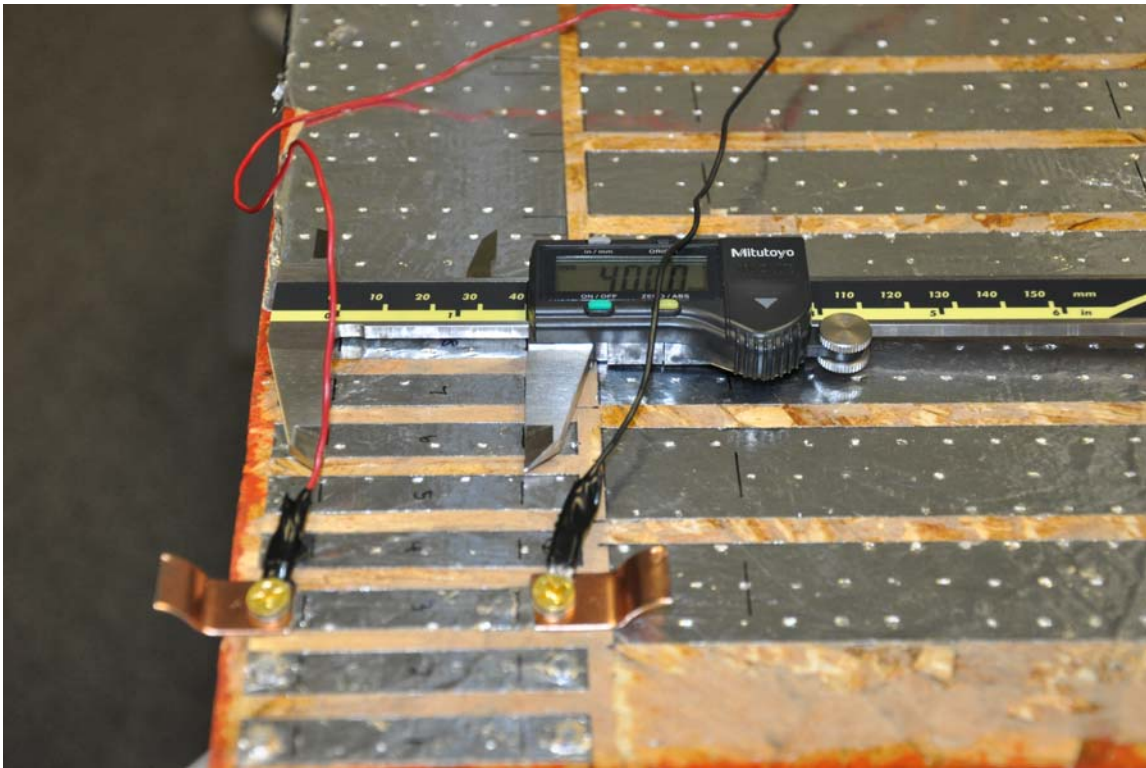
For measuring and analyzing these parameters we needed some carefully prepared test strips of the radiant barrier material. Photo 4 shows the two different sets of test strips we used.

PHOTO # 4
Shows the two sets of sample test strips
One set 1cm wide x 4cm long
One set 1 inch wide x 4 inches long

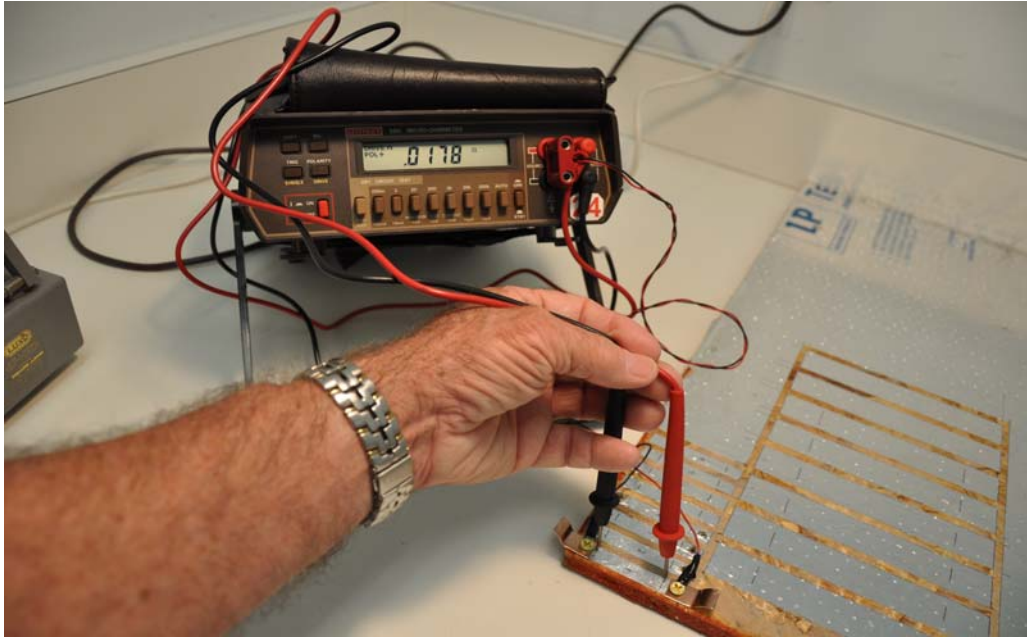
PHOTO # 5
Four Point Measurement of Test Strip Resistance

We performed four point resistance measurements on the test strips using a very accurate milliohm meter (as seen in photo # 5). We measured between 17.7 and 18.2 milliohms of resistance. Thus the theoretical value for pure aluminum test strips was about 35% lower than our measured value. This was actually about what we expected. Although we did not have the exact metal alloy composition analyzed, we can be virtually certain that the aluminum in these foils is not high quality “pure” aluminum. We can be highly confident that there are impurities in the aluminum and that the impurities will have the effect of increasing resistivity (Engineering Toolbox) (Fink) (Wikipedia). The fact that the theoretical values (for pure aluminum) differ from measured values in the direction we expected and by about the amount we expected provides us with a good “sanity” check on our measurement methods. The measurements we made were highly repeatable across samples, from reading to reading and over time, so we are very confident in these values. Since our test strips have an aspect ratio of 4:1, that gave us a sheet resistance value of 4.50 milliohms per square. To further confirm this value, we created test strips which were one inch wide by four inches long and repeated the four point measurements. Once again our measurements read between 17.9 and 18.4 milliohms. We are highly confident that the **actual sheet resistance** for the particular piece of roof sheathing we tested is very near the value of **4.50 milliohms per square**.

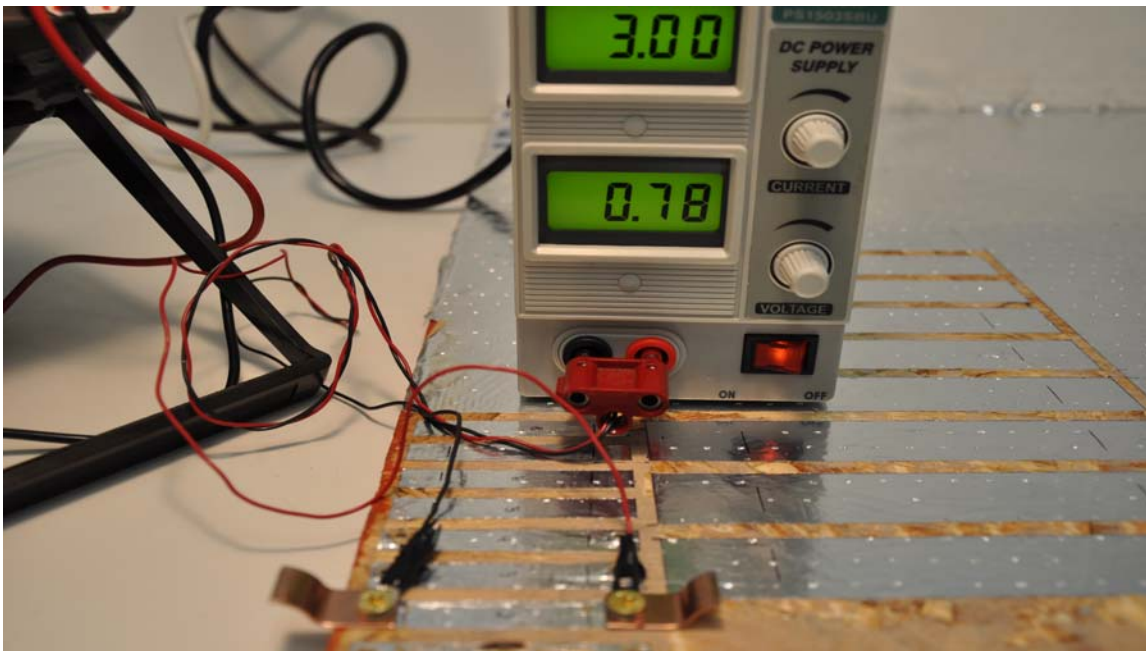
From experience in the semiconductor industry we knew that the current density at which aluminum conductors actually fail can be much greater than 10 Amps per square millimeter. Our bench power supply had accurately adjustable current output up to slightly more than 3 amps. In order to achieve the needed current densities at these low current levels we needed a test strip with a small cross sectional area. We created strips which were one millimeter wide by “splitting” our original one centimeter strips.

PHOTO # 6
Forcing 3.00 Amps Through a One Millimeter Test Strip

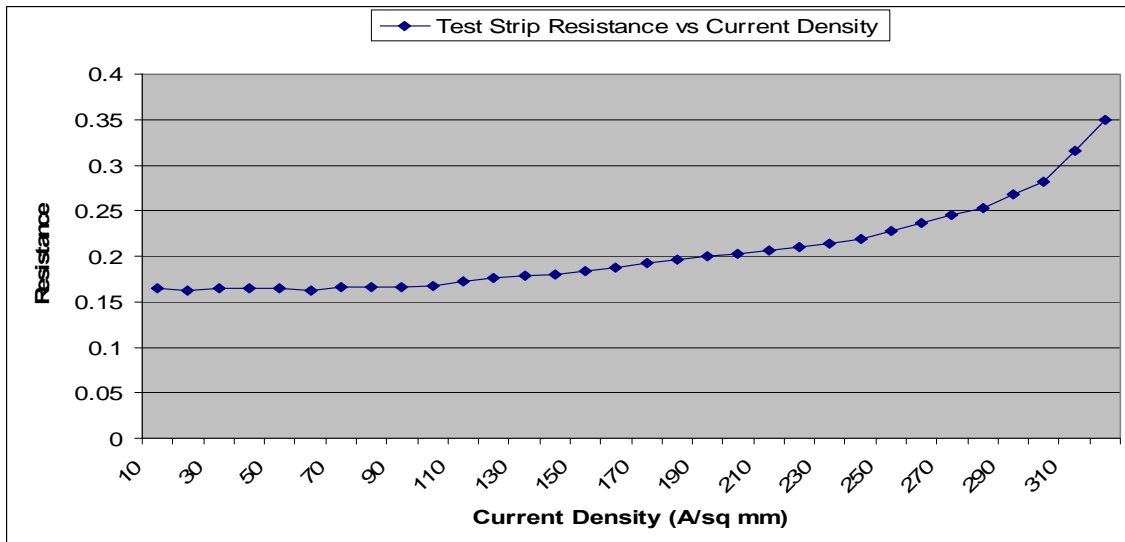
At 0.1 amp intervals from 0 amps to 3.2 amps we carefully measured the voltage drop, then used this to calculate the effective resistance at each value. The variations in test strip resistance versus current density are shown in chart #1.

CHART # 1
Test Strip Resistance vs. Current Density

The current density versus resistance measurements revealed two very valuable pieces of information. First, at levels above approximately 200 Amps per square millimeter, resistance of the material begins to increase rapidly (see chart 1 above). Second, at levels around 300 Amps per square millimeter our material **quickly** ignites and sustains flame. It should be noted that the material will ignite at current densities much less than this value (maybe 50% less) if enough time is allowed.

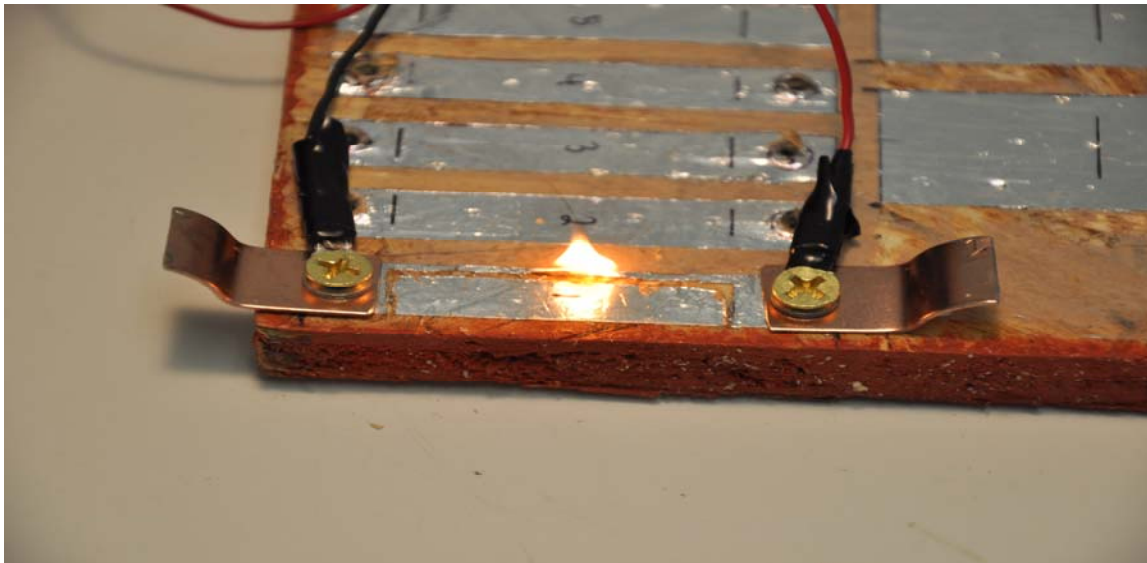
At a current density level of slightly under 300 amps per square millimeter, the material ignited and sustained flame. This is clearly seen in photo #7.

PHOTO #7
Test Strip Ignites at a Current Density of 300 Amps per Square Millimeter

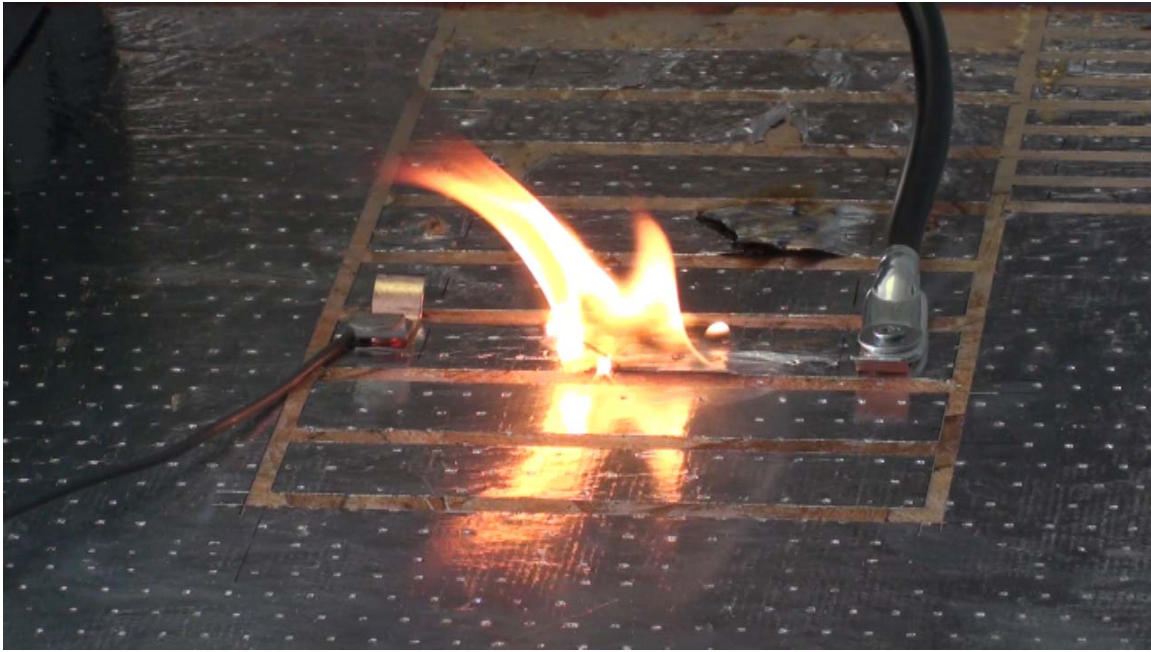
PHOTO #8
One Inch Wide Test Strip Energized With Current of Approximately 50 Amps

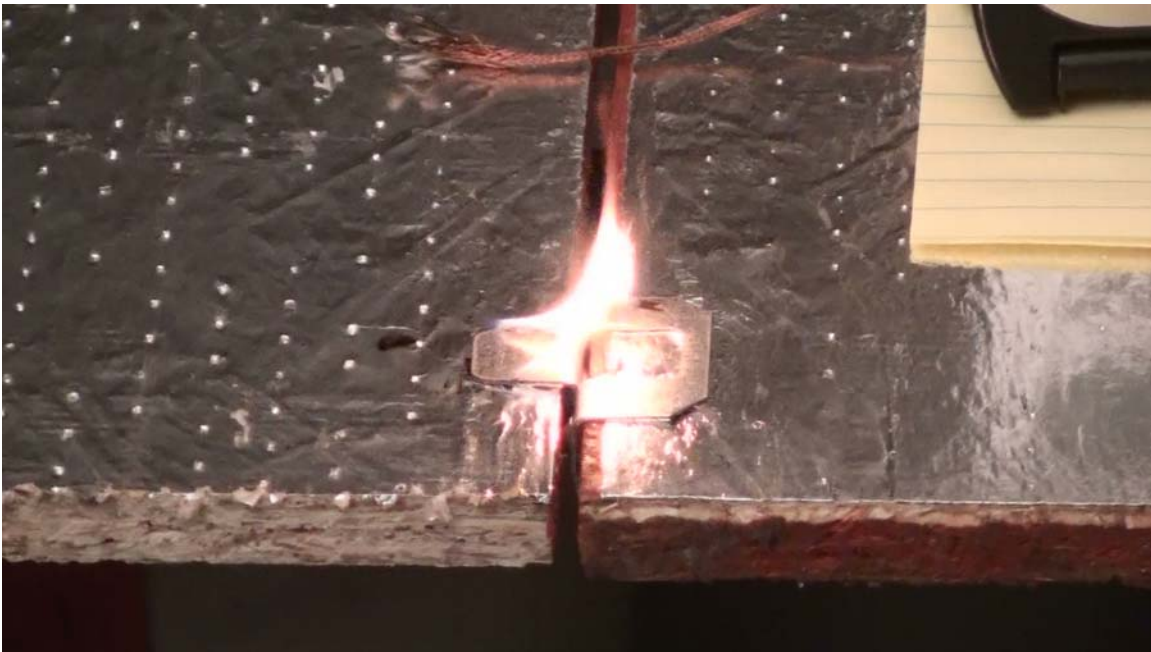
PHOTO #9
Roof Sheathing and Clip Energized With Current of Approximately 50 Amps

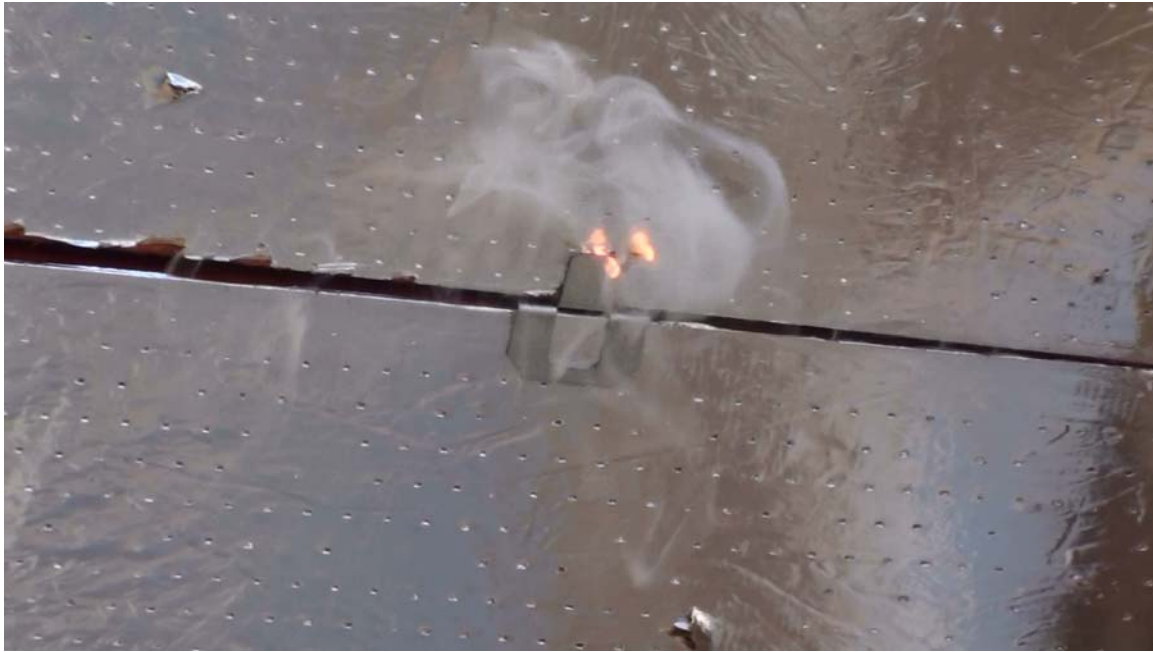
PHOTO #10

Plywood Clip on an Actual Roof Section – Approximately 50 Amps.

(Note that it is the barrier material which is igniting. This is because the current in the foil is “funneled” near the clip, thus the current density is highest near the clip)

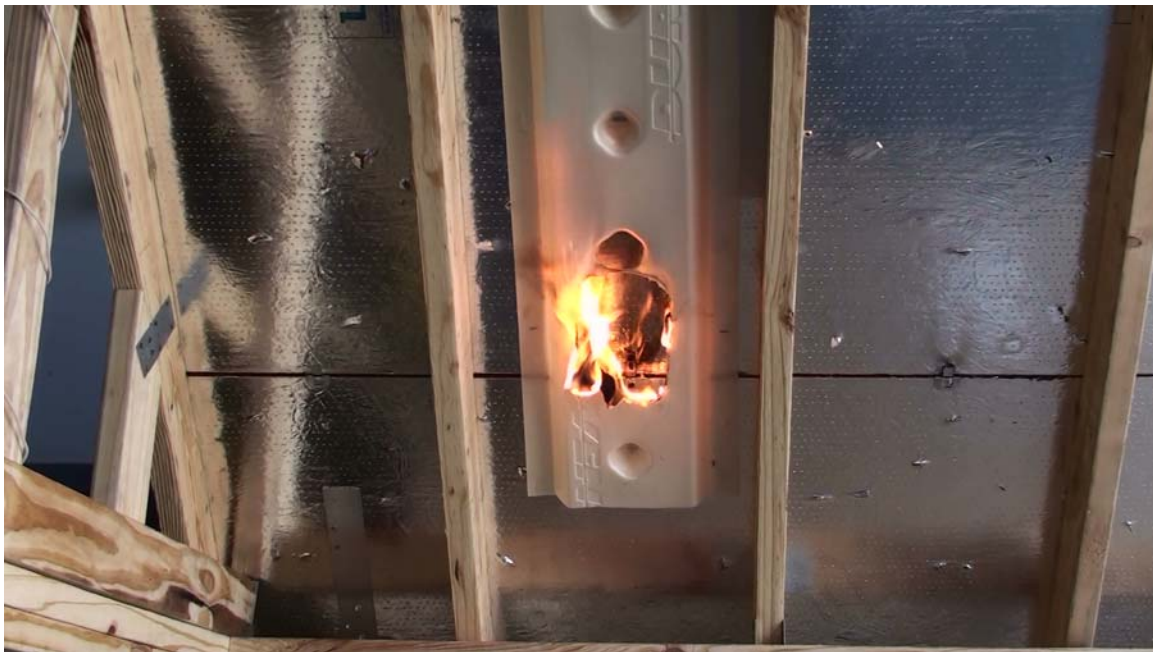
PHOTO #11

**Underside of Roof Deck – With Soffit Vent Channels Installed
Radiant Barrier was Energized with 12 volts @ 50 Amps**

The results demonstrated in these photographs conclusively answer the questions about how the radiant barrier material reacts in larger scale tests and in actual installations. When energized and heated by electric current flow, the material readily

generates heat beyond ignition temperatures of many materials. The barrier material itself becomes the first ignited material as it quickly burst into flame. If there are other flammable materials nearby (such as soffit vent channels) that material is easily ignited and the fire spreads quickly.

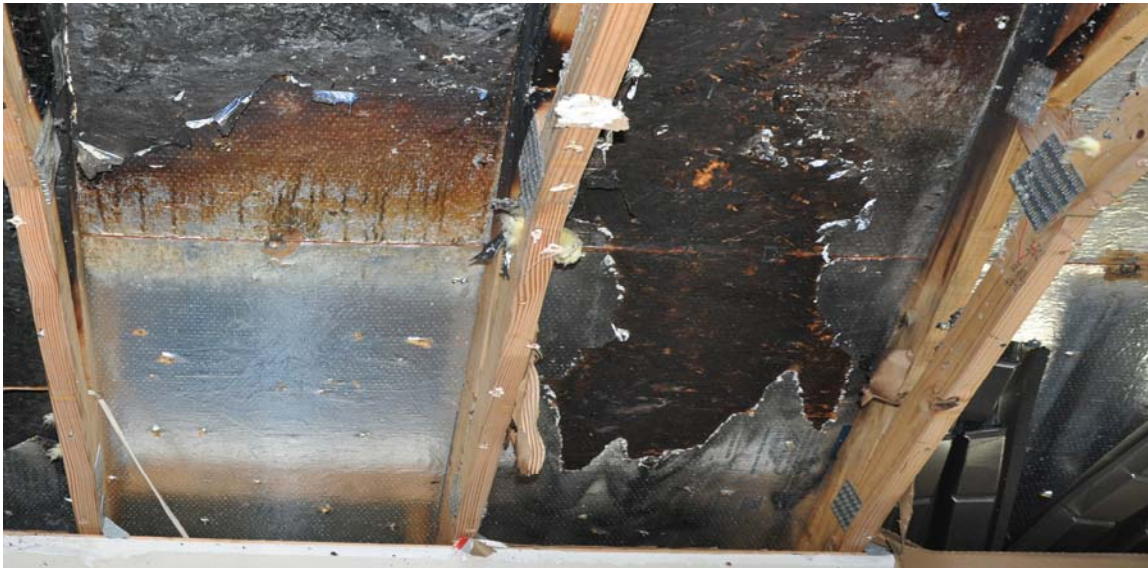
Photo # 12
Photo from an Actual Attic Fire After a Confirmed Lightning Strike

In photograph 12 note the clear evidence of localized heating and barrier material burning around the metal sheathing clips.

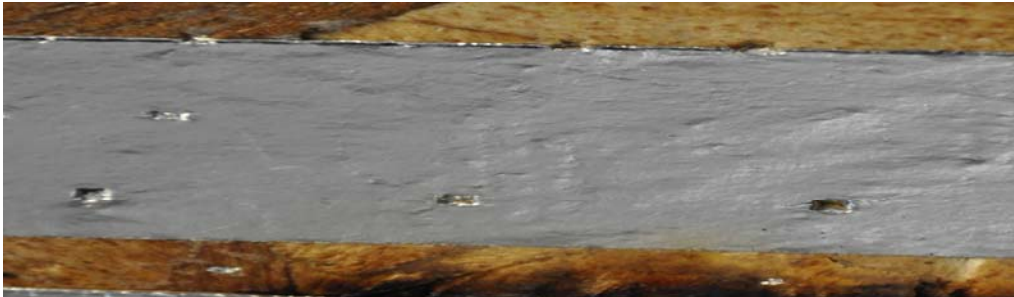
PHOTO #13

A Test Strip Which Has Not Been Subjected to Electrical Current

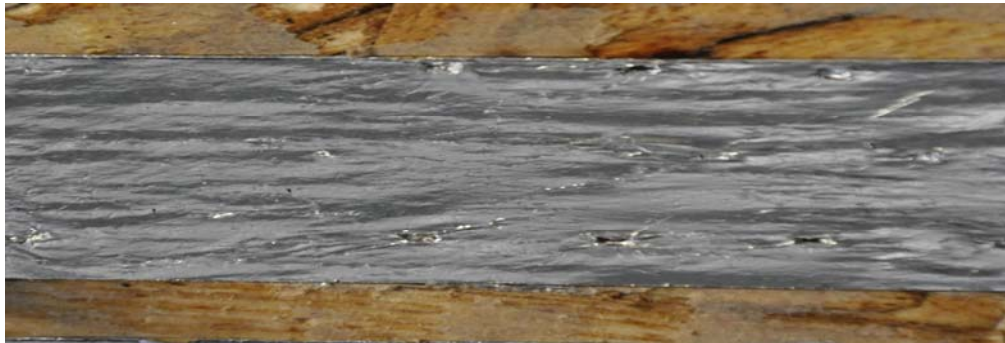
PHOTO #14

A Test Strip Which Has Been Heated Slowly By Approximately 30 Amps

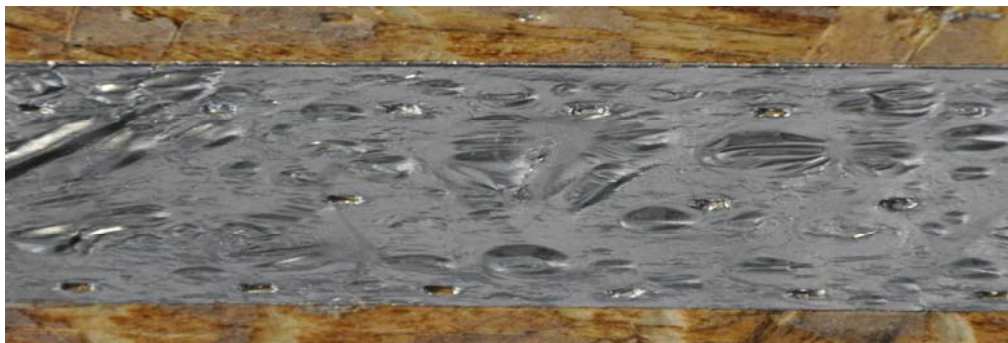
PHOTO #15

A Test Strip Which Has Been Heated Quickly By Approximately 100 Amps
