This article explains the mechanics of white efflorescence, how to help prevent efflorescence and some traditional methods used to remove efflorescence from new walls.

**Masonry  
Institute of  
America**

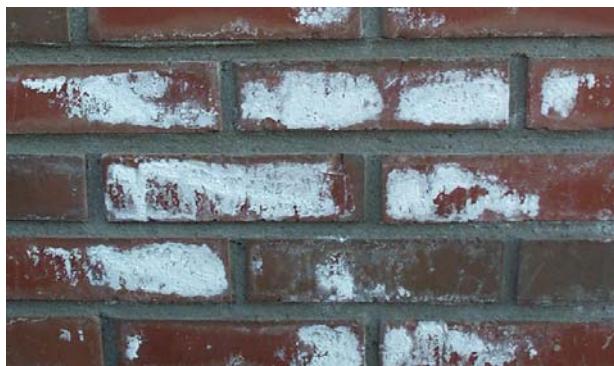
Figure 1. Typical white efflorescent salts on brick and block masonry

We know that efflorescence is a fine, white, powdery deposit of water-soluble salts left on the surface of masonry as the water evaporates. These efflorescent salt deposits tend to appear at the worst times, usually about a month after the building is constructed, and sometimes as long as a year after completion.

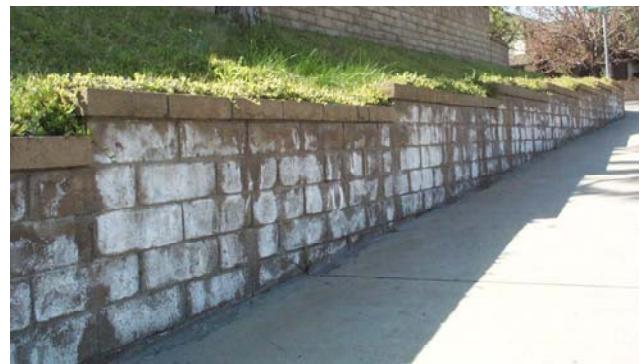
A chemical analysis of efflorescent salts in the Southern California area (1) reveals that they are principally alkalies of Sodium Sulfates ( $Na_3SO_4$ ) and Potassium Sulfates ( $K_2SO_4$ ). These are the main soluble salts to be concerned with in Southern California since these are 90% of the efflorescence found in this area. These alkali sulfates appear because they exist somewhere within the masonry wall, either in the brick, the mortar, or the grout, or possibly a combination of these three. These alkalies combine with sulfates from the masonry to form sulfate salts. The alkali sulfates in the wall are dissolved by water into a solution which then moves through the natural pores in the masonry. The solution migrates to the surface of the wall where the water evaporates, depositing the salts on the wall and generating the white powdery scum we know as efflorescence.

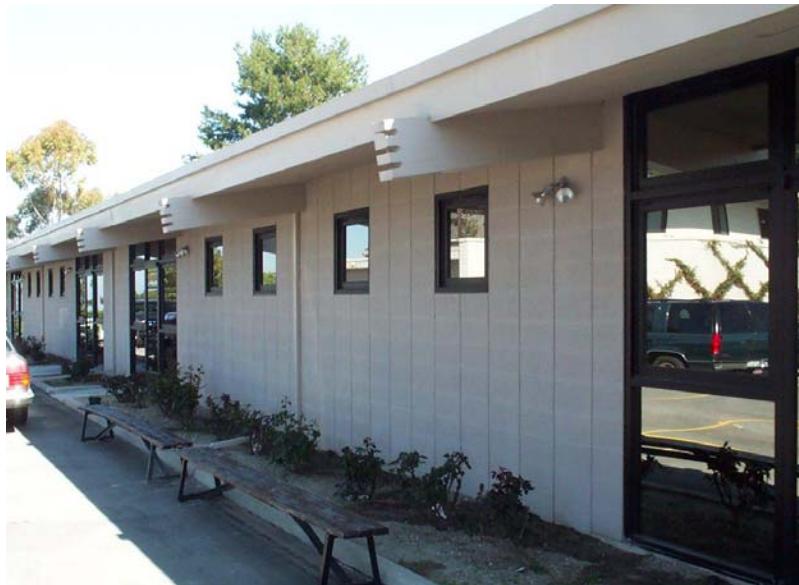
Figure 3. Overhanging eaves will help greatly to prevent moisture from entering this stack bond CMU wall.

The next critical concern is to prevent any water from penetrating into the masonry wall where it could cause efflorescence to occur. This can be done with good architectural details and quality masonry construction. Designing with overhanging eaves, copings and flashings, and careful attention to landscaping and sprinklers will reduce the chances of water entering the wall. In addition, specifying tooled, compacted mortar joints (concave or "V" type) will also reduce the potential for water infiltration. See Figures 3 and 4 for good efflorescence controlling design.

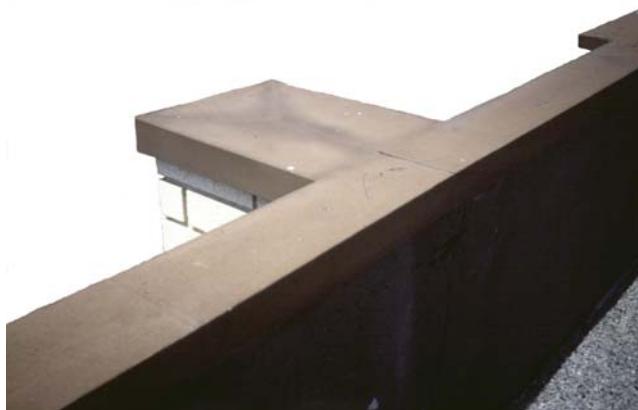
Figure 4. A full metal coping helps in waterproofing a wall and eliminates moisture penetration through the tops of parapets
