## STRUCTURE

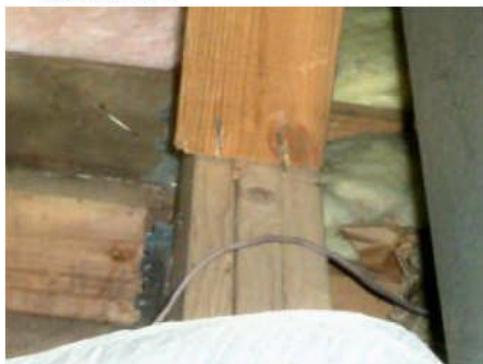
*The ceiling joists are not secured and are pulling away from the headers. Have a qualified contractor further evaluate and repair to reduce the risk of continued deterioration.*
