HOUSE INSPECTION REPORT

INSPECTION ADDRESS: 948 W. XXXXXXX Bolingbrook, Illinois

DATE OF INSPECTION: June 15th, 2008

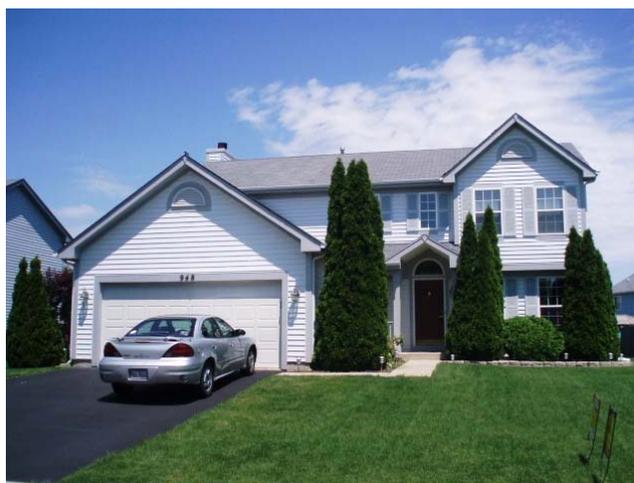
The weather was warm and sunny. The outdoor temperature during the inspection was about 80 degrees.

The soil was very wet. Heavy rains fell the past couple of weeks.
