Meruliporia 'poria' incrassata

prepared by

Steve Quarles

UC Cooperative Extension Advisor, Wood Durability
Richmond Field Station, Richmond, CA 94804

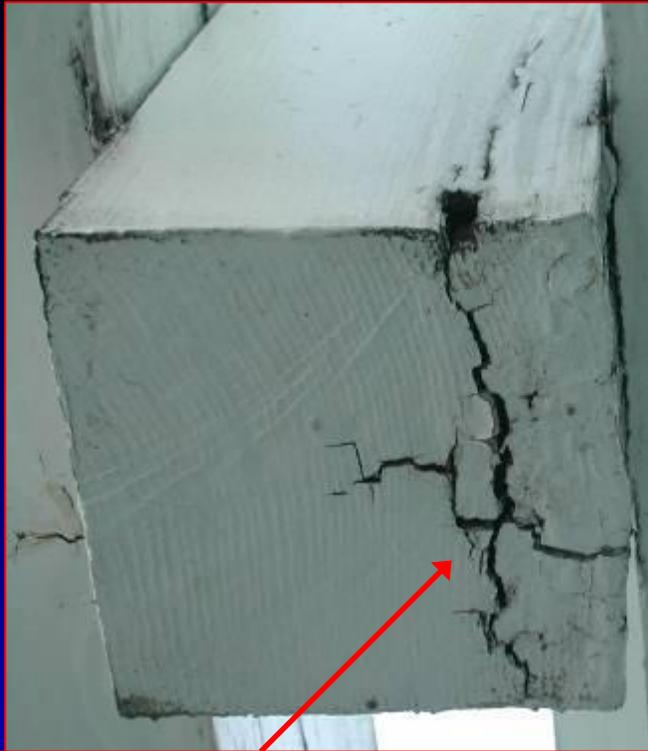
Damage from a decay fungi (one that can structurally degrade wood)

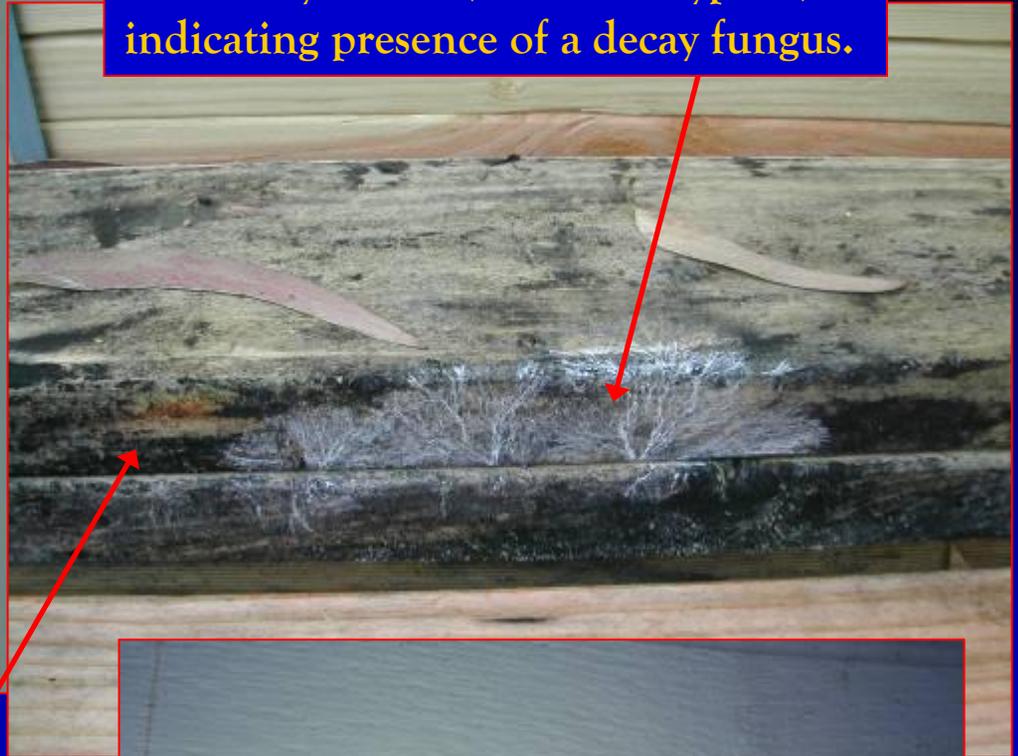
White mycelium (a mass of hyphae) indicating presence of a decay fungus.

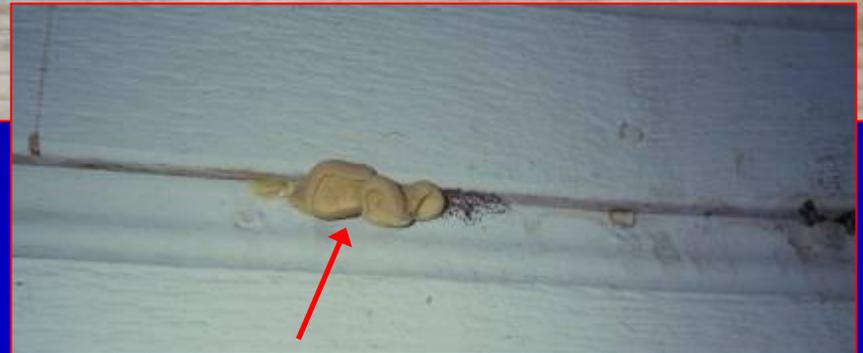
Spore-producing fruiting body from a decay fungus, emerging from behind this wood-composite siding product.

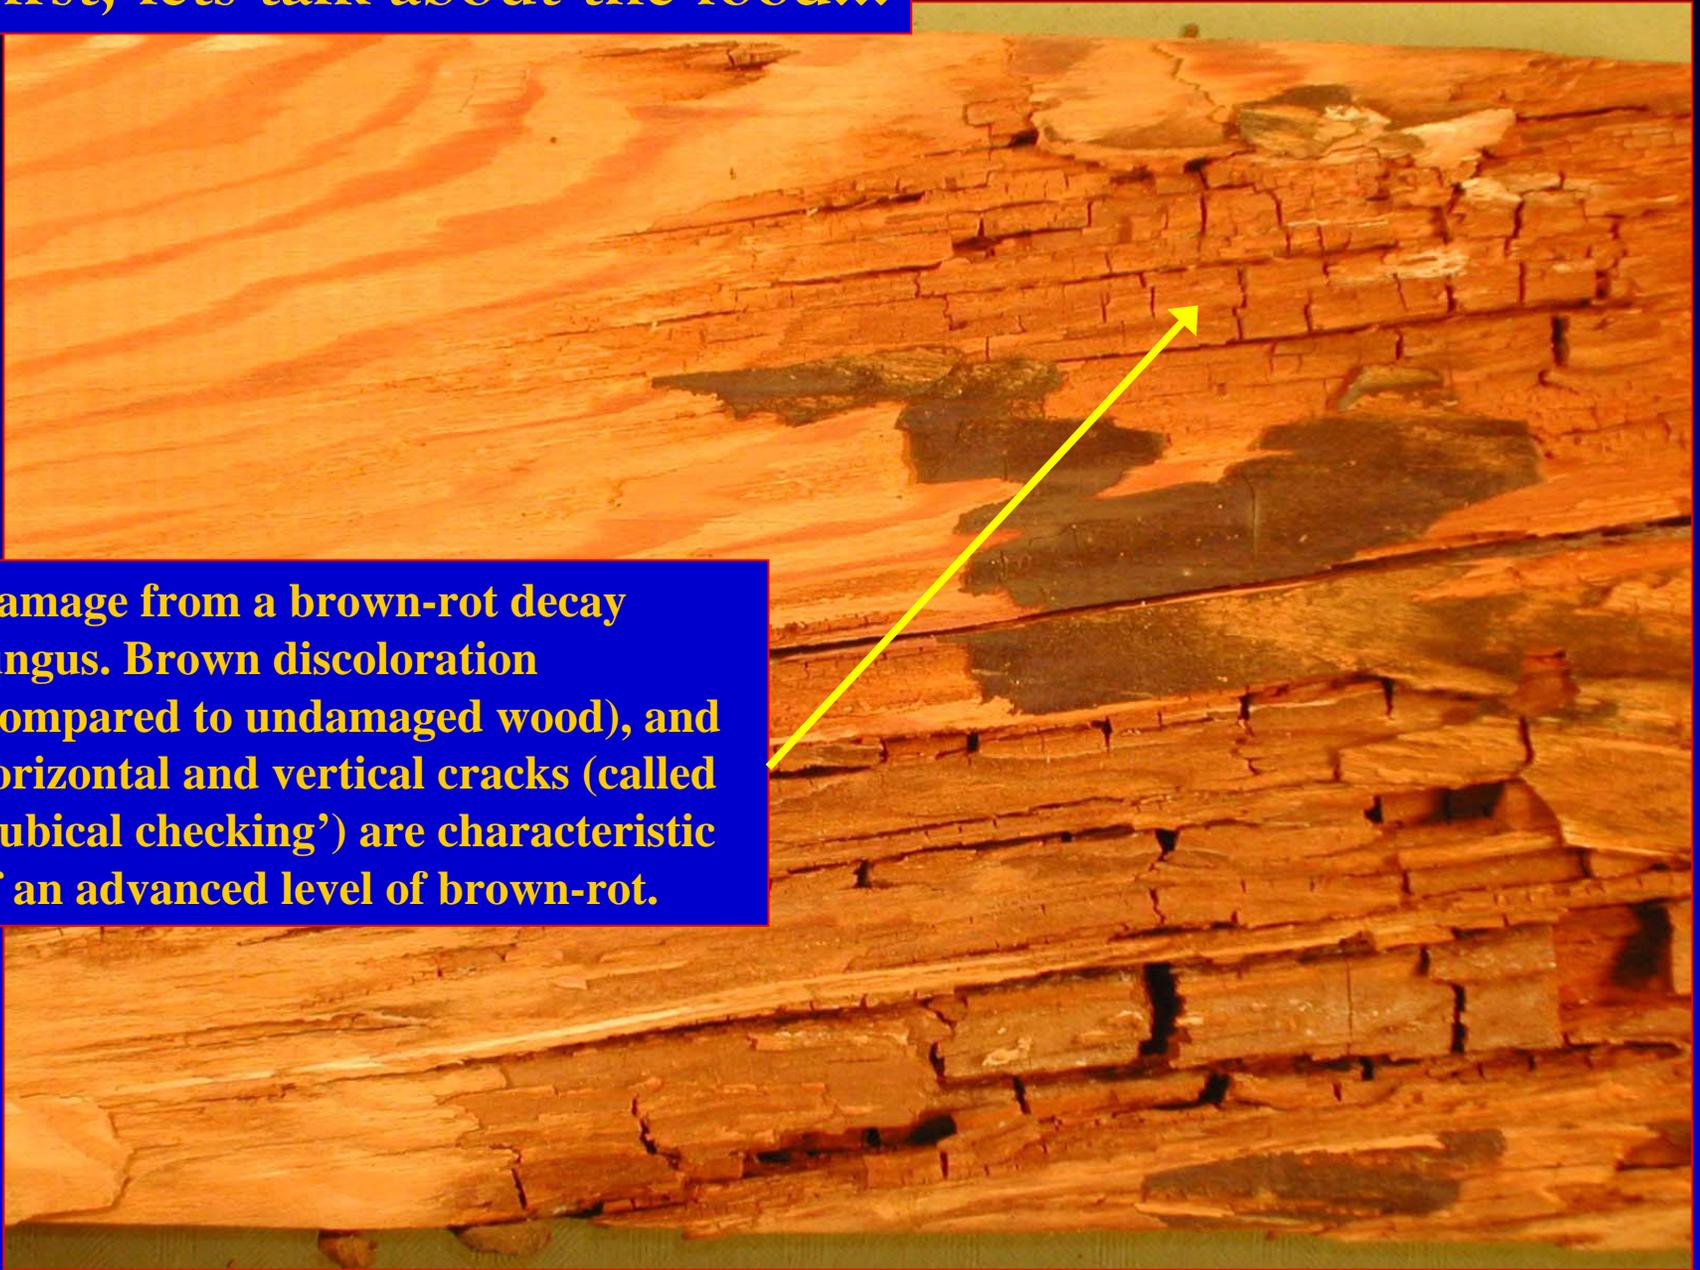
Damage from a brown-rot decay fungus. Brown discoloration (compared to undamaged wood), and horizontal and vertical cracks (called 'cubical checking') are characteristic of an advanced level of brown-rot.

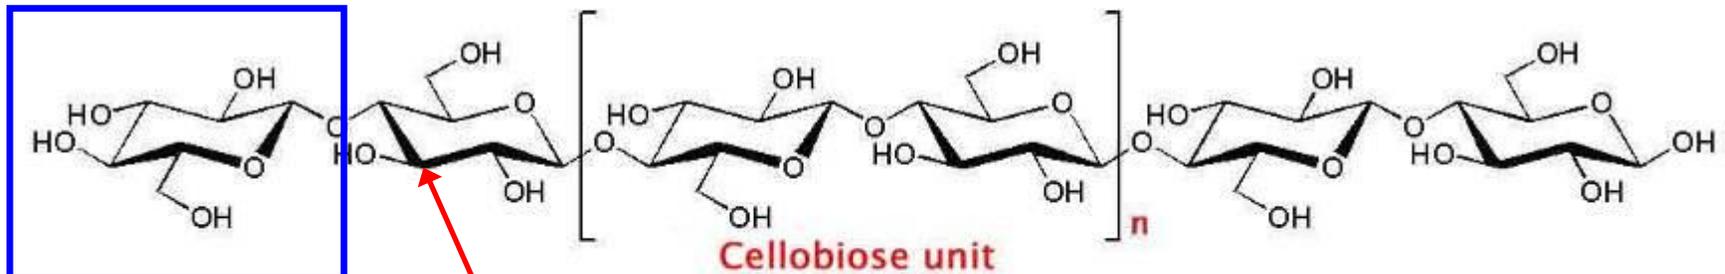
Cellulose

One glucose sugar molecule. If a particular fungus can break the chemical bonds between the sugar molecules that together make up the cellulose polymer, the fungus can then utilize the sugar molecule for food. Not all fungi have the capability to break these bonds.

Although not specifically indicated, carbon is located at each point where two lines meet.

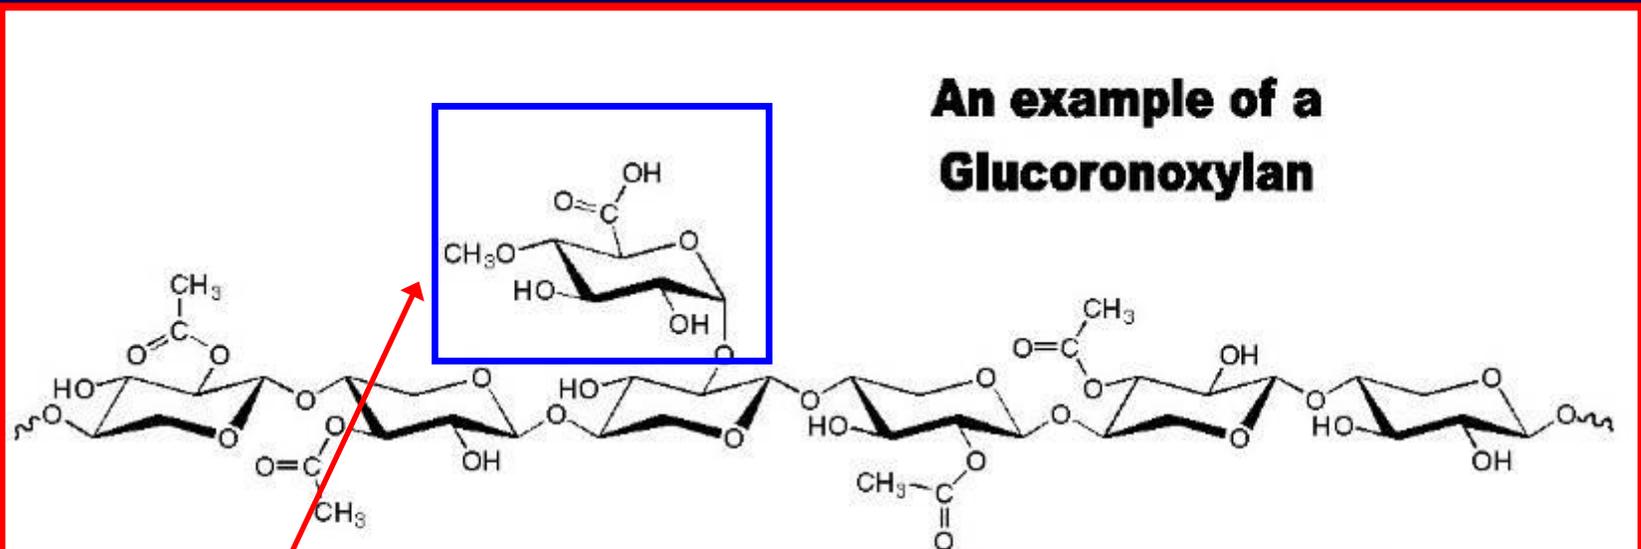
One sugar molecule. Hemicellulose is made up of a number of different types of sugars. Just as was the case with cellulose, if a particular fungus can break the chemical bonds between the sugar molecules that together make up the hemicellulose polymer, the fungus can then utilize the sugar molecule for food. Not all fungi have the capability to break these bonds.

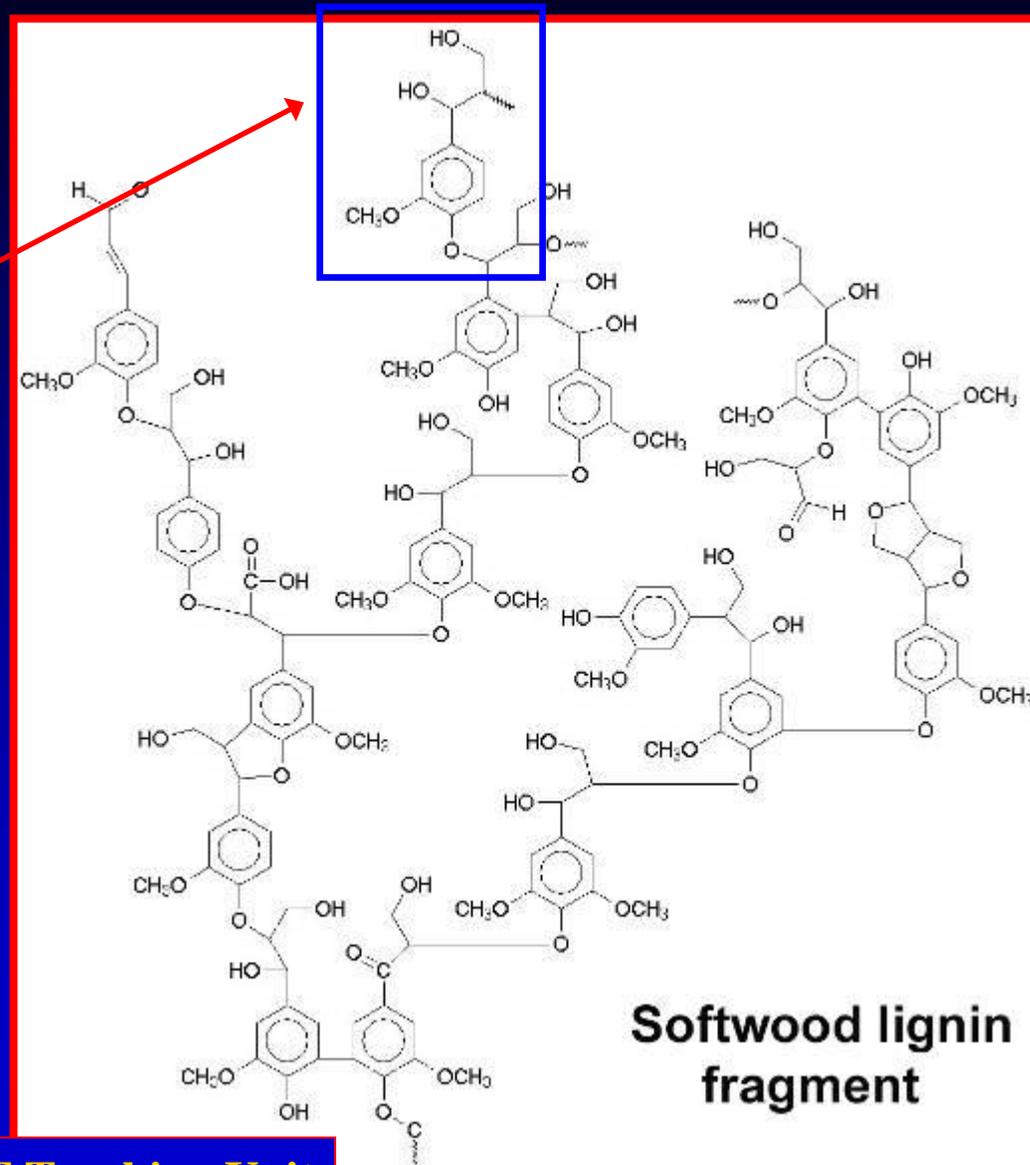
A phenyl-propane unit. Many of these make up the lignin polymer. As you can see, these molecules look different than the sugar molecules that make up the cellulose and hemicellulose polymers. Brown rot fungi cannot metabolize lignin. The ring structures in lignin have some level of toxicity, and their presence makes it more difficult for fungi to metabolize.

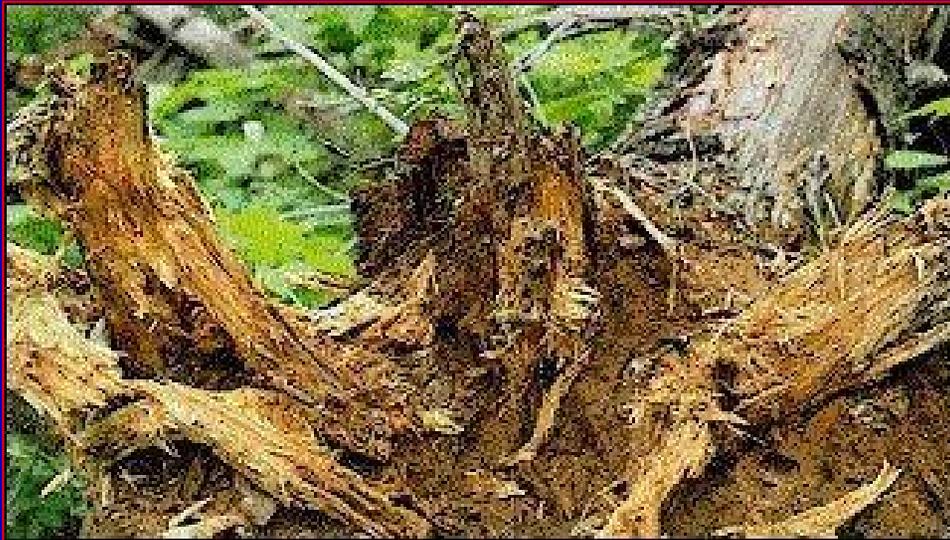
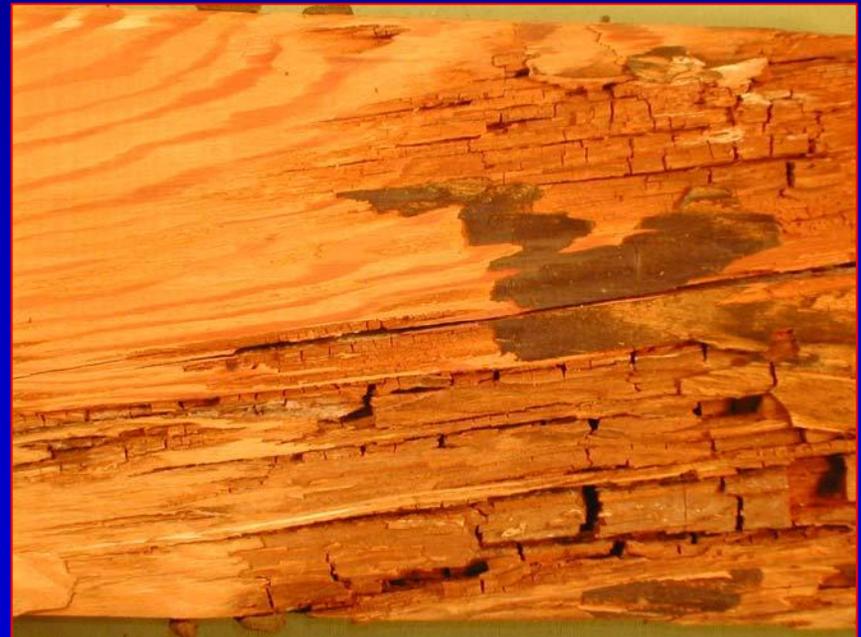
The natural color of lignin is brown. Because brown rot decay fungi cannot fully utilize lignin, the wood attacked by brown rot fungi is brown in color because of the remaining lignin residue. White rot decay fungi can fully utilize lignin (and the cellulose and hemicellulose polymers), and therefore wood attacked by these fungi is white in color.

Due to the predominant use of softwoods (Douglas-fir, white fir, southern yellow pine) in construction, and the fact the brown rot fungi preferentially attack softwoods, we more commonly find brown rot fungi in structures.

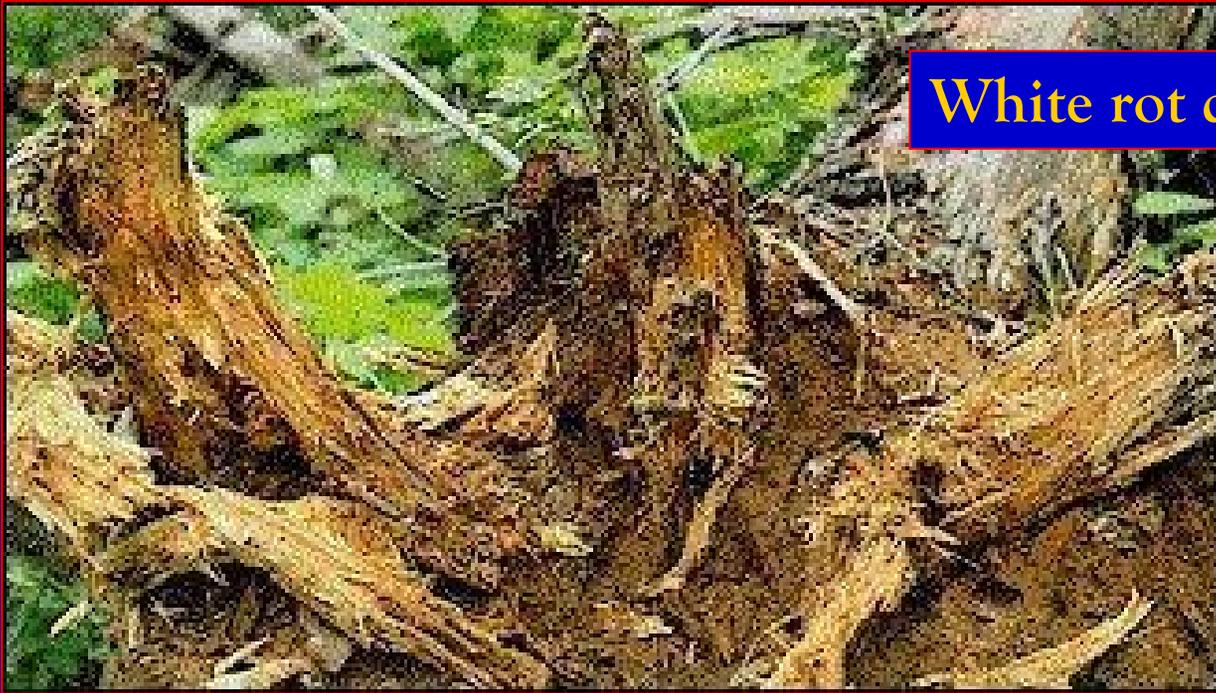
White rot damage in a tree.

Brown rot damage in a board removed from a glued-laminated beam.

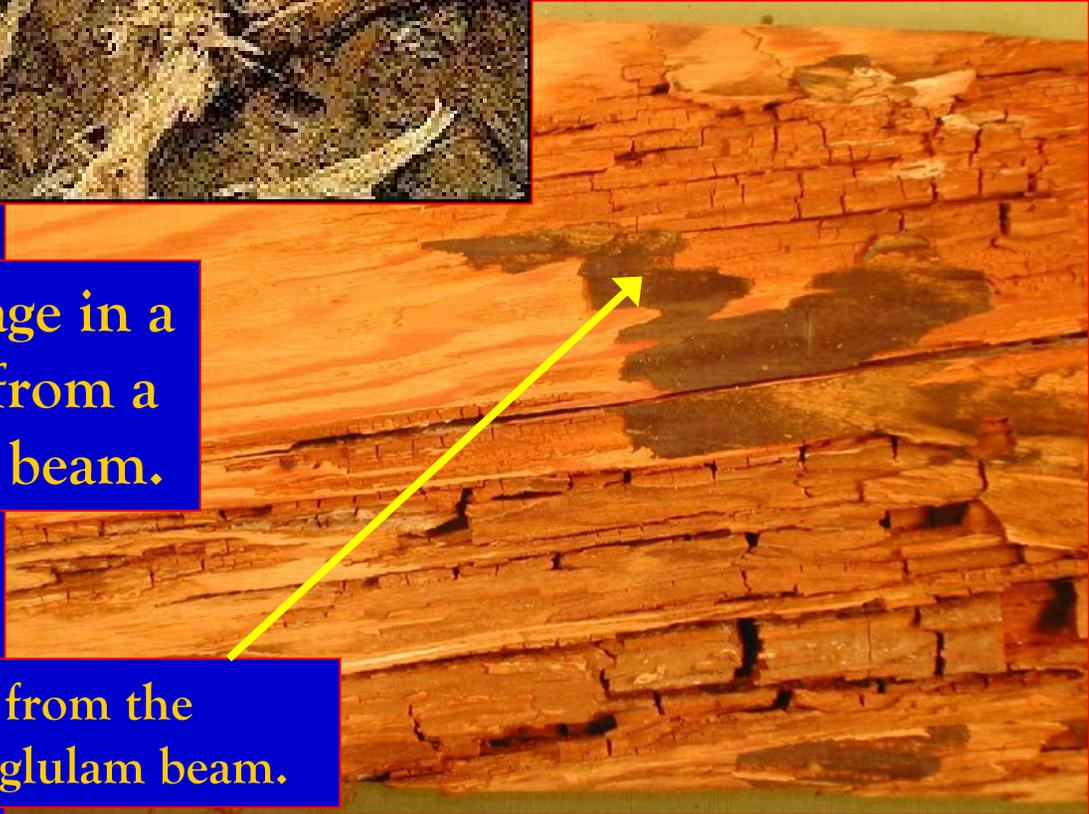
This reddish color shown here is from the adhesive (glue) used to make the glulam beam.

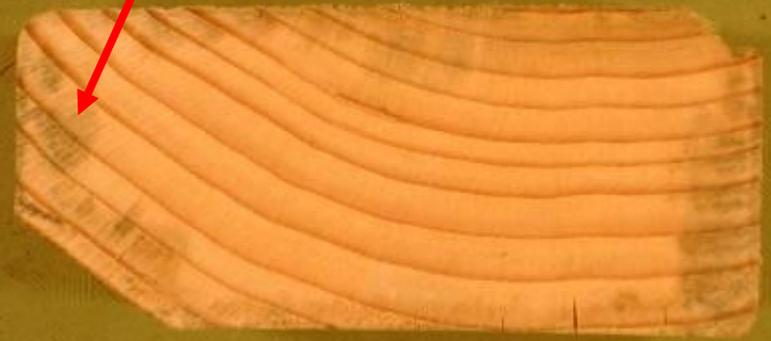
Hyphae from a stain fungus penetrating into the wood to locate sugars that can be used as food.

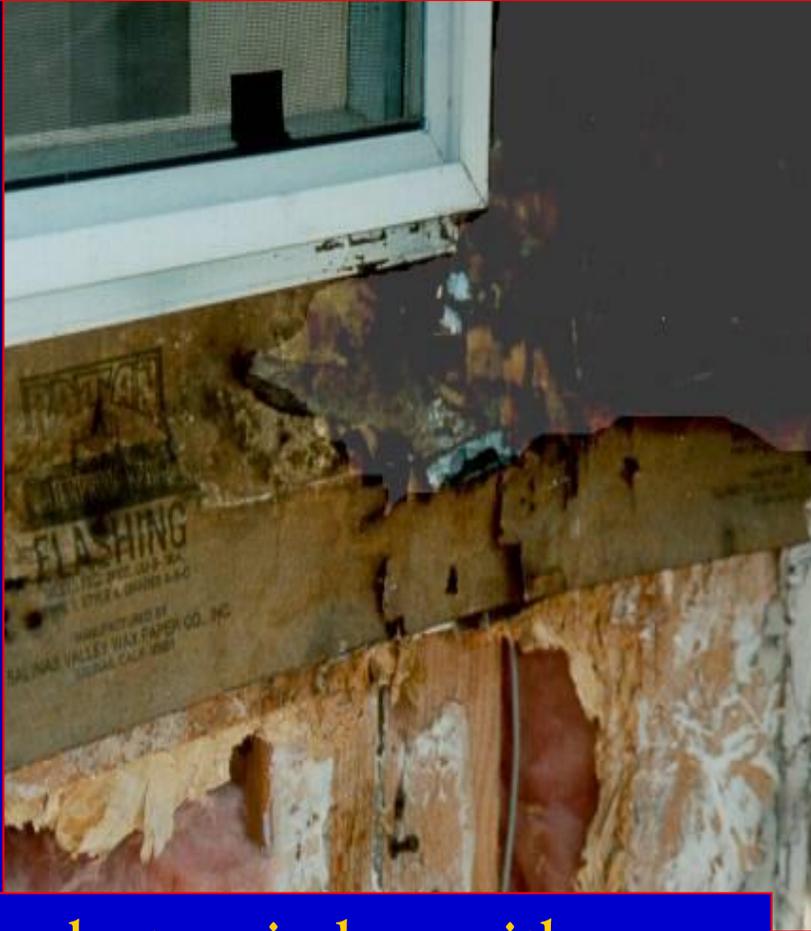
Leak at a window, with advanced decay in Oriented Strandboard (OSB) sheathing

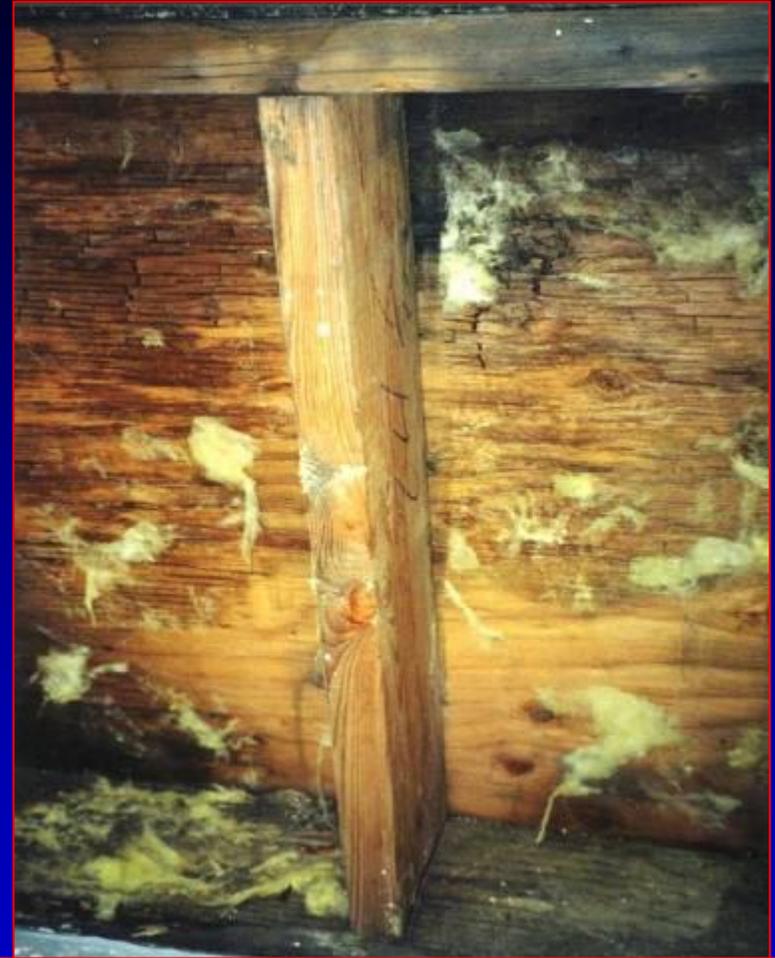
Leak at a window, with advanced decay in plywood sheathing...

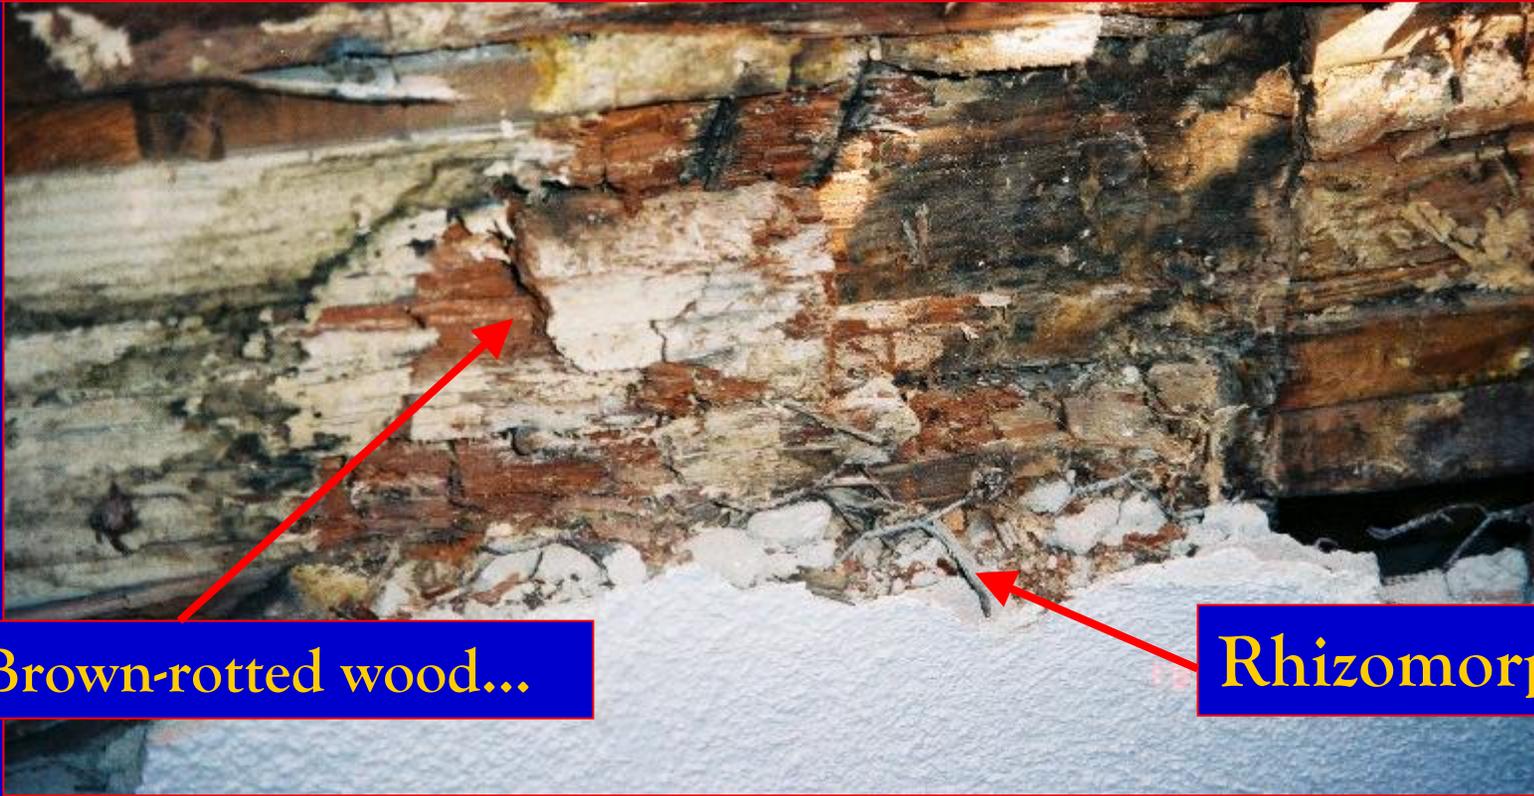
Brown-rotted wood...

Rhizomorph

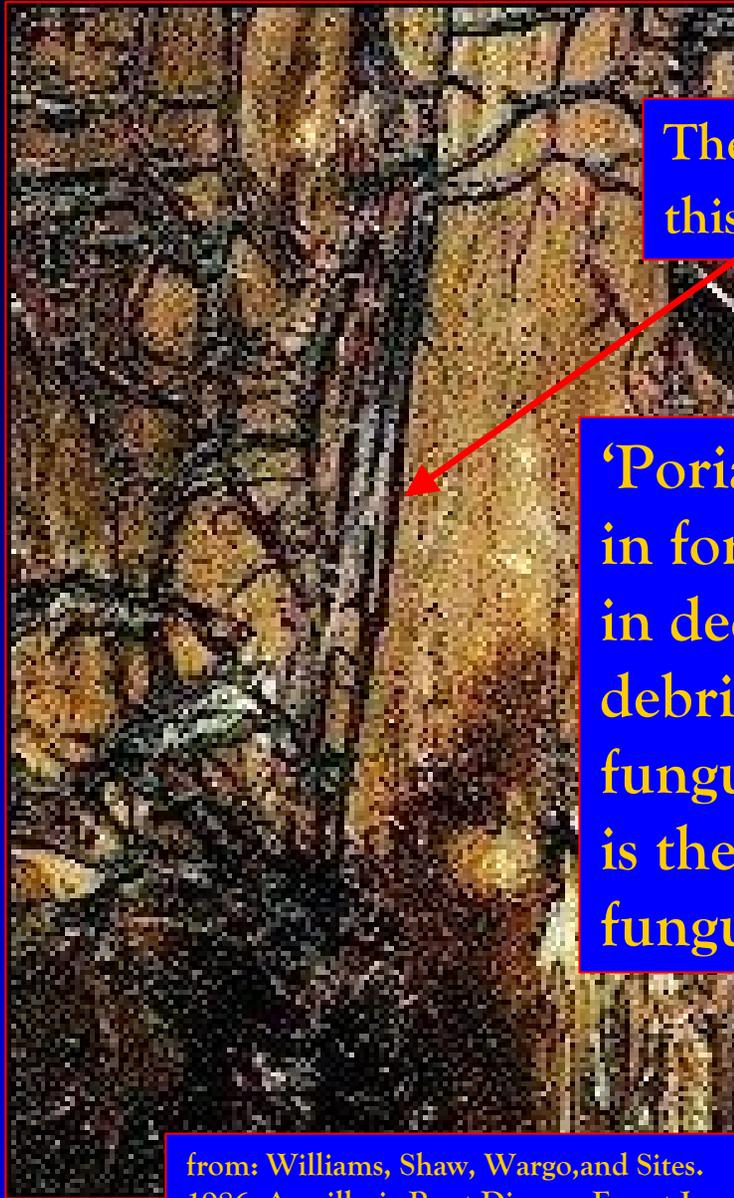
The rhizomorphs of decay fungi can look like this.

‘Poria’ is a common decay fungus found in forest soils and plays an important role in decomposing roots and other woody debris. As seen here, it isn’t the only fungus that produces a rhizomorph, but is the most common ‘water-conducting’ fungus found in structures.

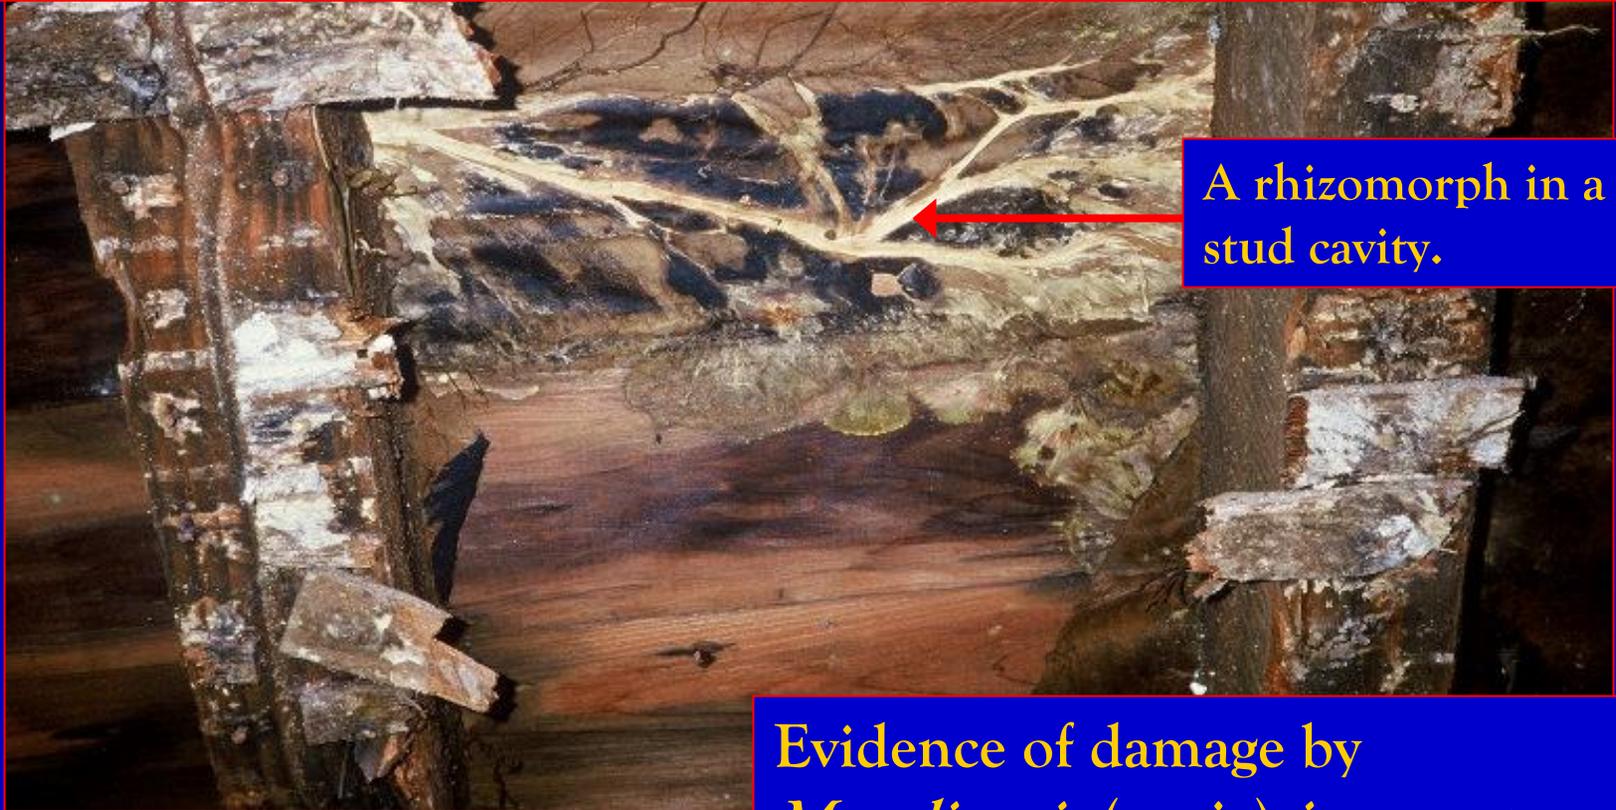
A rhizomorph in a stud cavity.

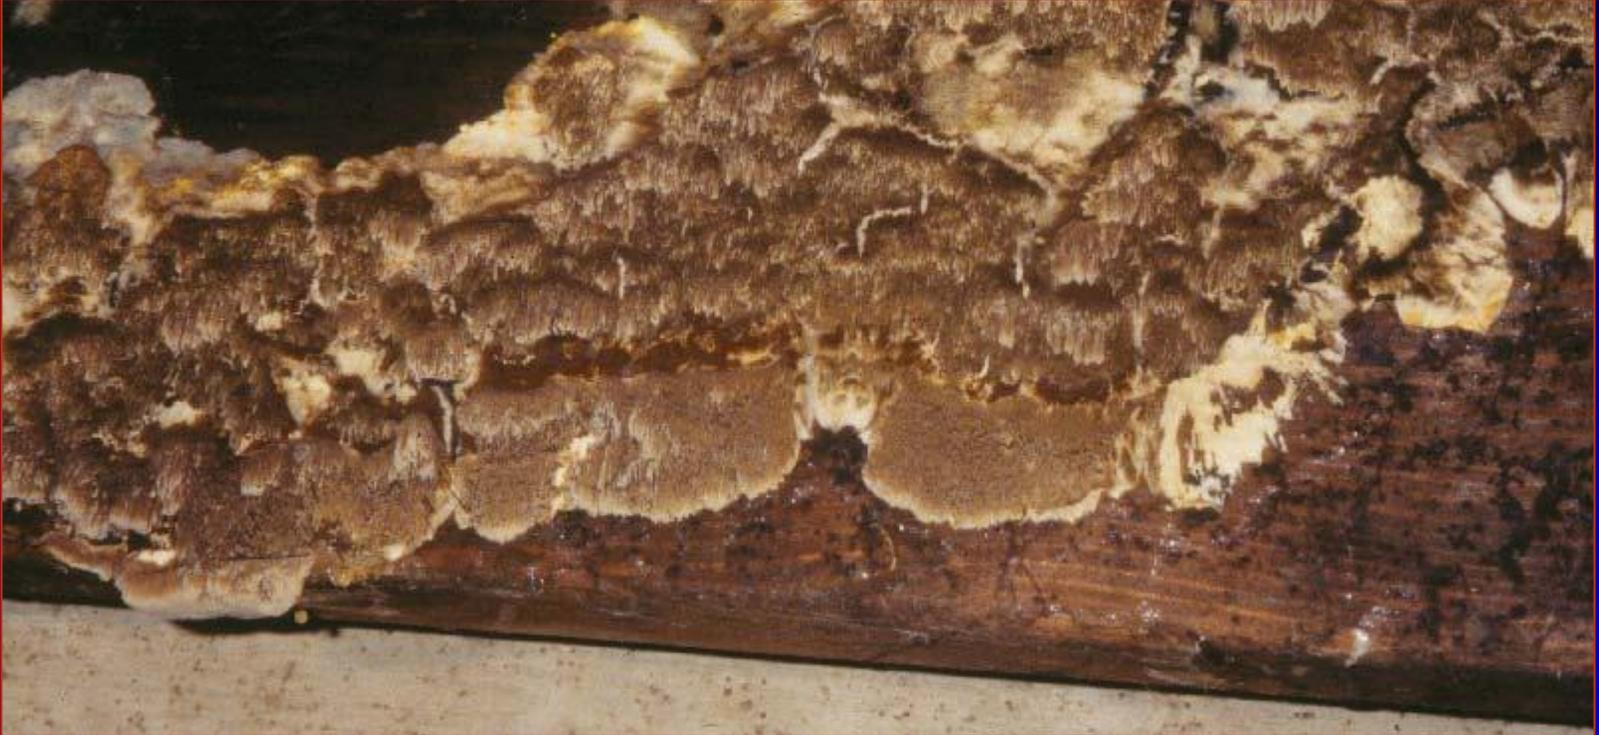
Mature fruiting (spore producing) body of 'poria'. The mature fruiting body produces a lot of brown colored spores. When touched, it feels a little like cream cheese.

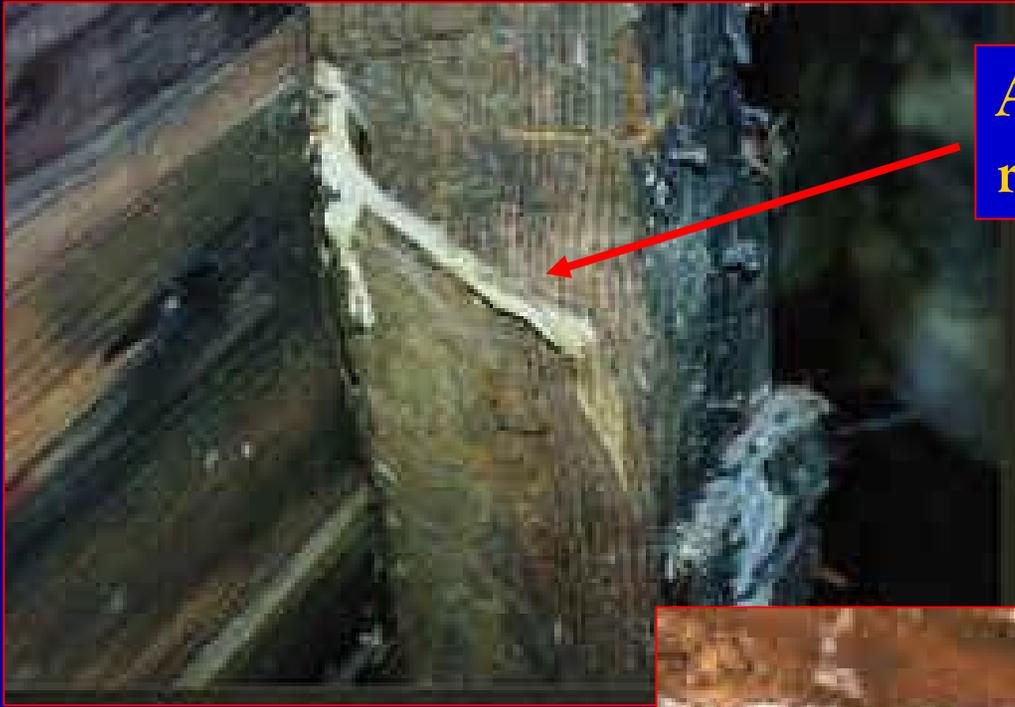
Another view of a rhizomorph in a stud cavity.

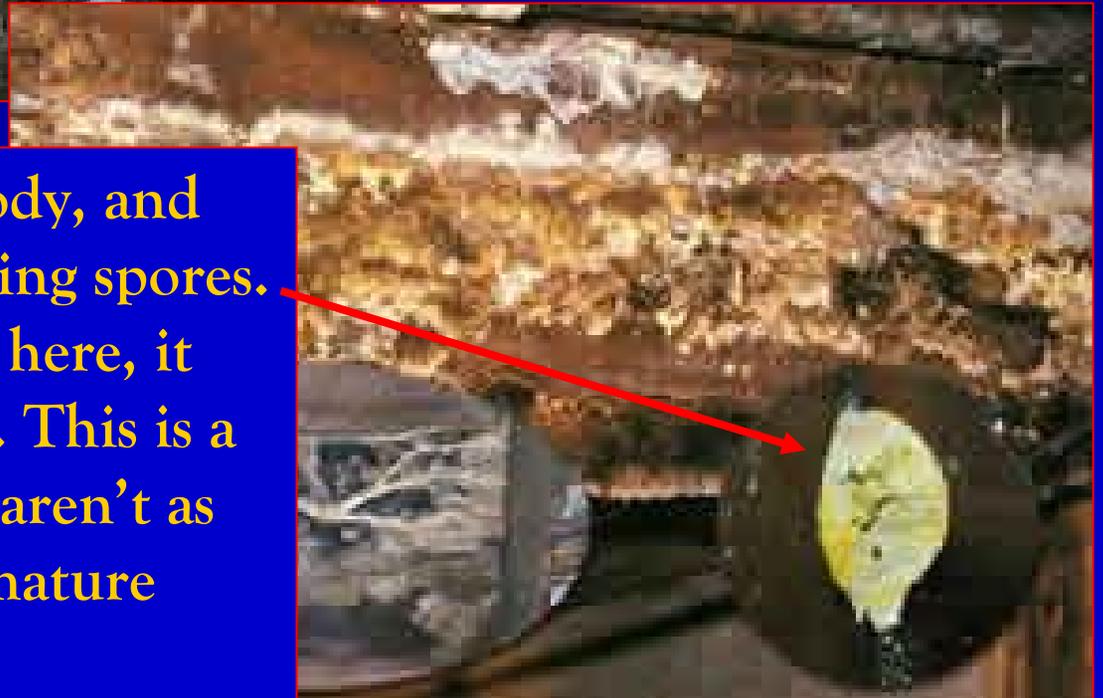
An immature fruiting body, and therefore not yet producing spores. Although it looks yellow here, it more often looks orange. This is a good id feature, but you aren't as likely to see it in the immature state.

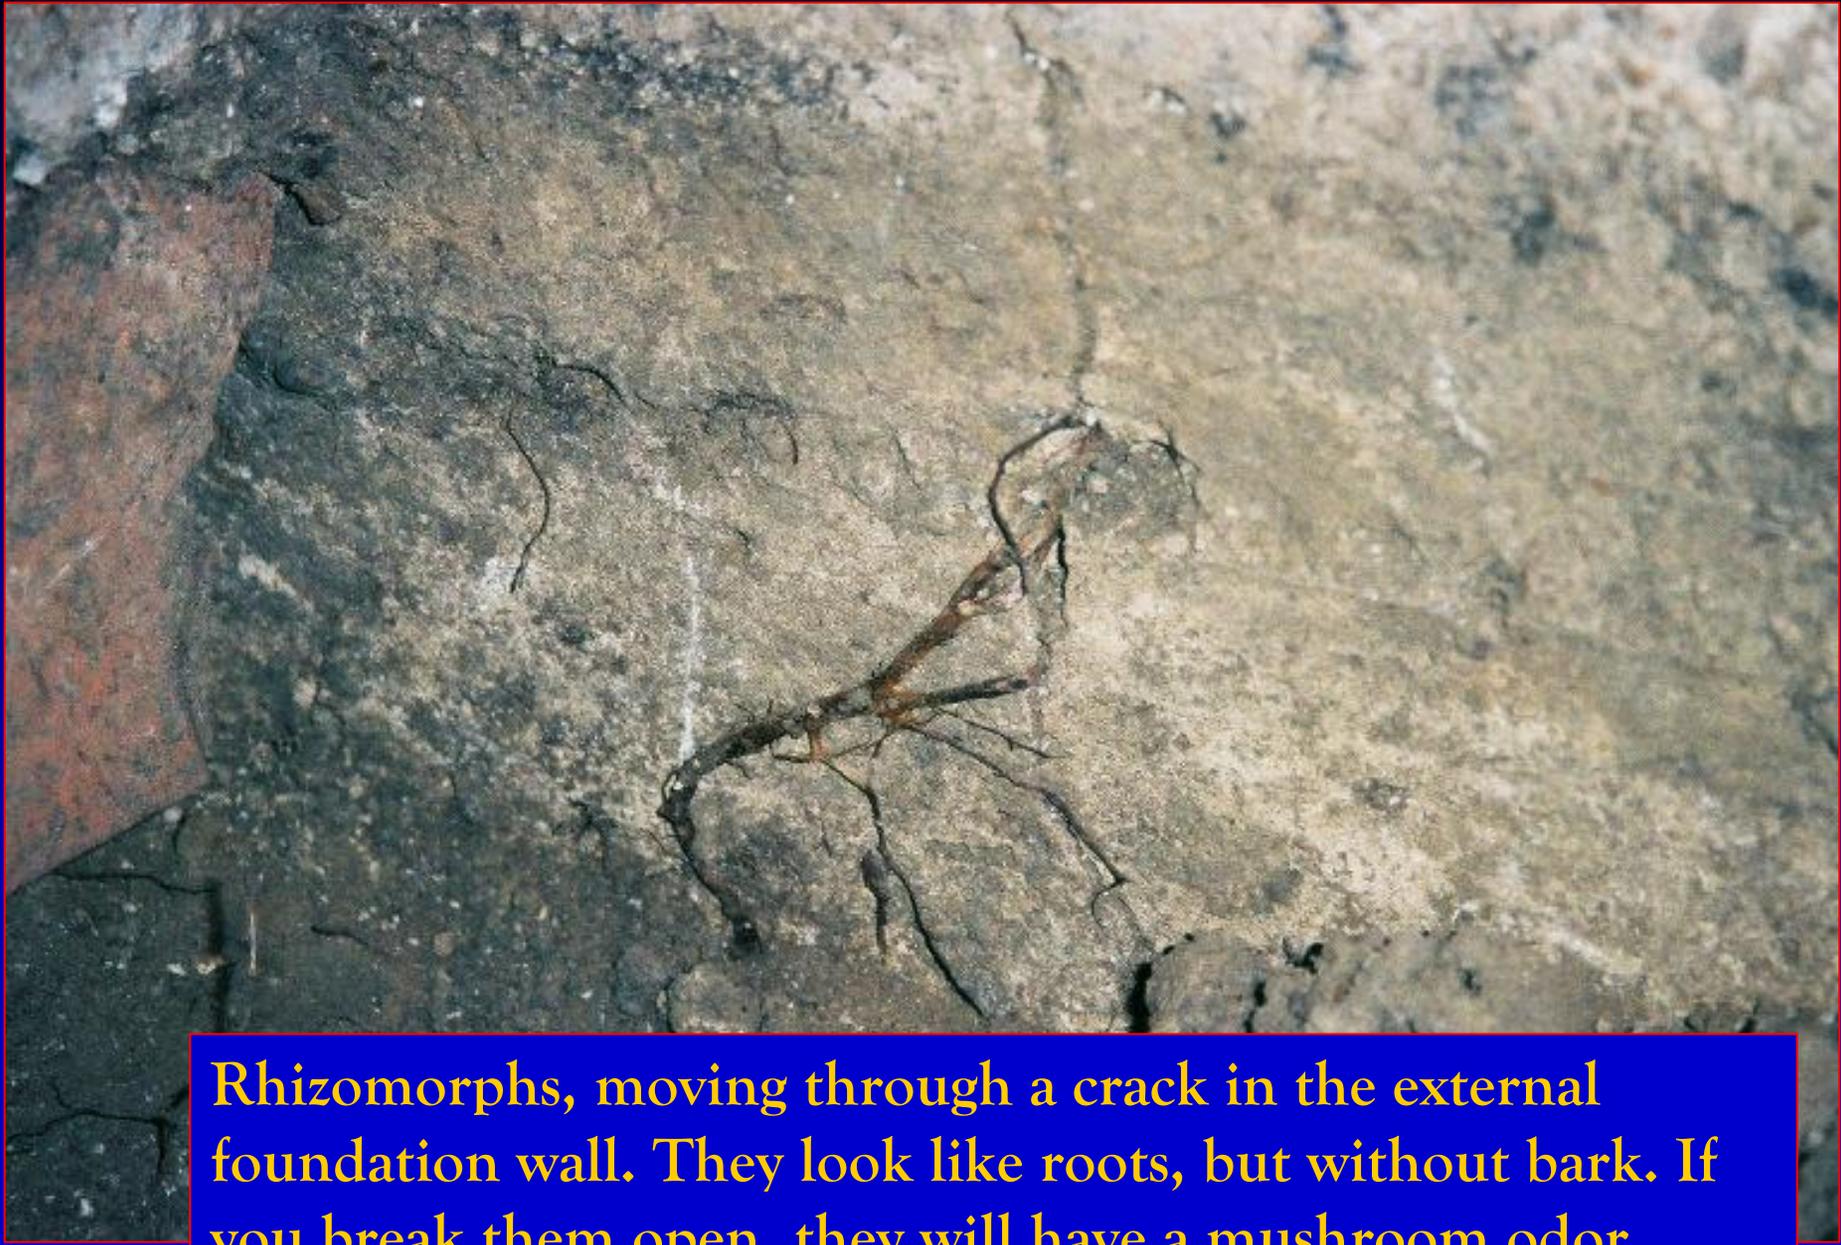
Rhizomorphs, moving through a crack in the external foundation wall. They look like roots, but without bark. If you break them open, they will have a mushroom odor.

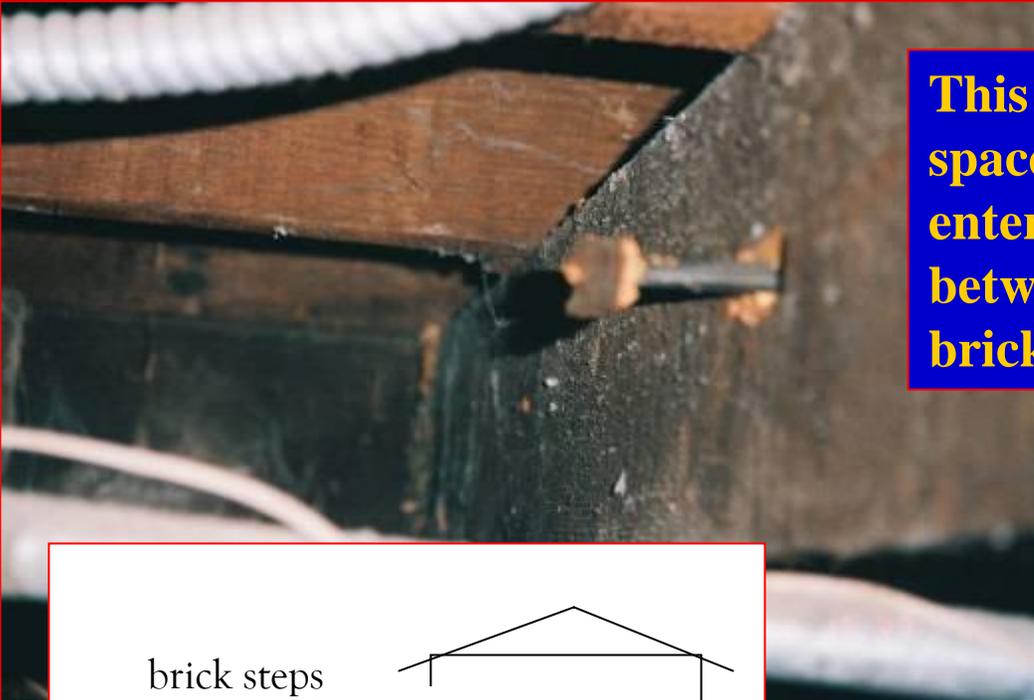
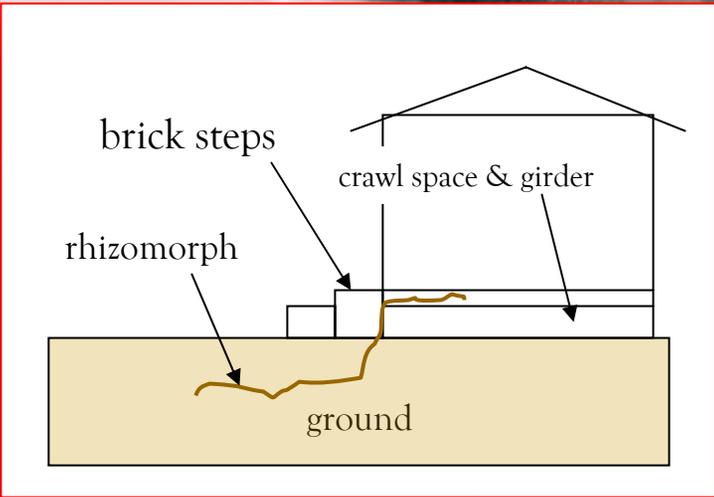
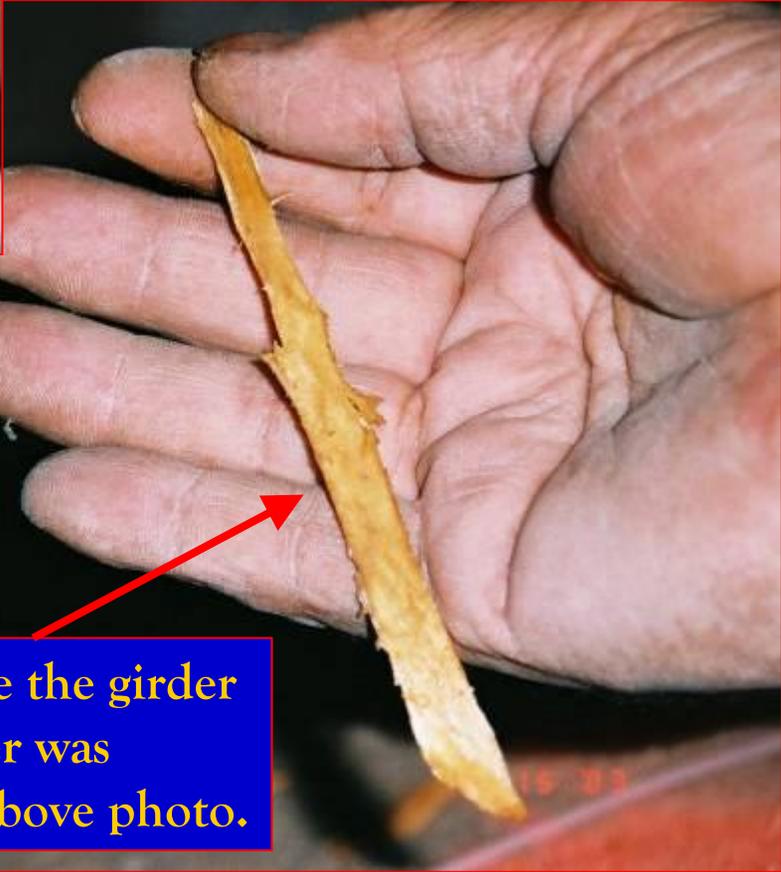
This view is of a girder in a crawl space. The rhizomorph of 'poria' entered the girder by growing up between the exterior wall and an brick stair entry into the home.

A fresh rhizomorph, taken from inside the girder shown in the photo top left. The girder was opened up the face not visible in the above photo.
