Meruliporia 'poria' incrassata

prepared by

Steve Quarles

UC Cooperative Extension Advisor, Wood Durability
Richmond Field Station, Richmond, CA 94804

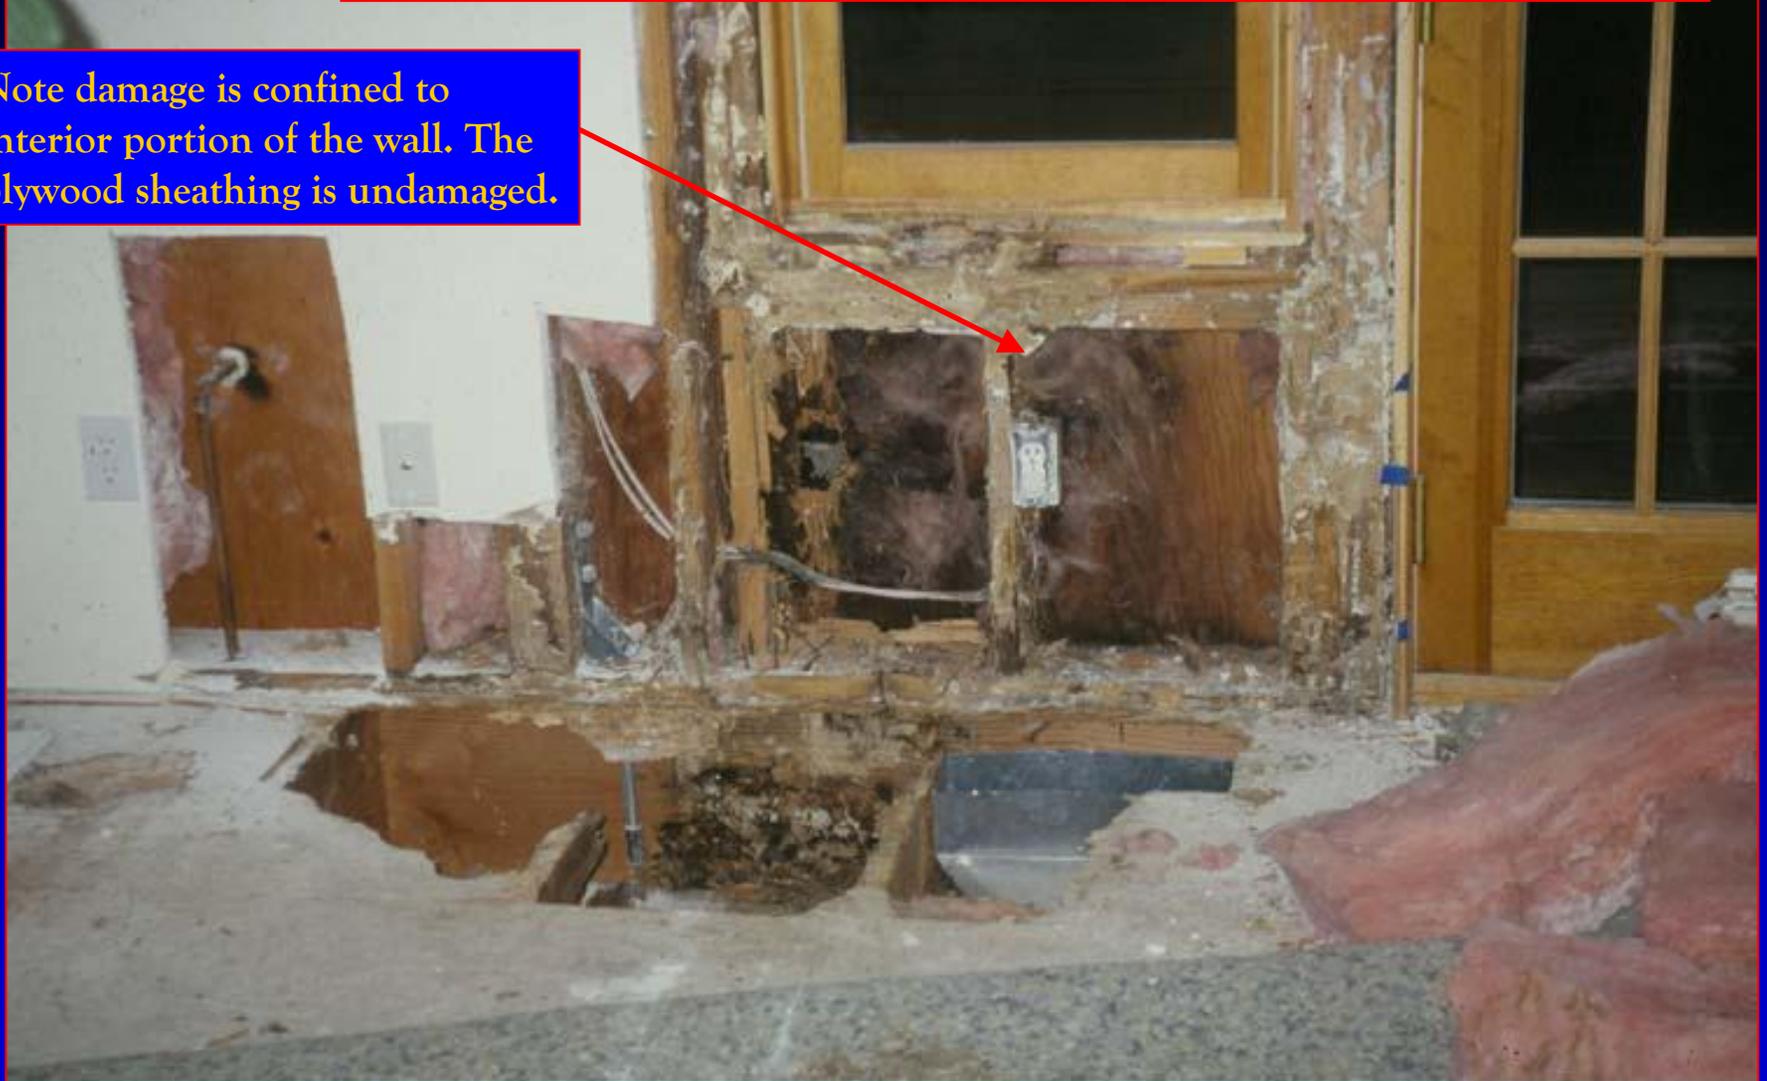
Is this damage from 'poria', or a 'normal' decay fungus that is relying on a leak at the window?

Note damage is confined to interior portion of the wall. The plywood sheathing is undamaged.

Yes, it is damage from 'poria'.

If you assumed the source of water was from a window leak, and either replaced the window, or tried to repair the window flashing, your efforts would not have solved the problem.

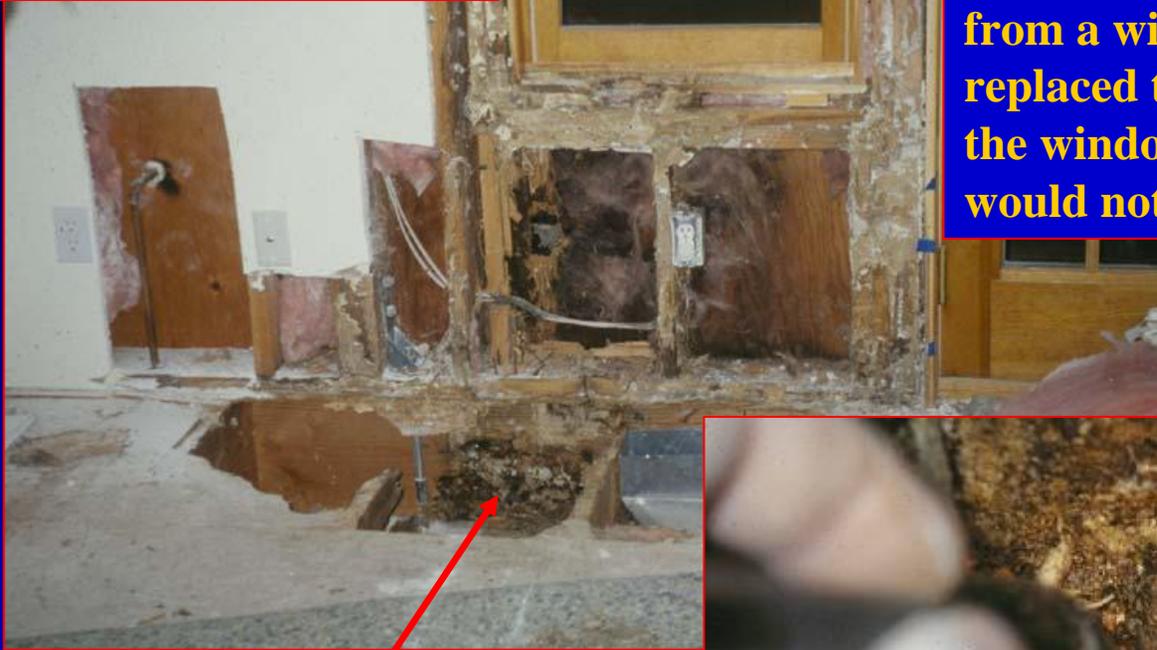
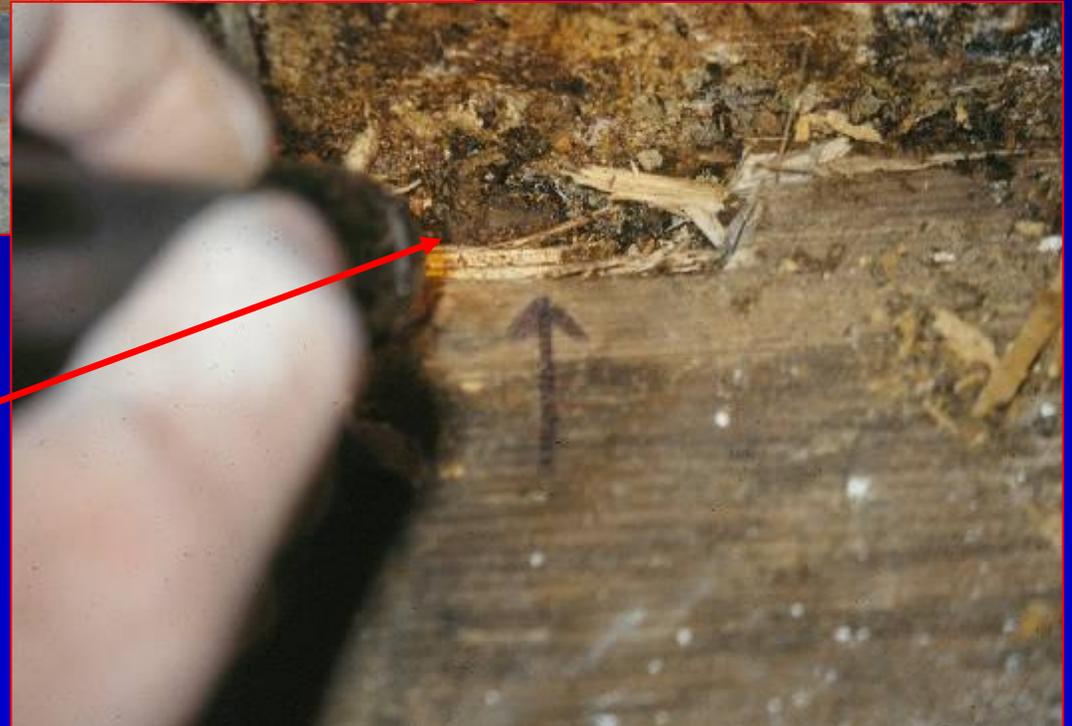
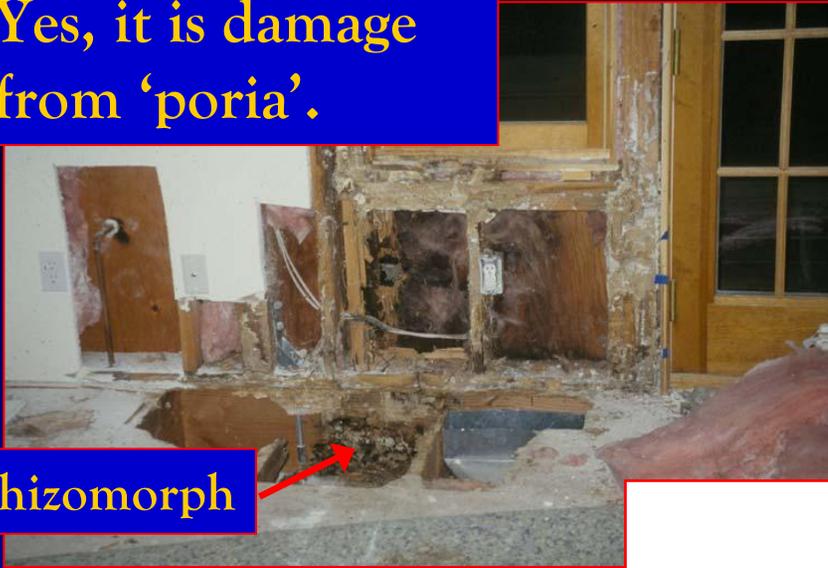
rhizomorph

Yes, it is damage from 'poria'.

At this house the outside grade was the same level as the inside floor framing. The rhizomorph grew through the gravel bed that was underneath the exterior concrete slab patio, and was able to enter and attack the 'between joist' blocking.

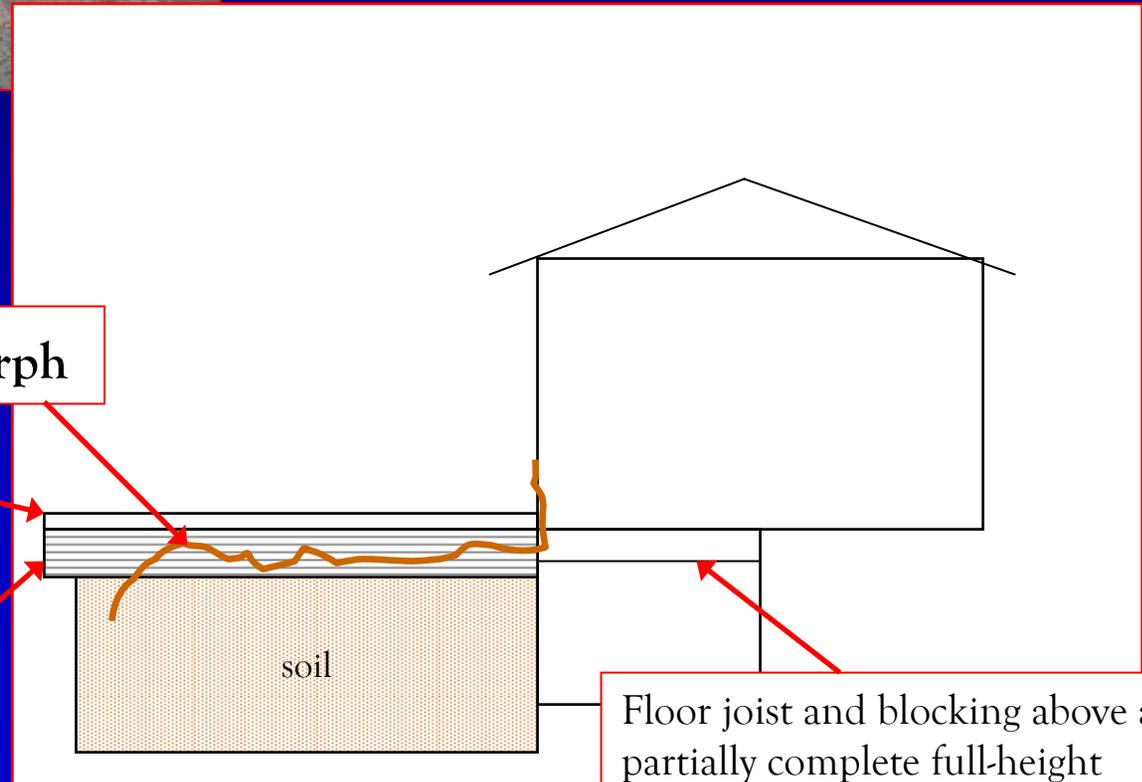
Floor joist and blocking above a partially complete full-height crawl space.

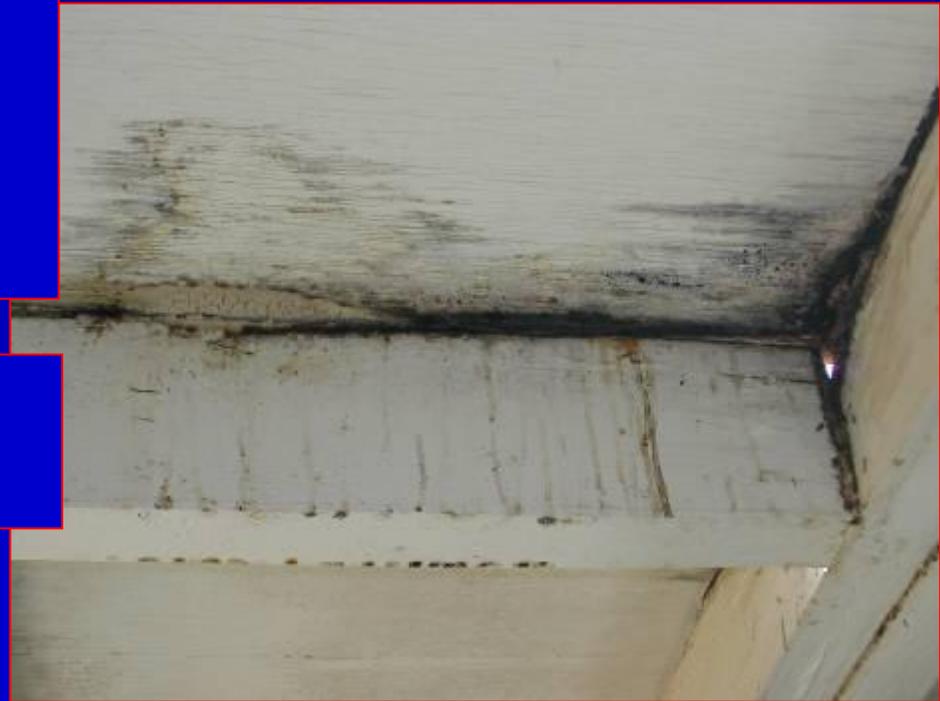
What would be an appropriate repair for the decay damage observed in the roof support system on this leaking roof?

Answer: Fix the roof leak and replace damaged wood.

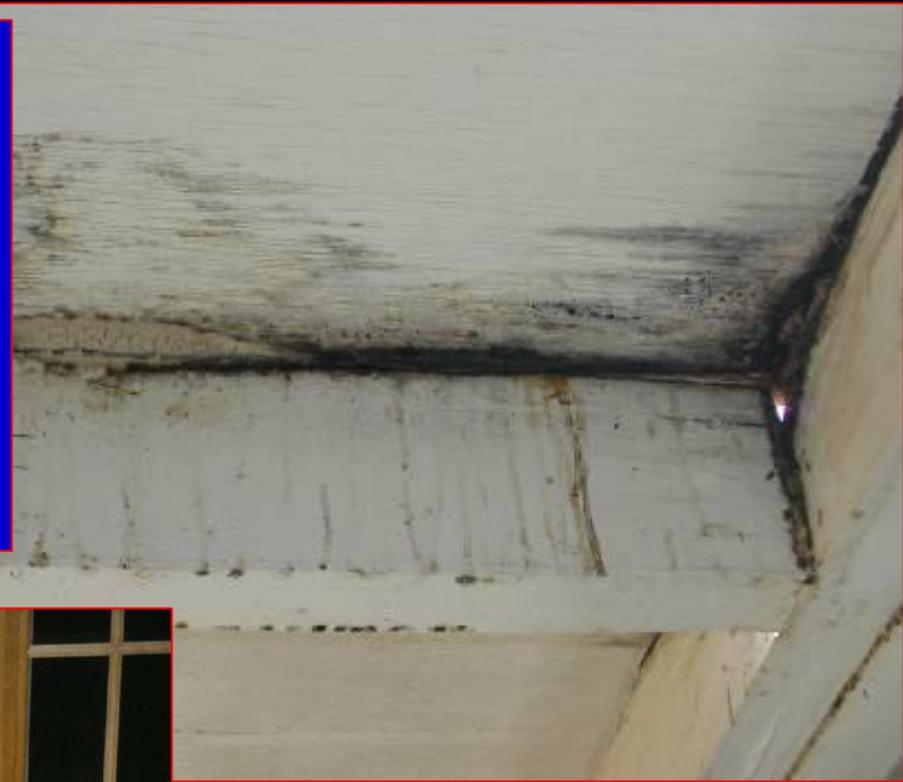
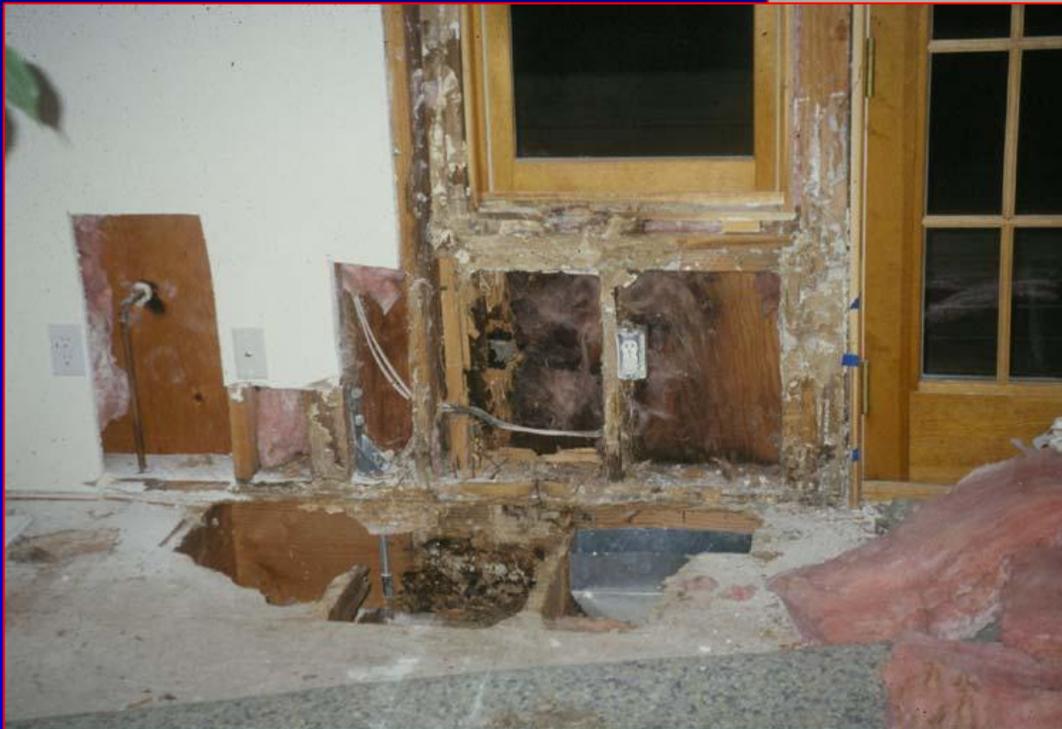
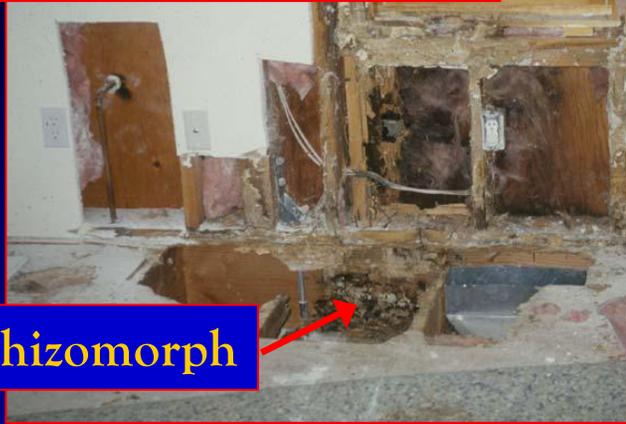
Yes, it is damage from 'poria'.

rhizomorph

Repair options for this 'poria' infestation could include:

- Lowering the exterior grade, all around the structure. This would force a rhizomorph to move over an the exposed concrete on the exterior of the foundation. With appropriate clearance, this can't happen. This is an expensive repair.

- Excavate around the perimeter foundation and apply a solid membrane (torch applied), and then back fill. Reasonable expense.

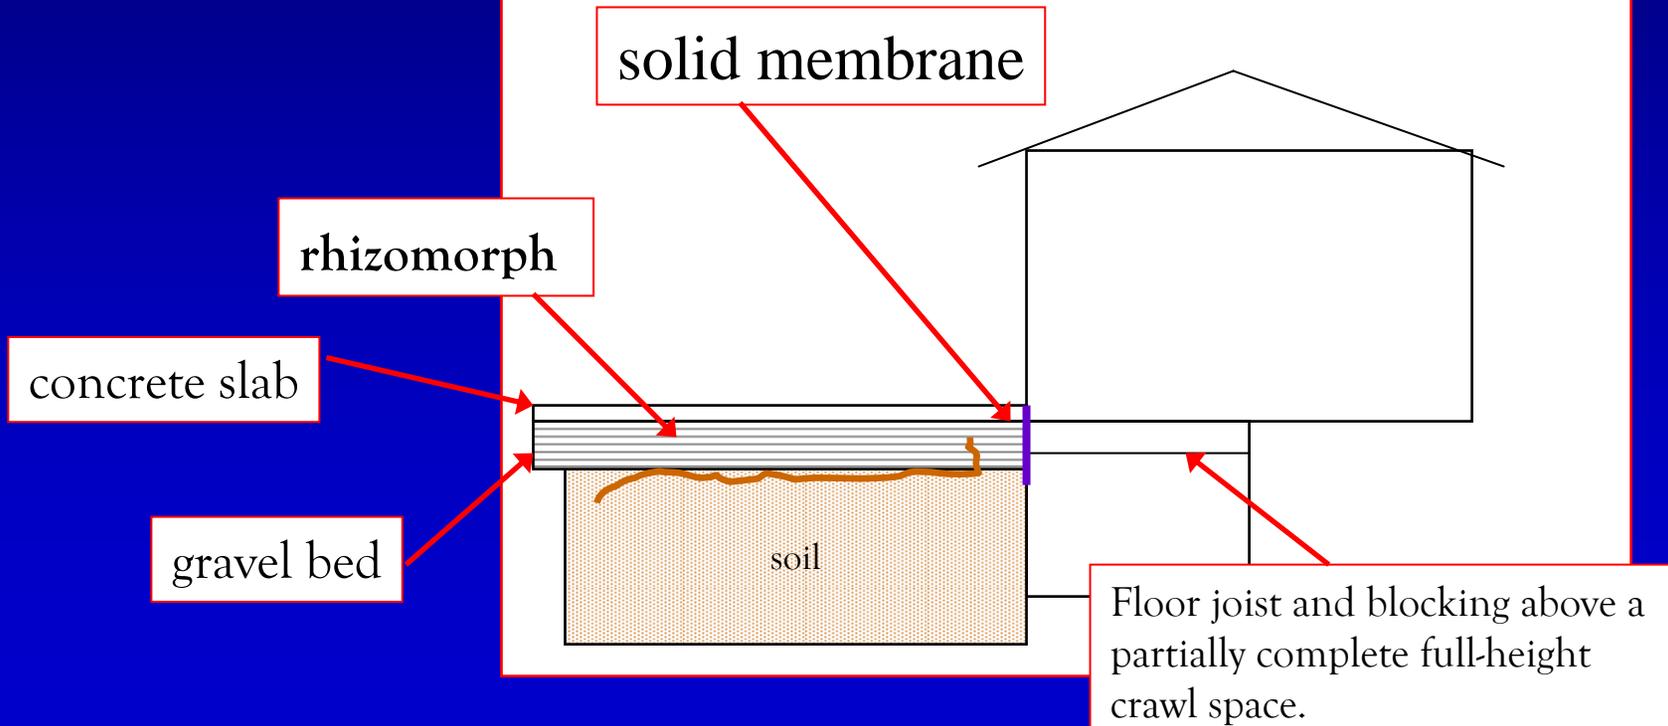
solid membrane

rhizomorph

concrete slab

gravel bed

soil

Floor joist and blocking above a partially complete full-height crawl space.
